Volvo Maintenance FAQ for 7xx/9xx/90 Cars

Editor: S. Ringlee

This list was developed for the owners of Volvo 7xx/9xx series cars who are interested in maintenance tips that are not generally available in commercial manuals. It was compiled from Brickboard and specific websites with useful information. Items which appeared to be of lasting value to 7xx/9xx/90 series owners were excerpted and copied to this file. Sincere thanks to all those who took the time to answer others' questions and contribute to this public discussion. Because these remarks represent contributors' personal opinions, users need to exercise caution about any advice given; indeed, some of the comments are contradictory. This list is current as of the revision date below and was compiled by Steve Ringlee, who is NOT a consulting mechanic but only recording secretary. While this public domain list may be shared either whole or in part without attribution, it may not be sold or rented. This site is not affiliated with nor sponsored by AB Volvo, Volvo Car Corporation, Volvo Cars of North America, Inc. or Ford Motor Company. "Volvo" is a registered trademark of AB Volvo and Volvo Cars of North America, with worldwi

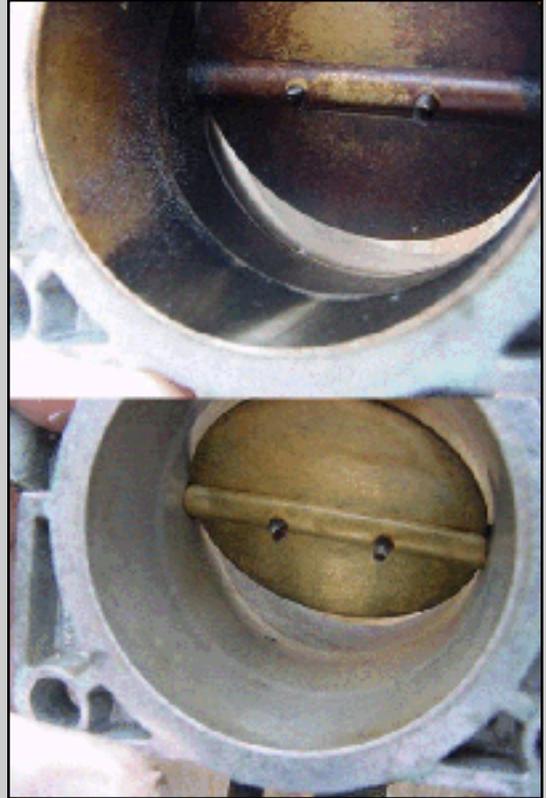
Symptoms and Why You Should Regularly Clean Your Throttle Body. The throttle body regularly fouls on the throttle blade and bore. The contaminants are oil droplets from the crankcase ventilation system. Every engine generates some blowby (gases blowing past the rings) - especially turbos. When the crankcase ventilation system routes these gases into the throttle housing, they carry oil residue with them. When this oily residue strikes the hot throttle blade, it condenses out due to reduced pressure and temperature inside the bore and "cokes" it with nasty, varnishlike deposits that restrict airflow around the throttle blade. Although the ECU tries to compensate for this restriction by tweaking the idle air control valve (IAC), it often can't compensate enough-hence, the driveability symptoms. Cleaning the throttle body often fixes the following driveability problems:

- stalling on deceleration
- rolling idle
- rough idle (hot or cold)
- off-idle or tip-in hesitation
- stalling just once, when the driver shifts into gear first thing in the morning
- sticking throttle in subfreezing weather (which may cause a no-start)

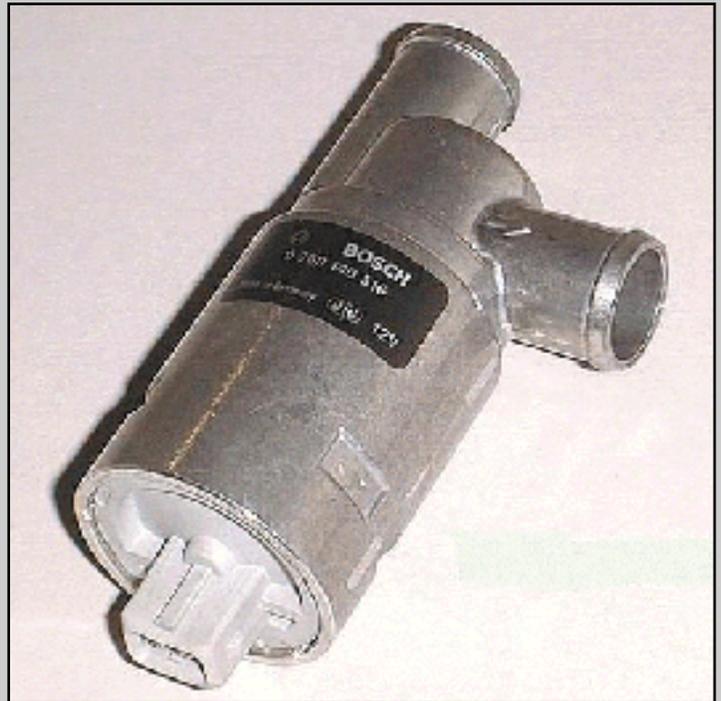
Cold Start, Dies; Dirty or Faulty IAC. [Symptoms:] Cold Start: Car starts immediately with no throttle application, idles smoothly for about one second, then hesitates and dies. Ditto for my 1990 245DL. Starts up cold for one second, then dies. Sometimes, all cranking I wish to do will not restart it. If I sit and wait about 5 minutes, it will start and run like a kitten, with no problems. I have replaced all spark plugs, s.p cables, rotor, cap. If it is a computer problem, can I fix it? [Suggestions:] Check the IAC (idle air control- This provides for more air, or faster idle on start up. The fact that it starts readily when cold indicates the cold start injector is working properly. See hints below.

[Symptom:] *Poor idle.* [Diagnosis:] Clean the dirty Idle Air Control Valve (IAC). I should have remembered. The car did not start at ALL. So, I took out, removed the two hoses and cleaned it by spraying it with engine grease remover. It had a lot of dirt in it. The Idle Air Control Valve is located under the intake manifold; below the second cylinder. It is about 3 inches long and about 1.5 inches in diameter (I do not have one next to me so these dimensions are from my memory.) It has two rubber hoses connected to it through a "T" connection. It also has a snap-on electrical plug. This is most likely your problem. Here is how I clean it:

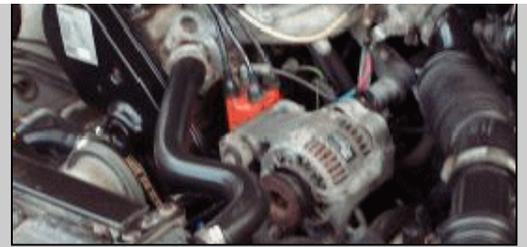
pulling motion on the boots. You may need to pry up a little on the boots to unstick them. Use an 8-mm wrench and remove the three bolts securing the cap. Pull the cap straight back and off. The rotor is tightly secured by press fit on the shaft and usually must be pried off with a large flat-bladed screwdriver. Remember the rotor orientation. To install, press the rotor back on, inserting it so that the keyway fits, and make sure it bottoms on the shaft. Reinstall the cap. Using silicone dielectric grease, coat the inside of the wire boots and reinstall. Press down firmly on the boot tops until the wire "clicks" into the cap.

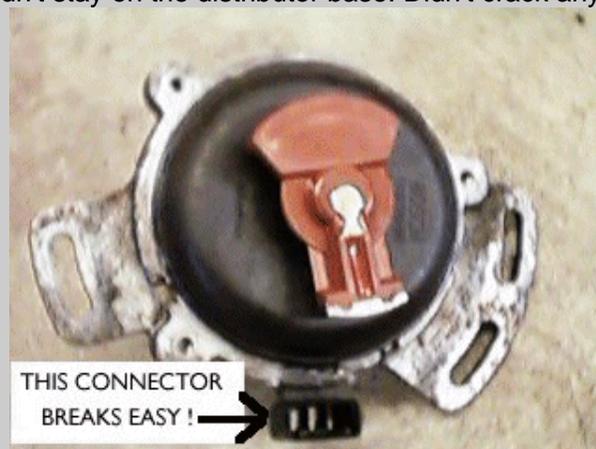
Wiring at the Connector. [Tip from John Sargent] Here is the correct wiring at the sensor connector in case your wires came out. Looking down on the top of the distributor, with the Hall effect connector down, left to right: black, green, red.

Hall Switch Distributor Connector. While replacing the distributor cap and rotor on the 87 764T the Hall switch connector at the distributor cracked off some of the old plastic and wouldn't stay on the distributor base. Didn't crack any wires/insulation. This distributor is used at least through 90 (my 90 740T has the part) and so did an 86 B230FT engine I used the long block on the 87. (Illustration courtesy of Mike Ponte)

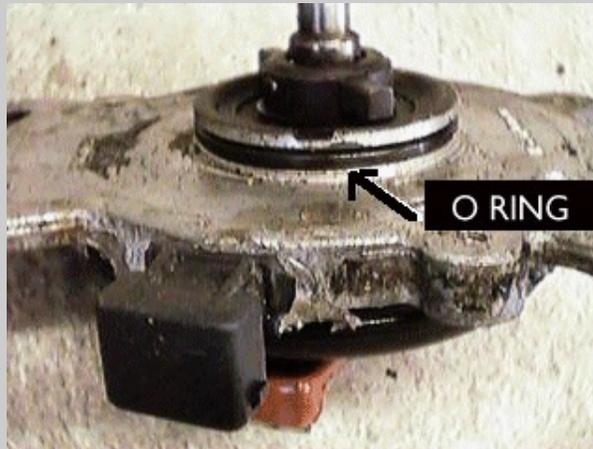
Distributor R&R and Shaft Seal Replacement. Oil leakage from the distributor on engines with camshaft-mounted distributors usually originates at the distributor shaft o-rings. High engine temperatures can cause these o-rings to shrink. There are three seals: two outer o-rings and an internal shaft seal under the drive dogs. [Editor's Note: See

Michael Ponte's excellent illustrations at <http://www.mikeponte.com/volvo/dist.htm> These picture a pre-89 distributor with a Hall switch, but are similar to newer ones as well.] Copies below:

There are two outer o-rings on the distributor shaft visible when you pull out the distributor. [Kevin Lawlor] The small o-ring fits on the end of the shaft and the large o-ring fits on the housing. Use a little Vaseline to install easily. [Tip from JohnB] There are three O-rings, but the inside one (the center shaft seal, see below) is almost impossible to replace, just forget it. The big O ring on the housing is generally the leaker and the little ring on the shaft helps to keep oil out of the distributor itself. [John Sargent] According to Volvo TSB of March, 1988, you should use the green o-rings made of improved elastomer rather than black rings.

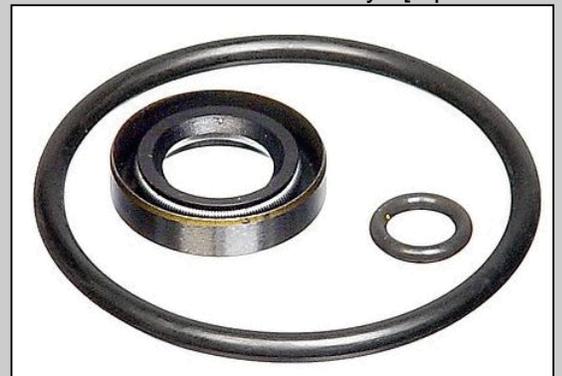
Where to Find Center Shaft Seal: [Tip from John Sargent] If you have distributor shaft seal leaks in the 700 series with B230 engines (cam driven distributor on rear of head), the distributor o-rings are available from Volvo, but the shaft seal is not. A few weeks ago I even looked in the parts manual, and the shaft seal is not shown. Jim found that Honda part #91205-KF0-003 is a replacement for this seal. It works perfect. However, it is not stocked by many Honda mower dealers, and some want a \$7.50 service fee to order a non-stocked part. The seal is about \$2.50 US from Honda (#91205-KF0-003 Honda or Transcom #12X20X4TC). This seal is simply a metric seal, 12mm X 20mm X 5mm. It is for a 12mm shaft, it is 20mm OD, and 5mm thick. It is also a rubber coated (that's good) seal with two lips. As near as I can tell, the original seal Volvo used came both rubber coated and non-coated, and appears to be a single

lip seal although I can't tell for sure. Now for the substitutions. Chicago Rawhide seal 4701 is exactly the same with a single lip. Transcom seal #12X20X4TC is a double lip seal, rubber coated, that is 4mm thick. That is what is in the distributor in my wife's 745T. When I installed the seal, I set it with the outer edge flush with the distributor housing. There is a 1mm gap behind it which won't hurt anything. You could also set it all the way back in the housing, and it should also be fine. It fits tight, and I doubt that it would ever move out against the seal retainer. The Transcom seal cost \$1.82 US from a local bearing sales house. For those of you who can't get those brands of seals, simply contact a bearing supply company and tell them you want a 12mm X 20 mm X 5mm seal, preferably rubber coated with double lips.

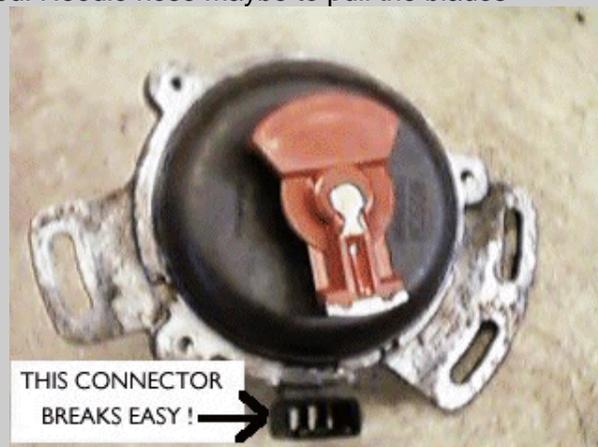
Fix or Buy? [Tip from Bruce] The procedure requires some skills (see Jim's remarks below.) If you can locate a Bosch aftermarket source or an independant Volvo repair center try to get a complete new distributor, cap and rotor as one unit. They are not cheap. Price out the Hall switch, o-rings and cap and rotor. You may not be much less that the price of a complete new unit. Shop

around for a Bosch service center or an independent Volvo repair center who may sell you the complete Bosch unit cheaper than a Volvo brand unit.

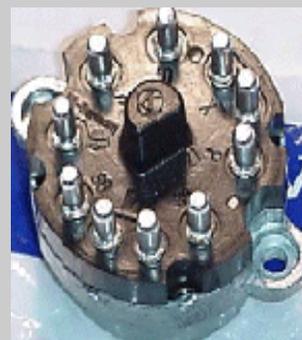
Changing Lock Cylinder Mechanism of Switch: Lock in Panel (740/940). [Response from Bob] You don't have to

remove the steering wheel under normal circumstances. The method for removing the lock cylinder is to remove top and bottom steering column covers and the panel on the driver's side footwell under the column. Insert key, turn to position 2. There is a small pin in the lock casting on the top just behind the chrome front of the barrel (about 1" from end of lock cylinder). At key position 2, depress this pin and the whole barrel pulls out. If stuck, push it from the rear. If you have drilled out the lock, this method may or may not work. Try turning to position 2 with your screwdriver, press the button and see if it will come out. The button is brass colored, about 1/8 inch in diameter. It doesn't move very far. All it does is release the spring clip that holds the cylinder in. If you can't get it out, you may have to pull the column out and press off the whole lock assy.

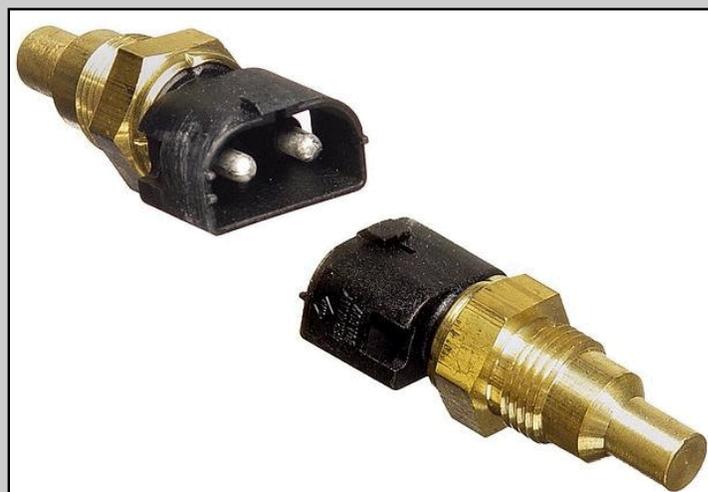
Removing the Sensors. [Inquiry] How do I remove the *gauge temperature sensor*? [Mark Duval] This is the front sensor under intake manifold runner number two. I bought the "stubby" 19mm combination wrench and a 19mm crow foot socket. First tried the open end side of the stubby and although I could get it squarely on the hex head, I could not put enough force on the wrench to turn the sensor. Then used the crow foot socket with a long extension. This rotated off the hex and cracked the electrical connection at the top of

the sensor. The answer all along was to remove the sensor's molded-on electrical connector (destroying the sensor) and gain access to the hex with an offset 19mm box wrench or a 3/4 inch socket. [Jay Simkin] Remove the old sensor and prep the new sensor by wrapping 1/2" wide teflon tape in two turns around the threads. Then apply grey pipe joint compound (not the white, teflon-loaded joint compound) in a collar of compound on the underside of the sensor's lip, above the threads. Keep the joint compound away from the threads. To reinstall, gently screw the prepped sensor into the opening in the block. Tighten snug using a 3/4" open end wrench. A 3/4" socket will not work, as the electrical connector housing is wider than the brass hex fitting used to secure the sensor. Check for leaks. Tighten gently if required to stop any leaks. Replace the knock sensor using a 12mm wrench to tighten it securely against the engine block. Replace both electrical connectors and reconnect the battery negative.

[Editor] It helps to first remove assorted tubes and pipes, including the IAC valve and the *knock sensor* nearby, which is merely bolted into the block. *Removing the Engine Coolant Temperature Sensor* (the rear-most of the three sensors) is a little tougher, since it is buried under intake manifold runner number three. [Tip from John Sargent] Removing the intake manifold makes it less than a 30 minute job. Trying to R&R without removing the intake manifold can lead to a broken sensor. The brass hex of the ECT is 19mm. The electrical connector is larger than the 19mm hex and a socket or box end wrench will not fit over the electrical connector, so you can only use an open end wrench to remove the ECT. The wiring harness connector can be very difficult to disconnect without removing the intake manifold. Save yourself

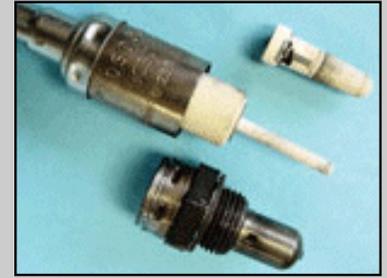
The O2 sensor is mounted in the exhaust manifold to monitor how much unburned oxygen is in the exhaust as it exits the engine. Monitoring oxygen levels in the exhaust is a way it gauges the

fuel mixture. The sensor "tells" the computer if the fuel mixture is burning rich (less oxygen) or lean (more oxygen).

The O₂ sensor works like a miniature generator and produces its own voltage when it gets hot. Inside the vented cover on the end of the sensor that screws into the exhaust manifold is a zirconium ceramic bulb. The bulb is coated on the outside with a porous layer of platinum. Inside the bulb are two strips of platinum that serve as electrodes or contacts. Between the electrodes is a solid-state electrolyte made up of a zirconic ceramic material that acts like a galvanic battery electrolyte under certain conditions. When the sensing element is cold, the zirconia material behaves similar to an insulator. At elevated temperatures, the zirconia material performs more like a semiconductor, and can generate a characteristic voltage output on the sensor connections. The outside of the bulb is exposed to the hot gases in the exhaust while the inside of the bulb is vented internally through the sensor body to the outside atmosphere. Newer-style O₂ sensors "breathe" through their wire connectors and have no vent hole. This is why grease should never be used on O₂ sensor connectors because it can block the flow of air.

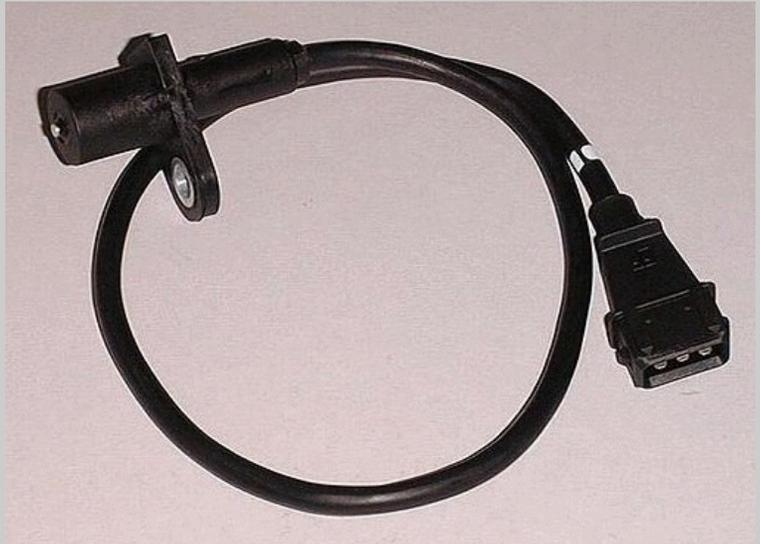
B2XX Series Engines. Symptoms of Failure: No Hot Restart. Suppose the car already has the upgraded silver-terminal fuel pump relay but won't restart promptly after a hot soak. Take an educated guess on a weak crank position (RPM) sensor. If you have Bosch LH2.4, then replacing this permanent-magnet sensor located in the top of the bellhousing fixes many hot restart complaints on 700/900s. [Tip from HansW] Check the lead to the sensor: it can rub against engine components and expose the wiring. Newer sensors come with plastic cable holders to prevent this.

[Response: Ivan K] Often these rpm sensors fail intermittently, usually when hot. This makes them hard to test. Since the sensor is cheap enough, just replace it. With high mileage cars, it's only a matter of time before they fail. [Response] Measure the signal while the sensor is still installed by unplugging the sensor at the cable connections at the firewall to the drivers side of the engine. Measure voltage here as the engine is being cranked. Use a low voltage setting on a digital volt meter, preferably in an alternating current setting if available in a low voltage setting. If no signal is detected, the unit is suspect. The other simple measurement is to unplug the unit (without removing it from its location behind the engine on top of the transmission housing). Check all 3 terminals for resistance or an open circuit. The new sensor measured about 160 ohms between the center lug and a side lug. My old defective unit had no continuity and no measurable resistance.

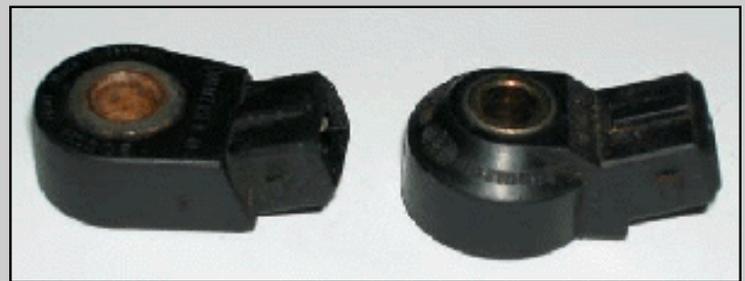
Sensor Styles. [John Sargent] The knock sensor is located on the cylinder head under the junction between number two and three intake manifold runners. It is next to the two coolant temperature sensors also bolted to the head. LH 2.1, LH 2.2, and LH 2.4 all use the same knock sensor, offered in two

interchangeable styles that may be used on the red engines. Type 1 is on the left in the photo on the right, and Type 2 on the right. The only difference in the parts is the torque for the bolt holding the sensor to the block. Type 1 has the flat top, and the fastening bolt is torqued to 8 ft-lbs (11Nm), and Type 2 has the domed top and the fastening bolt is torqued to 15 ft-lbs (20Nm). If you use anti-seize paste, reduce the torque setting by 30-40% to account for the lubrication by the paste.

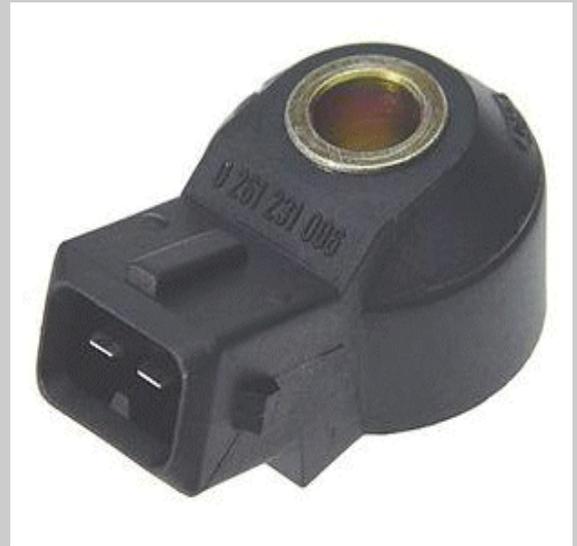
around 3000 rpm with moderate to high throttle. If it is not torqued properly it might not be as sensitive as it should or be overly sensitive. Torque is 8-11 ft-lbs. It produces a high voltage pulse when it senses the shock wave in the range of combustion knock. The voltage level is proportional to the severity of the knock. It will read 1.5 or greater megaohms but this is not really an effective test, only the control unit detecting a sensor signal when the conditions would absolutely assure a signal would be made is the real check. The knock sensor test by whacking on block (better than on the intake) next to knock sensor (see Duane's note below) is only effective on early Chrysler systems with the throttle opened as the closed throttle signal is supplied

to Chrysler ignition ECU and it cancels knock sensor retard activity. If you have Bosch ignition systems you can't do the whack it and watch it test for knock sensor operation. The Bosch systems are cylinder specific and you would have to knock within a few crank degrees of a given cylinder firing and be monitoring the timing light attached to that cylinder's plug wire. I don't think any of us are that good. [Tip for Chrysler Ignition Systems from Duane Hoberg] On the right side of the engine, in the area above and to the rear of the oil filter, tap the block with a metal faced hammer while observing the timing with a timing light. The timing should retard 6 degrees then return. If not then the sensor or the circuit in the control box is bad. When installing the new knock sensor, use thread lock. Apply too much torque and the sensor becomes sensitive as it is prestressed and reacts to normal engine vibration. When this happens you will idle fine but above idle run at retarded timing all the time. Acts like poor fuel delivery and doesn't like hills.

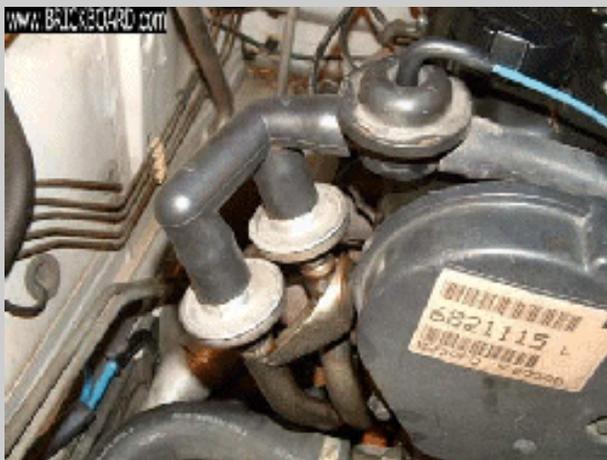
Pulsair Valve. [Tops from Tom F] Volvo introduced Pulsair system on B200/30A, E, and K-engines and on the US '94-'95 B230FD engines. The Pulsed Secondary Air injection system adds oxygen to the exhaust manifold to continue the combustion of unburned fuel in the exhaust

system and provides additional oxygen for the catalytic converter, thereby lowering harmful emissions.

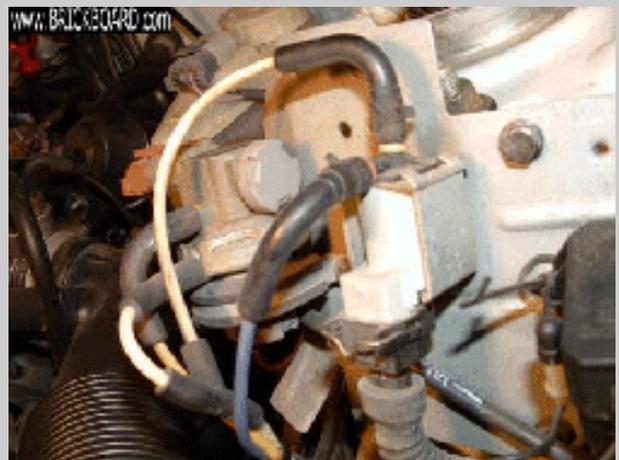
It is independent of the [EGR system](#) and many cars have both. The pulsed secondary air injection solenoid or PAIR Solenoid, receives a signal from the ECU allowing the vacuum control valve to open. It is located on the left strut support between the EGR Converter and the OBD box. The PAIR valve (Pulsair valve), with permission from the ECU, allows oxygen in every time the exhaust valve closes, which causes an instance of negative pressure (the pulse) and introduces oxygen into the manifold. No air pump required. The photo shows the two Pulsair valves feeding the exhaust manifold and a vacuum control valve which get its a signal from the PAIR solenoid to allow air from the air cleaner box to pass through. If a valve fails, it can allow exhaust gas flow back, cooking the rubber hose. The hose is connected to a vacuum operated shutoff valve connected to the air cleaner. To test the pulsair valve, on a cold engine, place your

hand over the valves, near enough to verify that air is being taken in and exhaust gas is not escaping. The action of the valve is a quick "pulse" corresponding to the opening and closing of the exhaust valves.

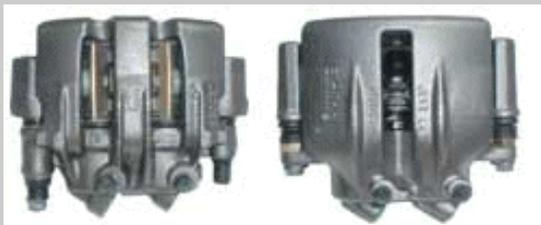
ATE calipers are ONLY used on rear wheels. Note that DBA is the same as Bendix. The best way to identify front calipers is to look thru the wheel for a large iron bridge that reinforces the caliper body (with a slot on either side i.e. two slots):

Bendix caliper is in the left photo, Girling in the right. [Photos courtesy of [IPD](#), a retailer of Volvo brake components]

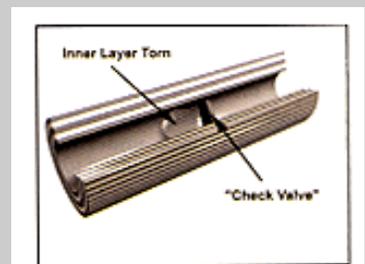
Fig. 7: Occasionally, the inner layer of a hose will tear or separate and form what is commonly referred to as a "one-way check valve".

Brake Hose Deterioration and Brake Binding. [Inquiry] My front brakes are dragging - both sides and quite severe. On the right side the pads are worn evenly and the pistons move freely. How can I check the brake line for internal swelling/collapsing? [Tip from Herb Goltz] An old brake hose acting like a one-way valve is a very common problem. The inside of the hose rubber deteriorates, creating a flap internally that blocks the return of fluid when the brake pedal is released, causing dragging brakes, warped rotors, and pad wear. Many "dragging" calipers get replaced for this reason. [John Randstrom] The easiest way to check for a bad brake hose is to pump and release the brake pedal, then open the bleeder screws on the caliper. If pressurized fluid escapes the hose is bad. I have had quite a few hoses that were bad that caused a caliper to drag. [Colin] Apply the brake a few times to get the brakes binding and then slacken the bleed nipples. If you get a spurt of fluid and the brake frees off you have a restriction preventing fluid returning back to the master cylinder reservoir. This could be brake lines or master cylinder. Do the same again but slacken the lines at the master cylinder this time, instead of the bleed nipples. If both brakes are binding equally it's more likely to be a master cylinder problem.

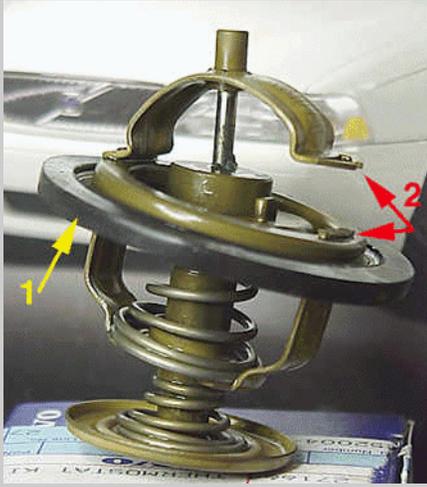
The illustration at left shows the typical failure mode for thermostats, with the rubber seal split at "1" and the piston brace broken at "2". Either may occur.

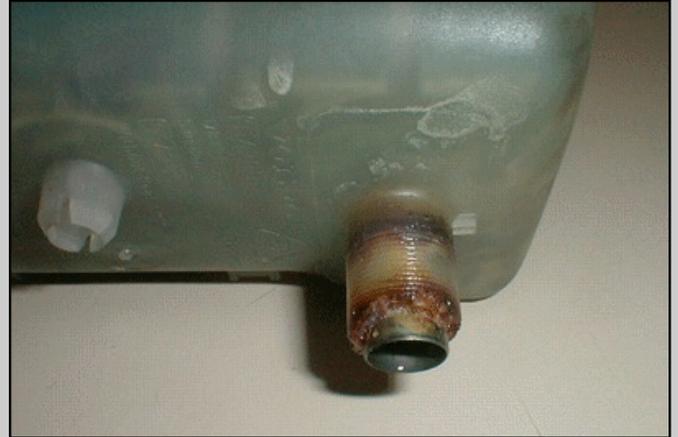
Coolant Reservoir Replacement . [Tip from Paul Seminara] I have found the source of disappearing coolant from a 1992 940T. The lower outlet on the coolant expansion tank is cracked. These rectangular tanks have a steel insert, presumably to prevent damage due to overtightening. Corrosion of this inset has lead to swelling and cracking of the plastic. I suggest that if you find a trace of leaking coolant at this point, you remove the hose and inspect this and not just tighten the hose clamp. [Brian Sullivan] My nine-year-old 945T

developed a very small crack in the top of the reservoir... it bubbled a bit when the engine was hot. When I pulled the outlet hose off the bottom of the old tank, the bottom 1/4" or so of the plastic crumbled and fell in the hose. Also, one of the interior plastic walls had broken, and a chunk was floating in the tank. [Editor] These tanks will embrittle over time and should be changed as a "wear" item. Every eight years, at the same time as the radiator, is appropriate.

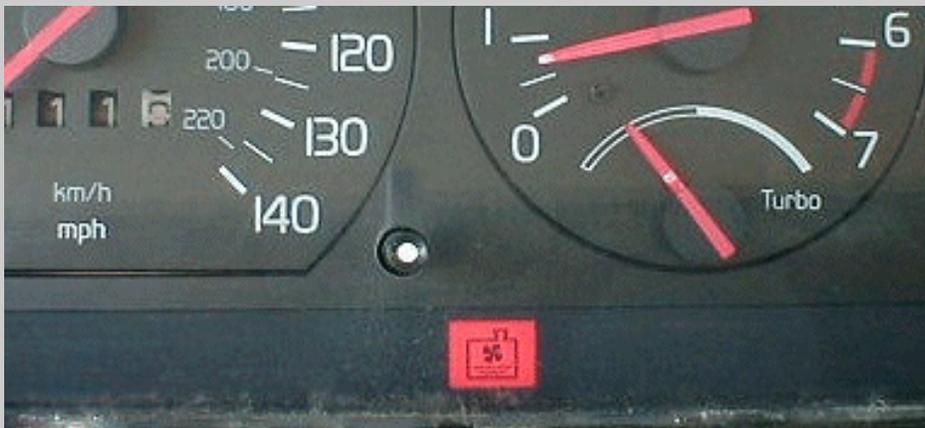
These plans allow you to fabricate and install a low-coolant sensor in your car so that you can detect either slow or sudden coolant leaks and take appropriate action before your engine overheats. Volvo 960 and some 760 cars have these sensors already

installed. Volvo 740 and 940 have the indicator position in the instrument panel, but no lamp or sensor (see the photo to the right). Note: Dick Riess contributed a [plan](#) for an easier-to-install warning light using a dash switch cutout instead of the panel. See the section at the end below.

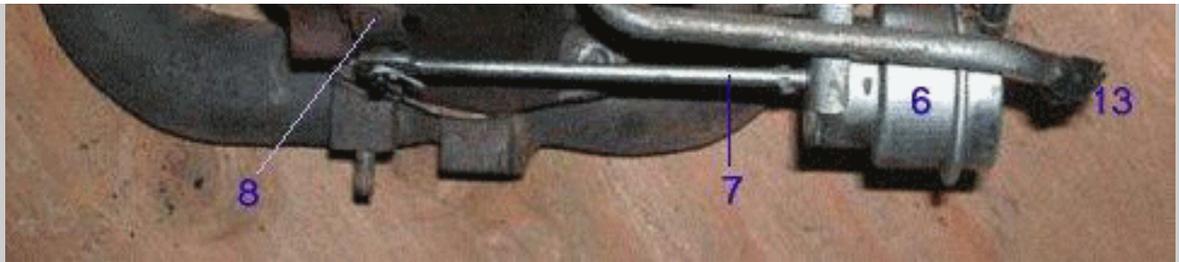
from filter
 2 compressed air
 to intercooler
 3 vacuum from
 intake manifold
 (drives CBV)

4 compressor bypass valve (CBV)
 5 hose with compressed air driving wastegate actuator
 6 wastegate actuator
 7 wastegate actuator rod
 8 wastegate shaft
 9 oil supply line mount point
 10 coolant drawn into turbo from overflow hose split
 11 coolant supply line
 12 coolant outlet
 13 water pump draws coolant here via lower rad hose split

The only things not clearly shown here are where the coolant supply line connects (180 degrees from coolant outlet connection) and oil outlet line (180 degrees from the oil supply line mount point).

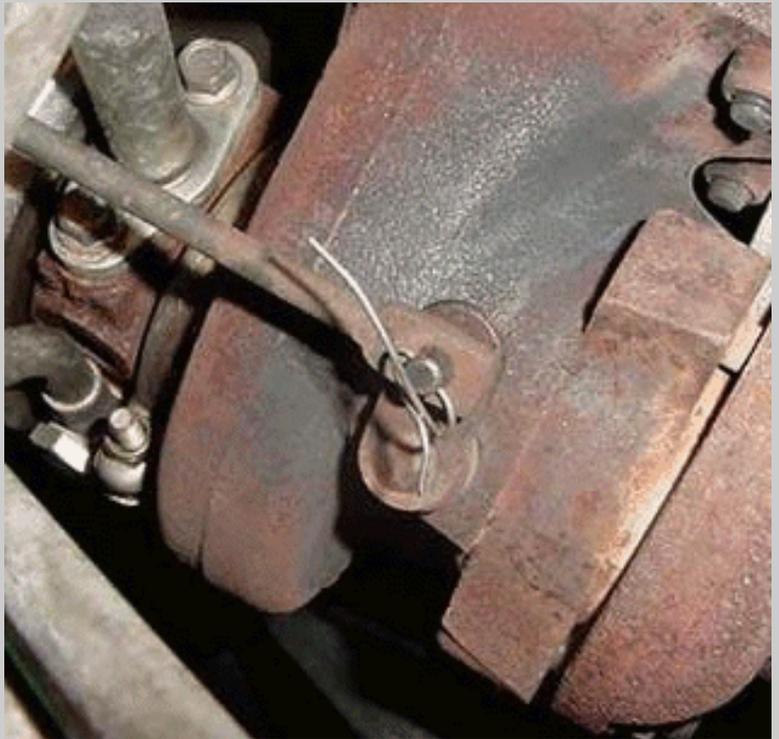
Wastegate Cotter Pin Failure. [Tip: Editor] Remove the small cotter pin clip holding the wastegate actuator rod to the wastegate valve stem occasionally and lube it with high-temp nickel-based antiseize. This clip can rust and fail, breaking off at the edges of the holes and leaving a corroded section inside. This latter piece is a bear to remove. If the clip is rusted, replace it. If you need to drill out the old clip remains, remove the oxygen sensor to gain better access from below and use a Dremel tool with a right-hand drill attachment. Be prepared to use up about five or six titanium 1/16 inch bits on this very hard rod. Replace it with a new clip, a stainless cotter pin, or a piece of stainless wire.

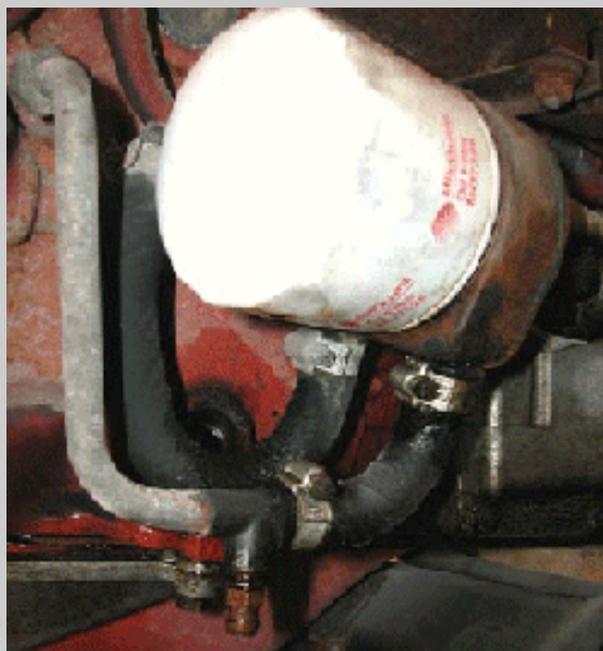
1. *Aluminum Heat Exchanger (Radiator).* [Tip] My oil cooler by the radiator sprang a leak on my 91 940 turbo. The top and bottom brackets are rusty (unusual) and when I undid the bolts I found that the bottom (aluminium) leg of the replacement cooler disintegrated. The top legs were also starting to show signs of aluminium corrosion!!! This is due (I think) to contact between the alloy and steel brackets and a poor paint finish on the steel brackets. Both sets of brackets are showing 100% rust coverage and both bottom brackets are rusted into holes! So: check them, paint them and introduce something to stop the action between the 2 metals. [Editor] Check all hoses as well.

2. *Coolant Heat Exchanger by Oil Filter.* [Tip] [Replace](#) the coolant hoses (see photo to the right) at the first sign of swelling, since they are exposed to oil dripping from the filter above. Use Volvo OEM hoses from the dealer, not aftermarket or old heater hose stock.

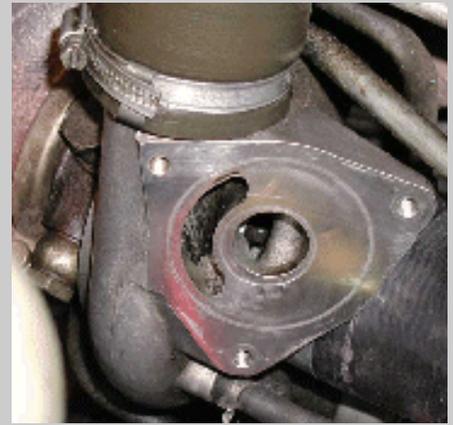
Compressor Bypass Valve Diaphragm. [Inquiry] My Mitsu TD-04 with integrated CBV has a torn CBV diaphragm, but no one carries a replacement. Volvo will sell me a \$300 rebuild kit with the CBV included but the parts stores don't have a clue about selling just the diaphragm. The rice shops want to sell me a \$200 Blow Off Valve that I don't want. Where can I get a NEW CBV diaphragm? [Responses:]

Replacement Diaphragms for CBV. Various turbo rebuilders carry the diaphragm repair kits for reasonable prices. Check Rick Banas at D&W Diesel (r.banas@dwdiesel.com) for Mitsu diaphragms and some Garretts.

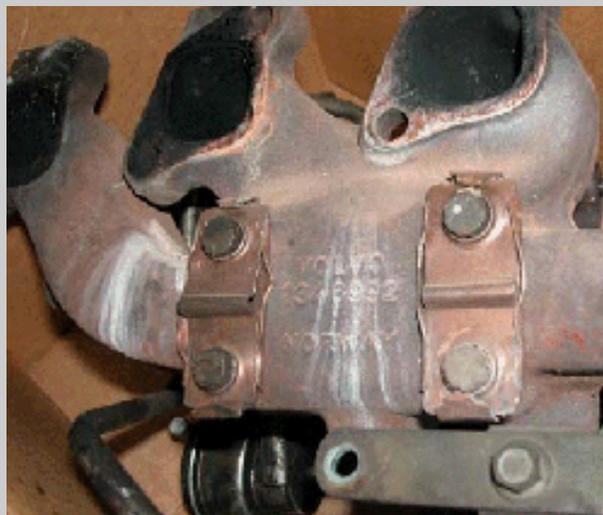
[John Sargent] There is no gasket between the manifold and the turbo. Until the 1990 model year, both Garrett and Mitsubishi turbos are bolted to the exhaust manifold with bolts from the engine side of the exhaust manifold (see photo right). For the 1990, and later, model year 700/900s Volvo used nuts to hold the turbo from the front side of the manifold. The later

manifold has studs which the nuts screw on to. You will also need new keeper plates which lock the nuts in place. [Notes from JohnB] The problem with checking the bolts that hold the turbo to the exhaust manifold is that they're supposed to be locked in with a lock plate. The bolts on the manifold side are 12 point cap screws angle-torqued using [special tool 5411](#) to 30 Nm or 22 ft-lbs, then the lock plate is pounded over the bolt heads. Checking the bolts is useless...if they move the lock plate is defeated and if they don't it's no indication of proper installation. If they are loose, then the dealer didn't install the turbo mounting bolts correctly. Generally the exhaust

manifold needs to be removed to properly install the turbo mounting bolts and locking plate. A new plate and new bolts should be installed every time since the bolts are torque-to-yield. However, in my experience and in everything I've read, angle tightening isn't that far off from simple torque-wrench, something like 25% variance from specified clamping force vs 35% for torque wrenches. [Inquiry] My turbo to manifold nuts are loose. Is there a gasket in there? How do I tighten them? [Response: Bob] There is no gasket between the turbo and the manifold. If the nuts are loose, don't just tighten them. They will loosen again. Replace them with new

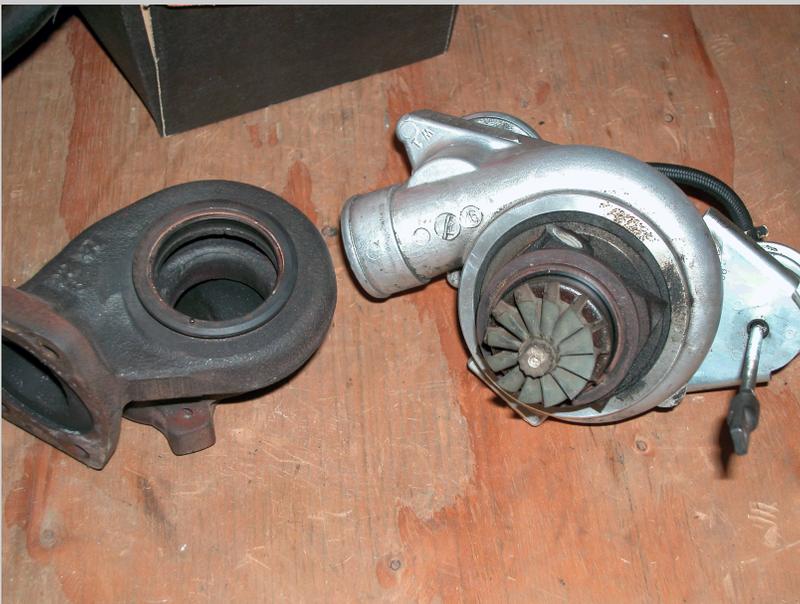
identify if you've got a Mitsu or not, the Mitsu turbos have a big clamp in the center between the compressor housing and the exhaust-driven outlet housing. It's like a huge hose clamp made of stainless steel. If it's loosened up the two housings can rotate relative to each other (and it'll leak there). If you don't have this clamp it's not a Mitsubishi. A good many replacement turbos are Mitsubishis. Any case, good luck, hope you don't break any studs, and if you do, get ready to pull the head. Don't try to fix exhaust studs in place. [Removal Tip from John Sargent] The Mitusubishi turbos are made to be removed by removing the one bolt and the hinged clamp. No need to pull the manifold. It is the wastegate which remains fastened to the manifold. The Mitsubishi TD05 turbo used on 87-89 700Ts has the wastegate bolted to the turbo with bolts from the engine side of the exhaust manifold. In order to remove the wastegate, you have to remove the exhaust manifold. The Mitsubishi TD04H used on the 90-93 700Ts and 900Ts has the wastegate mounted to the turbo with nuts on studs which are on the manifold side away from the engine. On this turbo, you can remove the turbo and wastegate assembly without removing the exhaust manifold. Wastegates do crack and sometimes need to be replaced. [Paul Demeo] Removing: Don't sweat the oil

return line for now, you can remove the turbo with it attached. (You'll still have to go through the pain when reinstalling, but for now...) Easiest way to remove a Mitsu: There is a pipe-clamp-ish collar between the center section and the exhaust housing, which should come off very easily. Once removed, the turbo is held in place only by virtue of the fact that it's been there a while. A good thump with your hand and it should pop free, allowing you to pull it up and out with the drain hose attached.

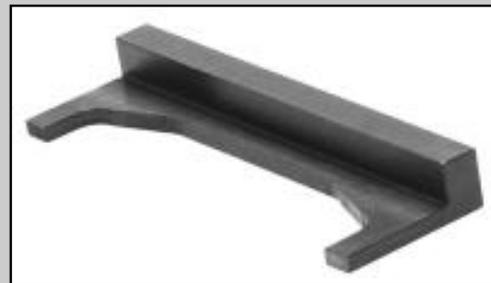
It is of the utmost importance that the crankshaft is spot on TDC. Buy yourself a small mechanic's mirror and use it to site the TDC mark as if the engine were out of the car and you were looking straight down at it. The manual does not show you how to install the camshaft locking tool. You need to remove the rear camshaft sprocket (make sure to lock the injection pump at TDC with the pin) and I found it necessary to remove the last two valve cover studs. There is a slot in the back of the cam that the tool fits into.

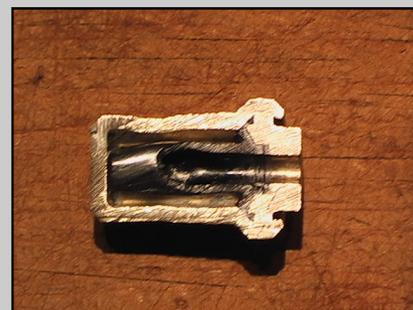
The punch is used to get the wax thermostat out of its housing. Here is a picture of my old one cut in half(above). It has a rubber boot that goes around a sliding rod. I have no idea how this thing works, but I like to take things apart.

To replace the innards of the cold start device you will need a vise, small needle-nose vise-grip, 4mm allen, a hammer and a punch. When you disassemble the device you will quickly notice that it is under a LOT of spring pressure.

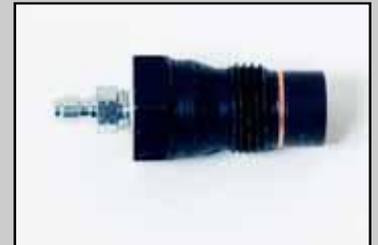
I found it very difficult to find a diesel compression gauge (one that reads up to 500 psi) at local auto parts stores. You also need the adaptor for injector hole (see pic at right) This adaptor is the same as the VW one.

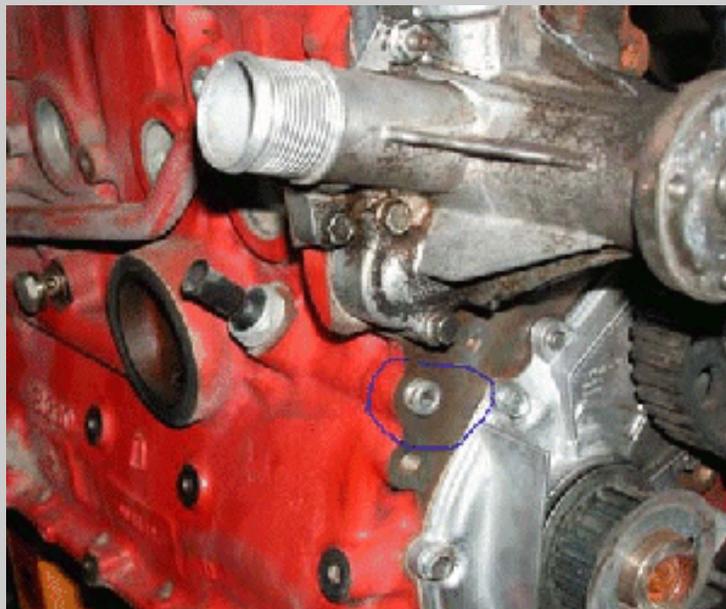
[John Sargent] To install a gauge to test oil pressure, use the front oil galley port (circled in blue in the photo) which is just ahead of the oil pressure switch on the block, and faces the front of the engine. It is 6mm internal hex, and the block threads are 1/4 inch NPT.

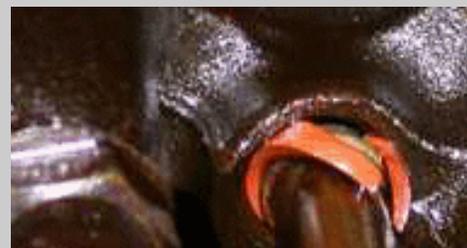
B230 [John Sargent] The oil delivery tube connects the oil pump outlet to the inlet for the oil galleys in the block. Occasionally the o-rings sealing the oil delivery tube at the pump will slide out of place, reducing oil pressure. [See the photo: the seal is bulging out on the left.] Oil delivery tube seal

failure is a known problem, but I can't give you any figures. If you don't get the tube seated all the way in the block and oil pump cavities you will probably experience the failure. It is possible that some tubes are manufactured with a smaller ridge on them than others. Those tubes would be likely to have the seal slip up and over the ridge. When you reinstall the tube, carefully drive it into place with a mallet, using a wood block as a cushion against the delivery tube. Make sure it fits: some are looser than others. Watch carefully and make sure it is fully seated.

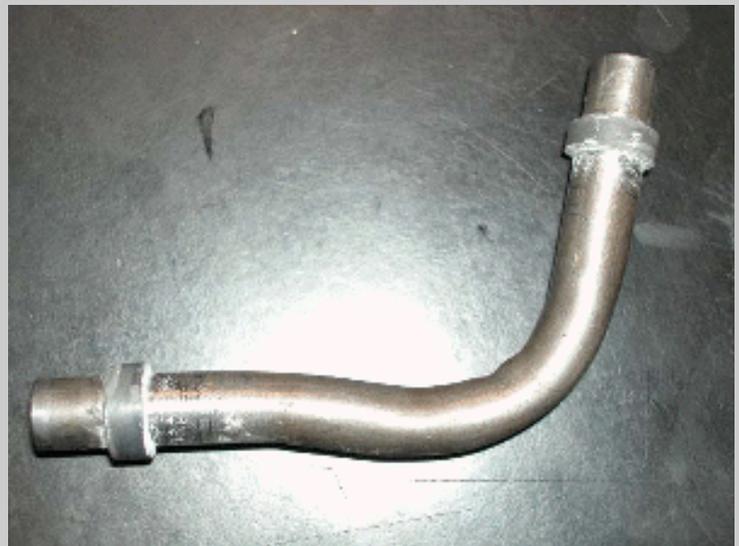
Solving the Problem. To solve this I modified an extra oil delivery tube by building up a ridge of JB Weld, a high (read slow setting) strength epoxy that bonds well to metal, on both ends of the pipe. I did this by using an old oil pump for a casting mold. I use a Q Tip to put a light coat of wheel bearing grease in the cavity which the oil delivery tube fits into. I mixed up the JB Weld and coated the ridge and about 1/4 inch of the delivery tube above the ridge with the epoxy. Then I inserted it into the oil pump housing and let it set up overnight. The next morning I twisted the oil delivery tube out of the housing and went through the same process with the other end of the tube. I used a fine mill file to smooth the epoxy at the ridge where the square cross section o-ring fits. The ridge now has a square shoulder and the o-ring cannot be pushed over it with high oil pressure. The tips of the oil delivery tube are unchanged, but the tube at the ridge and past is now a precision fit in the respective bores in the block and oil pump. The modified tube is shown to the right. The seals cannot get pushed past the improved lip on the tube. Hot oil pressure is now 42 psi at idle. Hot running oil pressure is 65 psi.

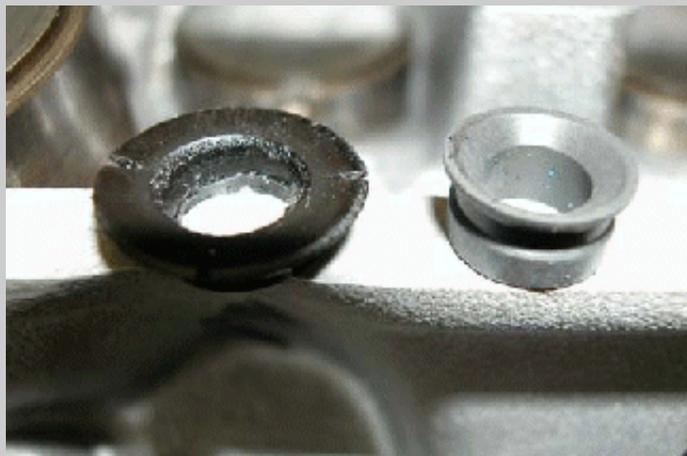
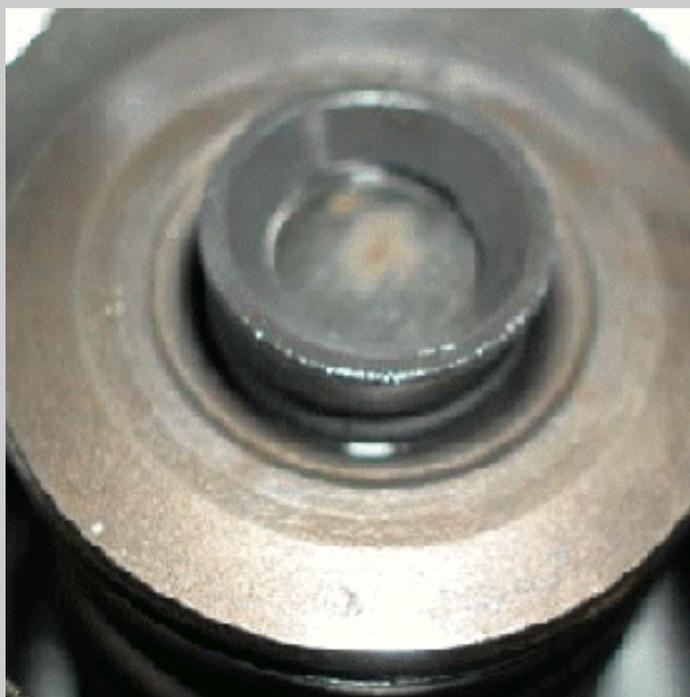
shims held in the valve depressor. The valve depressor looks like an inverted straight sided bucket, and the shim snaps into the shallow (up) end. Under each valve depressor there is a little rubber cushion which serves to take the "click" out of the actuation of the valve. This little rubber cushion is called either a "husher" or "valve absorber" depending on who your are talking to. These hushers snap into the valve keeper. The rubber loses its elasticity over time and heat, and you get noticeable valve noise.

The husher is a rubber flange shaped device that sits on and around the top of the valve stem which keeps the stem and lifter from clattering against each other. The actual valve stem seal is located on intake valves and is on the guide and under the spring---more difficult to reach. If you start to hear some valve noise in your car and it is high mileage, you might want to seriously think about replacing these little rubber hushers. They are inexpensive and do not change your valve clearance. Your engine will be quieter too. To change, first remove the cam. If all you are doing is replacing the little hushers, just remove the valve adjustment discs and keep track of which valve they go to. Be sure to clean out the buckets which slip over the valve and remove all the husher pieces before reassembling and installing new hushers. Your clearance will not change, but measure if you like. You are only

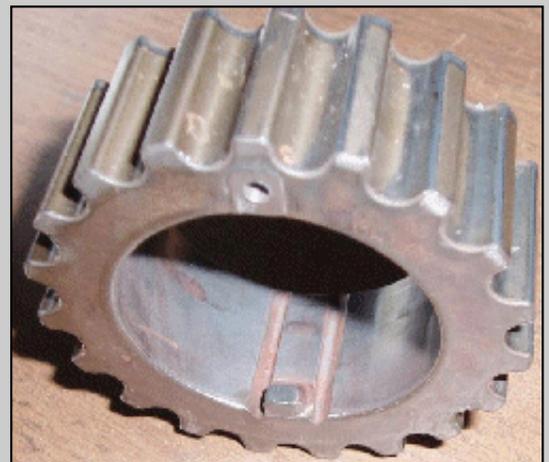
1. File the old key away. Make sure to leave a couple of thousands of an inch worth of material still protruding, so that you can easily see the boundaries of the old key.
2. With a caliper, mark the center of the old key. You do it by measuring with and length of the old key, and marking in the half.
3. Use a center punch. Don't miss this step. If you don't have a center punch, get one. It is used to make a guiding "pit" so that the drill won't slip when you start drilling.

4. Drill a 1/16" hole in the spot you've marked. Make it about 1/4" deep, no more.
5. Re-drill the hole to 2/16" and then to 3/16".
6. Get a hammer, super-glue, and a 3/16" drill bit you want to make a tad shorter.

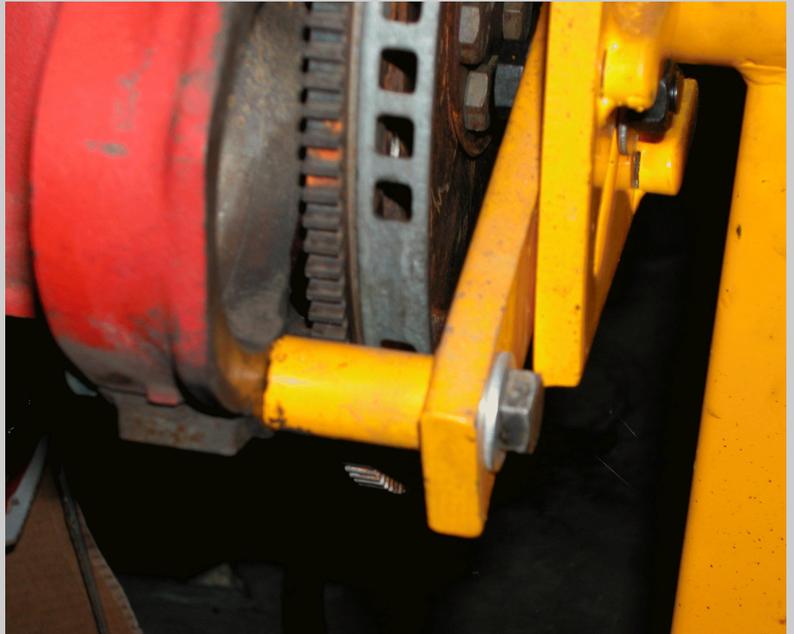
1. Mark the arrow on the flex plate so you can see it. It is marked on the side toward the engine, which really doesn't help.
2. Place the flex plate so the arrow is pointing to the top of engine, where the crank position sensor is located. The 'long tooth' should be at 270 degrees, or 90 degrees down from the top of the engine.

Checking Correct Position After Installation. [John Sargent] The LH 2.4 RPM sensor gets its signal from a slotted wheel riveted to the drive plate. For LH2.4 engines there are 58 slots with room for 60 slots, there being two hole voids. To check the ring gear installation for proper timing, remove the starter and position the engine on TDC for number one cylinder. There are 58 holes on the timing ring, with a void of two holes (room for 60 holes, total). The void will be at the bottom of the starter opening if the ring gear is installed properly.

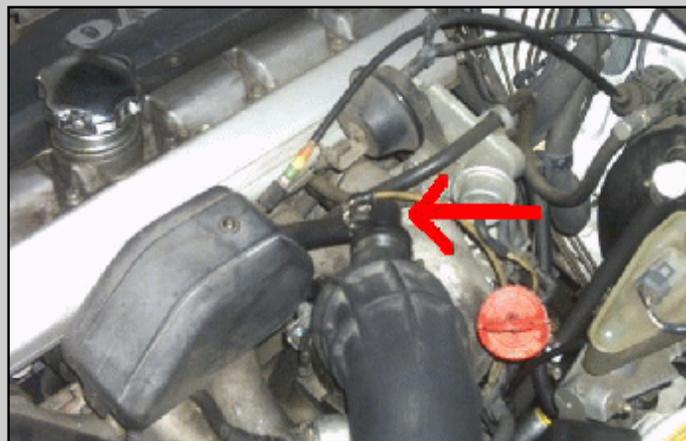
960 Flame Trap in B6300 Engines. [Inquiry] Can anyone tell me where on the 6304 engine the flame trap is located, and how one goes about servicing it? Last year I replaced the rear engine seal, and I notice there is sometimes a faint smell of blow-by. [Response: Tom Irwin] The flame trap is in the rear of the air intake runner, which is the big air hose between the Throttle Body and Air Mass Meter. The housing is made of 2 separate plastic pieces.

One should be clamped in the air intake hose. The other is clamped in the flame trap hose. One plastic piece fits inside the other with a snap and a click. It is released with a firm twist, 1/8th of

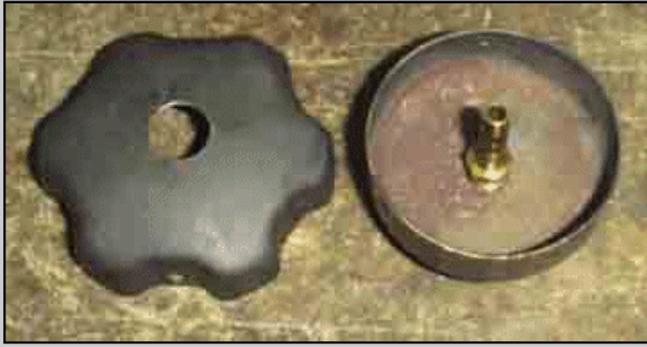
Crankcase Pressure Gauge and Tester. [Tips from Don Foster] To measure crankcase conditions, I built a vacuum gauge to quantitatively measure the actual vacuum. I started with a modified oil cap, shown below. It's an older style metal cap into which I soldered a brass barb fitting, available at any hardware store. One could use a plastic cap with the same fitting, glued with Goop or a similar adhesive.

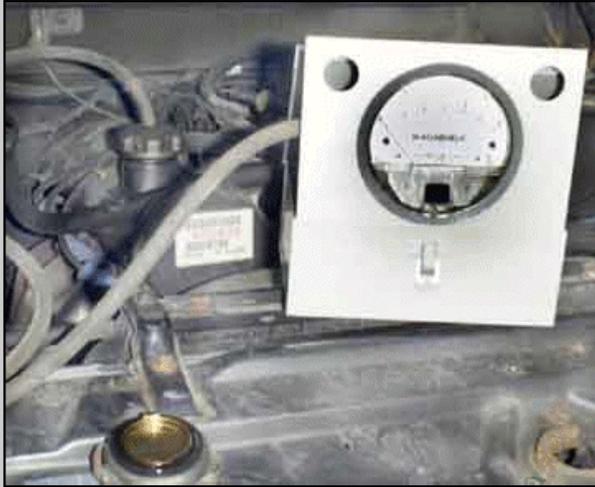
The gauge is a Magnehelic gauge, by Dwyer, which measures very low pressures. It can be hooked to measure either a pressure or a vacuum -- it's a differential gauge. These gauges are often on eBay for a few bucks. All my cars tend to run around 1"-2" of water vacuum, so a gauge that measures 5" of H2O max works fine. Below you can see the gauge (mounted in a metal box)

measuring crankcase vacuum on my '86.

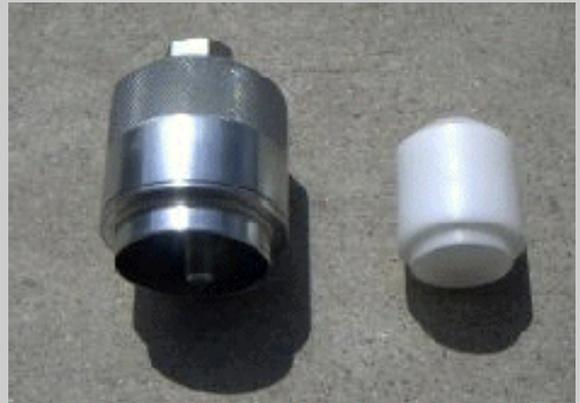
[Technical Tip from Volvo TSB 21121 Oct 93] New Volvo OEM seal designs are now used for camshaft and intermediate shafts starting in Oct 93. The seals (p/n 6842273-2) are more compact and use a special version of the seal installation tool p/n 9995025 (see photos right and note the lips on the tools). Lubricate the seal and press it onto the shaft using the tool. To ensure that it sits correctly, it must be pressed in for at least 30 seconds. If pressed for a shorter period, it may creep back out. Remove the tool carefully to avoid damage to the seal lip or spring. See the Procedural
