Volvo Maintenance FAQ for 7xx/9xx/90 Cars

Editor: S. Ringlee

This list was developed for the owners of Volvo 7xx/9xx series cars who are interested in maintenance tips that are not generally available in commercial manuals. It was compiled from Brickboard and specific websites with useful information. Items which appeared to be of lasting value to 7xx/9xx/90 series owners were excerpted and copied to this file. Sincere thanks to all those who took the time to answer others' questions and contribute to this public discussion. Because these remarks represent contributors' personal opinions, users need to exercise caution about any advice given; indeed, some of the comments are contradictory. This list is current as of the revision date below and was compiled by Steve Ringlee, who is NOT a consulting mechanic but only recording secretary. While this public domain list may be shared either whole or in part without attribution, it may not be sold or rented. This site is not affiliated with nor sponsored by AB Volvo, Volvo Car Corporation, Volvo Cars of North America, Inc. or Ford Motor Company. "Volvo" is a registered trademark of AB Volvo and Volvo Cars of North America, with worldwi

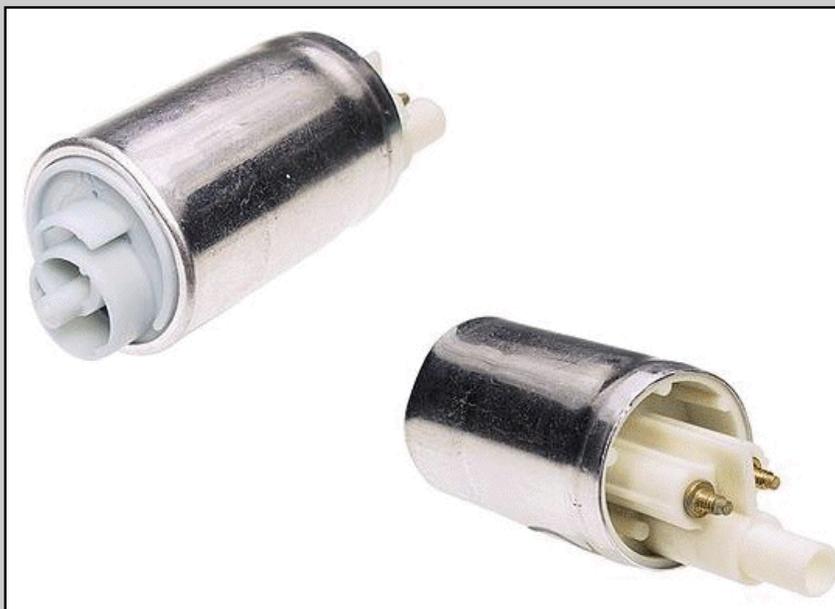
[Remove that panel.](#) You will see the top of the [fuel pre-pump/sending unit assembly](#). It is retained by a large plastic nut. Take the hoses off, remove the plastic nut, free the electrical wiring from any clamps and

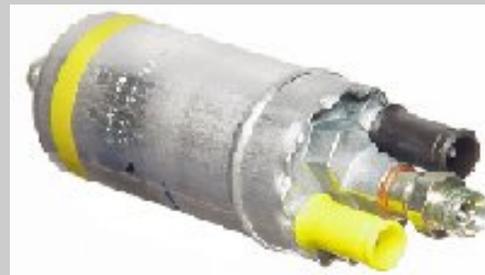
[Fuel pressure](#) can be checked by connecting a gauge to the Schraeder valve service port on the fuel rail (later B230F) or teed into the fuel supply line at the fuel rail (earlier B230F). If an engine has no fuel pressure (cranks, but won't start), and there is no pump noise, the pump may not be receiving voltage from the [fuel injection relay](#). There may also be a problem in the wiring to the pump, the pump ground or an open inertia safety switch.

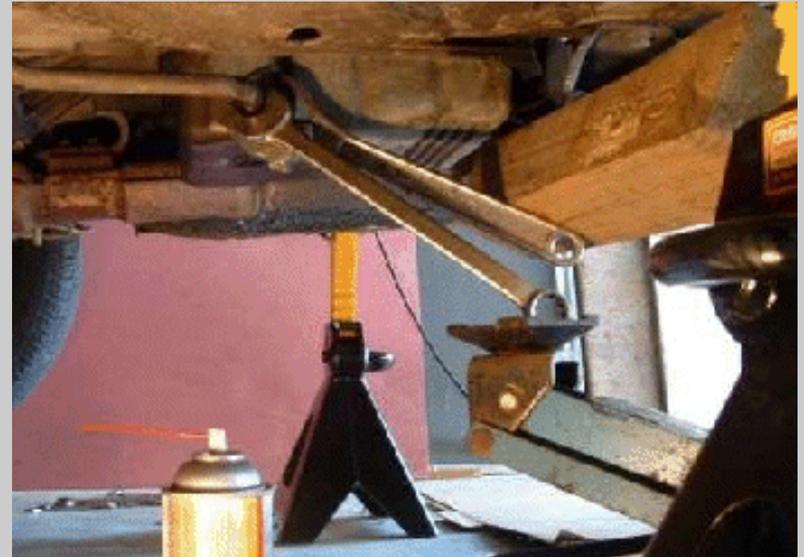
- Use heat from a hot air gun or a torch (flammable! caution!) if needed.
- See the photo for a tip from Tom F. to gain more leverage. "To remove the filler tube, I wedged a 4X4 betwixt a crescent wrench and the frame then used a small jack to encourage the filler tube nut to turn. It fought back all the way. The last three turns took two of us pulling the wrench using a bar through the combination wrench's closed end."
- If you cannot remove the nut without destroying either nut or pan, you can still [pull the pan](#) with the tube installed by removing the two starter bolts that hold the fill tube. It is not essential to be able to remove the fill tube. If these are seized, then you should call it a day and forget the entire procedure.
- On reinstalling the fill tube, make sure you use antiseize to prevent this from happening in the future.

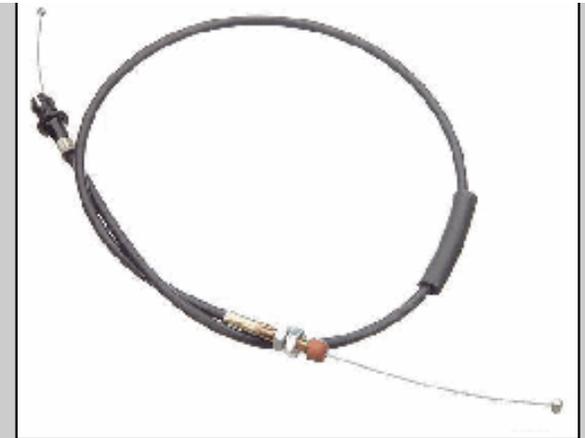
- o Have somebody fully extend the cable, this will rotate the internal valving fully. Clamp onto the rotating valve (where the cable attaches) with the narrow vise grips immobilizing the valving (it is spring loaded). With a second set of narrow pliers remove the cable end from its recess in the valve actuator. [Tip from Ian Billerwell] I recently replaced cable on my 89 745 with AW72L and found a handy tool to rotate the pulley. A bit of coathanger wire 6 to 8" long with 90 deg. bend only 1/4". In my pulley there is hole in the side near where the cable locates, I found it a cinch to rotate pulley. [Tip from Bean] I tried needle nose pliers to squeeze two of the locking tabs together but to no avail. Instead I put a medium sized screwdriver in the middle of the plug (from below) and whacked it with a hammer. This released the plug with no effort at all.

- o Remove the cable & sheath - friction fit in transmission, bolt-on at throttle body.
- o Re-assembly is reverse of disassembly. Careful not to remove the vise grips until the new cable sheath is seated in the tranny and the cable end is attached to valving

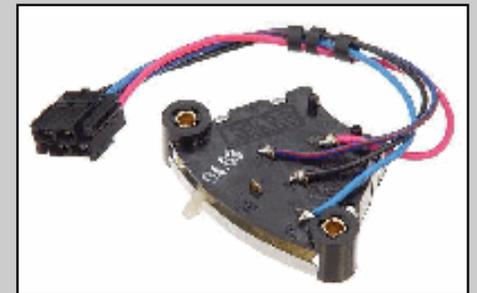
[Response: Rob Bareiss] Your neutral safety switch is beneath the shift indicator plate on the right.

1. MAKE SURE CAR IS BLOCKED
2. Remove ashtray.
3. Remove two screws in bottom of black console tray under parking brake handle (Torx screws on your later model 740)
4. Remove clip at front of tray under ashtray.
5. Adjust shifter and park brake handle position to allow you to pull tray up, forward, unhook, then back and twist to get over the shifter handle. The tray is split up front to allow this.
6. The neutral safety switch is a black pie-wedge shaped thing right on the side of the shift lever. Probably 2 more Torx screws hold it in.

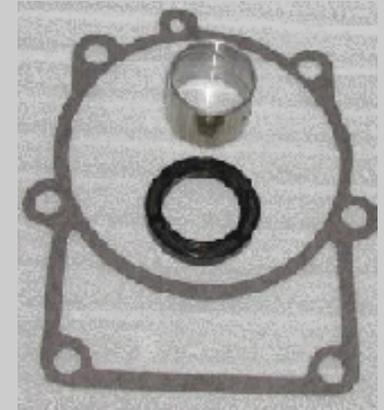
[Note from Abe Crombie] The 93 through '95 model AW71 gearbox has a ball bearing instead of the earlier bushing. You can tell by looking at the output flange where driveshaft attaches. The bushing style has no bell shaped slinger/protector for the seal; the bearing type has this type flange. The slinger/protector prevents you from seeing the seal. The standard flange on the bushing versions allows you to see seal on tailhousing. The bearing can't be used in place of the bushing as it requires a different output shaft in rear of trans; and it is costly. This style has an oil seal at the rear of the housing and an o-ring inside. Repair is simple: just pull the housing off and replace both the seal and the o-ring.

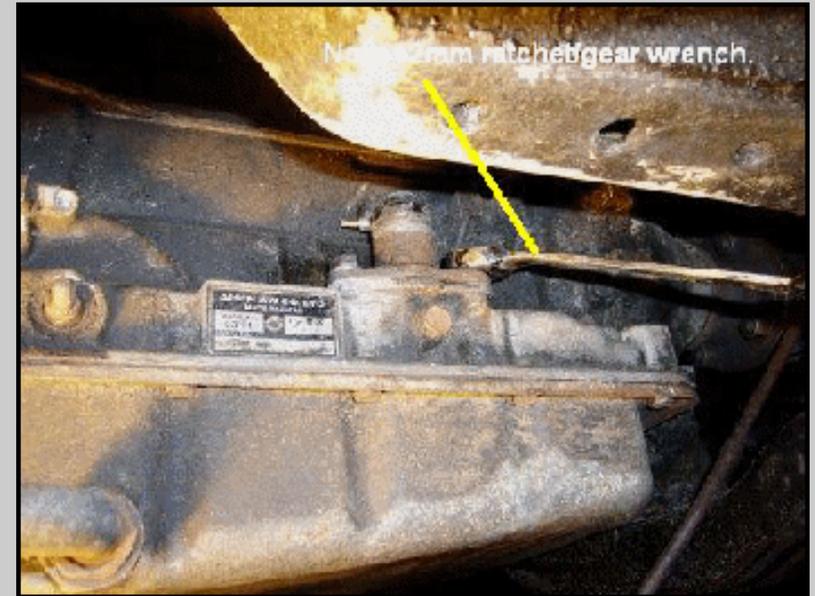
Tools. What kind of special wrench do I need to get 2 bolts out of solenoid to remove it? Doesn't appear to be much room for tools or hands. [Tip from R Haire] Support the transmission with a jack and remove the cross member. Then lower the trans as little as possible to give you enough room to CLEAN the area around the solenoid until it is spotless before ever attempting to remove it. Do NOT lower it so much you crush the distributor cap against the firewall. To remove the solenoid, you need a stubby angled 12 mm wrench. It is kind of snug up in there. A "gear wrench" is ideal to turn the bolt. [Tip] I have used a short (approx. 6") angled/bent 12mm open end wrench that I heated and bent myself. Access is difficult: you may have to remove the linkage and drop the transmission support (placing a jack and large wood plate beneath the pan to support the tranny). [Tip] Bend a flex socket handle to fit and use a 12mm socket on the end to remove the solenoid bolts. [Tip] Use a smaller 1/4 inch drive socket set to remove it.

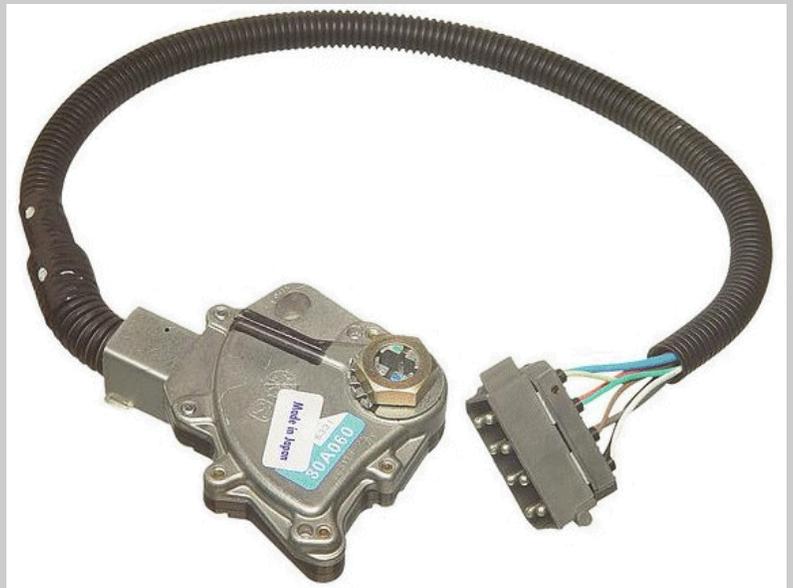
[Tips from B and Stan Sexton] The PNP or gear position sensor is located on the right side of the transmission case. It slips over the manual linkage shaft and bolts to the case. The wiring routs to the left side of the trans, where it is attached to a short metal rail toward the front of trans. The pigtails are long and the clips

are released by squeezing with a needle nose plier from atop the trans pan lip. Mine gave out at 48,000 miles. When it fails, you will have 3rd gear only and the check engine and tranny dash lights will go on. The switch R&R at a Volvo dealer runs between \$300 and \$400. I decided to buy the switch from Nils Sefelt Volvo in Houston on the Internet for \$110.00 plus \$8.00 shipping UPS instead, and do the labor myself. [Tip from JohnG] DO NOT purchase an aftermarket (Scan Tech) switch. Spend the extra \$10-\$10 and get an OE one.... trust me.

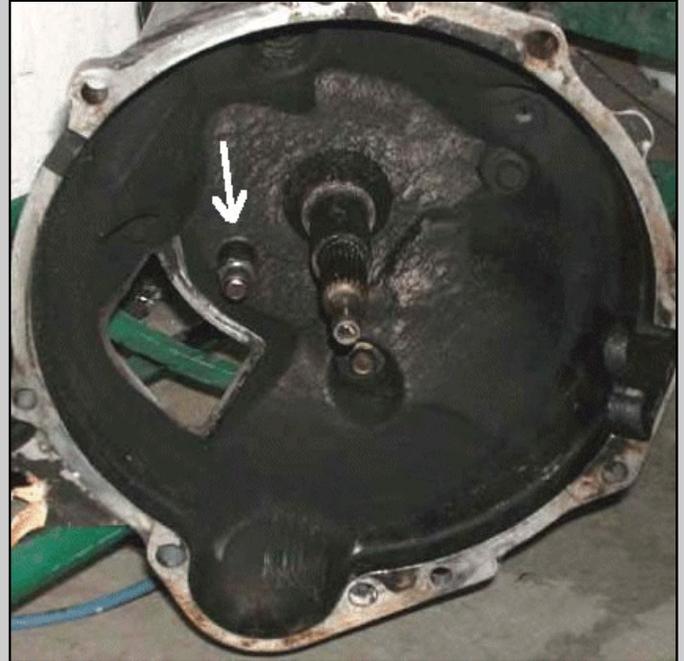
Replacing Turbo Manual Transmission with Non-Turbo Model. [Tips from John Sargent] My son wrecked his 744T with manual transmission last summer. His replacement 1984 760T had an automatic, and he badly wanted a manual transmission in the car. The M46 with P type OD in his wrecked car had been giving some OD trouble, and I told Evan that we wouldn't replace a good automatic transmission with a bad manual transmission. I was able to buy a good 1987 M46 with J type OD very cheap. A P type OD is stronger, but J type is quite adequate for the job, and all Volvo did on the early turbo cars with J type was have the ECU disable injector number 2 when shifting into OD (or so the service manual says). I told Evan the J type would survive quite fine if he shifted sensibly in and out of OD. Turbo 700 series cars with manual transmission have a hydraulic clutch. Early Normally Aspirated cars have a mechanical cable clutch; later NA cars have the same hydraulic clutch as turbos. On turbo cars the ball stud for the throwout arm is between the throwout arm opening and the input shaft as pictured to the right.

In order to use the NA transmission in the turbo car all you have to do is remove the NA ball stud, and then remove the turbo ball stud and screw it into the NA transmission bell housing. The bell housing has a hex socket cast into it with a threaded nut in it just waiting for you to use. The ball stud from the turbo transmission is internally threaded has a metric stud that screws into it and also fits the nut in the bell housing socket.

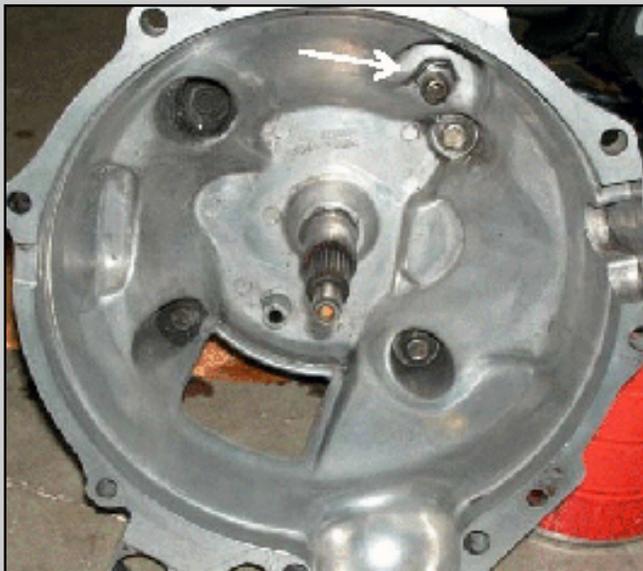
On normally aspirated cars the ball stud for the throwout arm is on the opposite side of the input shaft as pictured left.

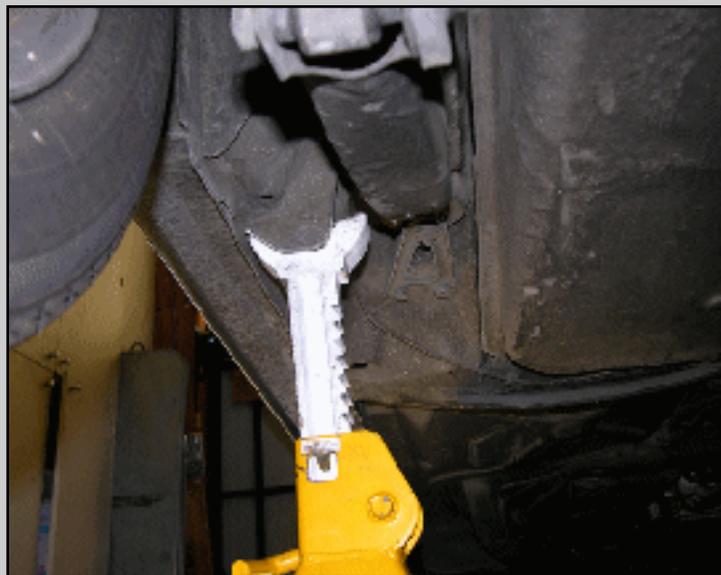
the parts I jacked the rear of car up, started the engine, and shifted through the gears and into OD. Once into OD I stuck the clutch in and hit the brakes. This procedure unloads the pressure on the transmission output shaft splines so the OD will slide off of the transmission. You can also shift into reverse and very firmly let the clutch out and achieve the same thing. The picture to the right shows where I like to put my jack stands.

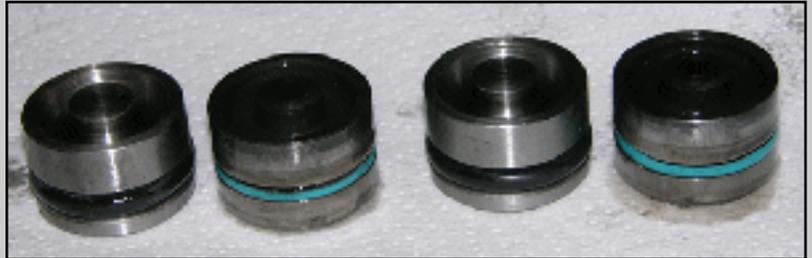
The new (black o-ring) and old (blue o-ring) pistons can be seen to the right. They fit tighter than the old pistons, even before the seals go into the bore.

M-46 Piston Replacement. [John Sargent] My son's 1984 760T with M46/OD recently started dropping out of overdrive in hot weather. The problem is worn overdrive actuating piston seals. The original seals had a blue Teflon sealing ring, and the seals give trouble with age. The upgraded new pistons use a nice fat rubber o-ring which gives better service. I ordered two new pistons (part number 6814454), and two new o-rings (part number 6814455-9), and the gasket (part number 380618-9) between the OD and the transmission. Once I had

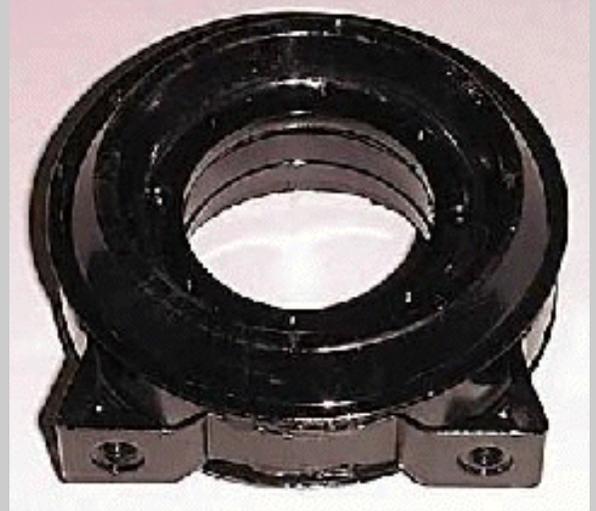
Diagnosis. [Response: Mike Froebel] Classic hanger bearing noise. This is located just in front of the center universal joint on the driveshaft. There is a plate that is bolted to the frame rails with 2 bolts per side, the hanger bearing support is bolted to this plate with 2 bolts. The bearing lives in this support.

Bearing Replacement. It is generally a good idea to replace bearing and support together, especially when the bearing is going bad. It is quite an easy job to do yourself, but you need some kind of puller or press to remove/install the bearing from/to the driveshaft. Just take the driveshaft to a machine shop where they will be able to remove the old bearing for you, and press on the new one, unless you have access to a hydraulic press. Or use the method outlined [below](#). It's a very tight fit pressing the bearing into the mount and alternative c-clamp or mallet and block of wood methods don't work. Do not pound on the driveshaft or new bearing or you could damage the splines so you won't be able to put the two halves back together, or the u-joint, or maybe change its shape just enough to put out of balance. Just to make it more fun, your car could have 2 different driveshafts each of which take a different bearing and support. Measure the distance between the hanger bearing and middle u-joint and use the following Volvo part numbers:

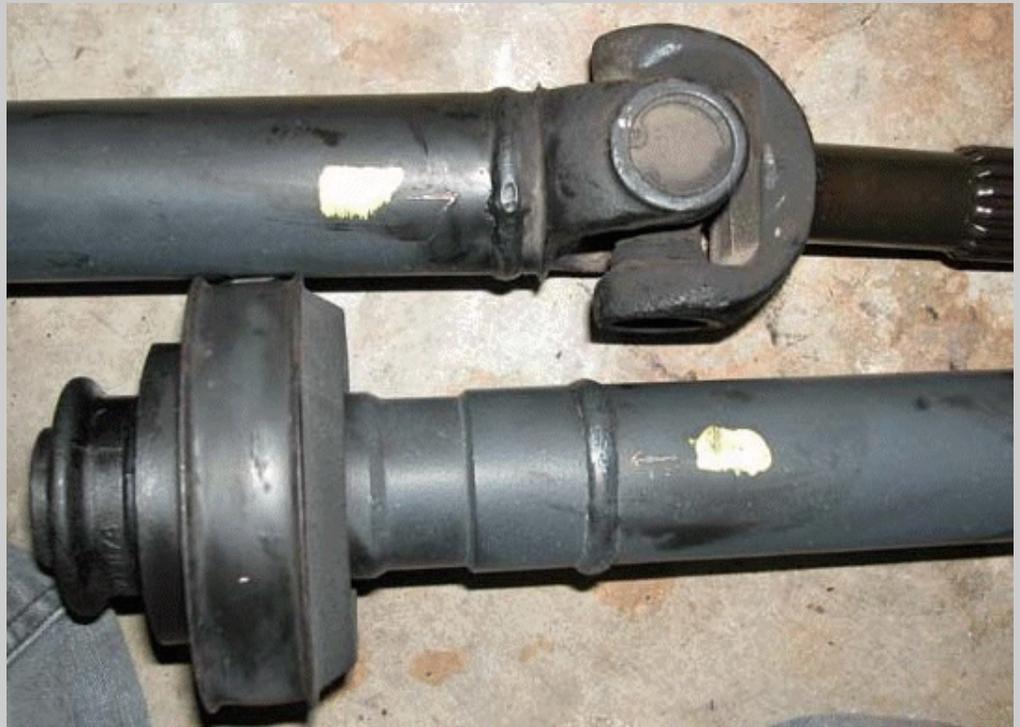
The front section must be kept in the same alignment with the back section. The only approach I could suggest if yours appears out of whack is to remove the center bolts and rotate the rear shaft 1/4 turn then try it again. If it cures the vibrations you're home free, if not, rotate another 1/4 turn till you've tried all 4 combinations.

[Response 2: Warner Bowles] I believe that the yokes of the universals at the centre

bearing have markings on them from manufacture which indicates the correct alignment. You will have to clean off the paint and any other build up which has accumulated on the yokes to see them. A second alternative is to ensure that the yokes on the universals at the centre bearing are parallel, (ie in the same plane). This will result in the universals working together rather acting against each other. If worse comes to worse you may be 180 degrees out but should still reduce the vibration. [Tom Irwin] Drive shafts are dynamically balanced, which is why some of the flange bolts are longer than the others. When removing, you should mark the position of each bolt too. [Response 3: John Yuristy] Since you pulled the centre connecting spline apart, and there are about 17 teeth on there, you could have got it back together haphazardly in almost that many different orientations. Only one is right, and you can probably find it again by knowing how the yokes should be oriented w.r.t one another. If you did not take apart any U joints while you had it out, and therefore also possibly rotate the half-shafts in the process, then you get to try once or at most twice to get the original position. The vibes come from both the U joint yokes not operating with the right geometry, and also if you have lost the shaft mass balancing which was done originally.

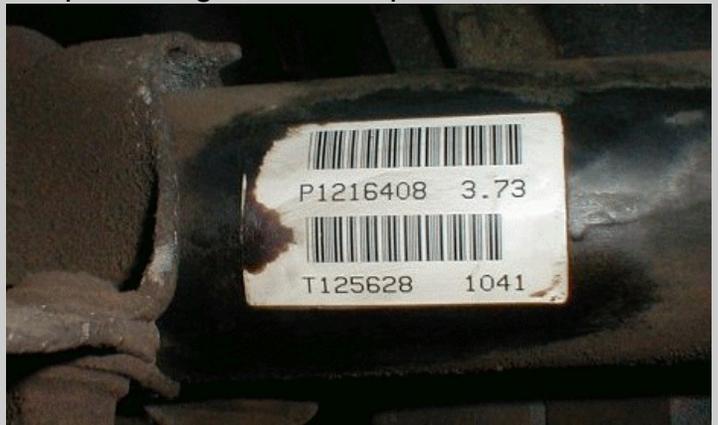
Axle Model? [John Sargent] The axle identification decal is on the left rear side of the differential and covered with undercoating. I use either solvent or brake cleaning fluid applied with a rag to reveal the decal. If the axle serial number has a "S" preceding it, then the pinion seal uses a collapsible spacer.

Which Seal Spacer Do I Have? [Inquiry] [Response: Brian Sullivan] Find your axle serial number - should be a plastic tag with a bar code and some numbers on the driver's side axle tube, facing the rear of the car. You might have to clean off some gunk to see it. If you have the letter "S" preceding the serial number, you have the collapsible spacer (and therefore lower torque spec) No "S" means no collapsible spacer, and higher torque spec. The actual seal you need to replace is the same for both arrangements. I don't know which number on the tag is the serial number - but as you can see, I didn't have an "S" preceding either number - so no collapsible spacer, in my case.

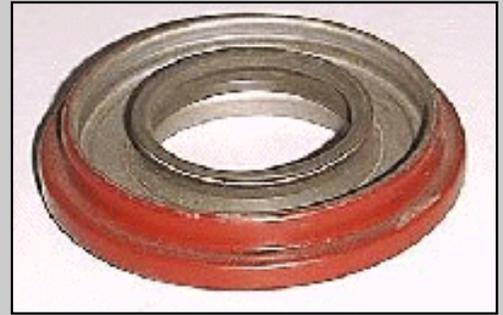
at assembly. Remove the [pinion flange](#) that the drive shaft bolts to, first marking it in relation to pinion so as to preserve its position since it may have more throw (run-out) if not put back into position. Drain the rear differential oil. [See below] First remove the [center flange nut](#), then remove the flange with a puller; no hammering allowed!. Seal can be removed by any reasonable means that doesn't scratch the opening in diff housing where seal fits. You can put a good-sized screwdriver in between the seal and the pinion shaft and pry it out. It will distort and tear but will come out. Or you can take a small chisel and tap it into the little crease that exists between the edge of the metal seal and the edge of the diff housing (*be CAREFUL not to damage the differential housing!!*). This will cause the tin seal housing to bend over and loosen its grip on the diff housing. Do this at least 50% of the way around that outer edge and then put a large screwdriver in next to the pinion where the flange was and use it to lever the seal right out. It should pop out with no problems if you did it right. Carefully clean the flange where it contacts the seal. Make sure you install the seal right way around: "outside" is stamped in the metal seal ring. Put a little lube on the seal surface so it won't rotate dry and then tap it in place. The new seal will need to be driven in evenly to be just below flush with front of diff housing unless it is one with a lip that stops it when the lip contacts the diff housing. If you have a socket that is about the size of the seal use that to get it in even, if not just keep at it gently until it is seated evenly all the way around. Re-install flange as marked and then refit nut (volvo recommends new nut) to a torque depending on whether your seal uses a compression sleeve or not. *No compression sleeve*: 148 lb-ft. **NO IMPACT WRENCH ALLOWED, TORQUE IT!!!** *Compression sleeve*: 49 ft-lbs; ignore any instructions to count rotations. [tip thanks to JohnB]. Failure to torque it properly will result in the pinion bearing being overloaded which will kill the bearing and place the pinion/ring gear relationship in a new, different, and noisy relationship that will result in replacement of a bunch of parts (\$\$\$\$\$). Oh, don't forget to fill it up with gear lube when you're done.

Flange Torque. [Editor] Re-torque the flange coupling bolts and nuts as follows: if you have M8 bolts, torque first to 22 ftlb (30Nm) then angle tighten another sixty degrees. If you have M10 bolts, then torque to 37 ftlb (50Nm) in total.

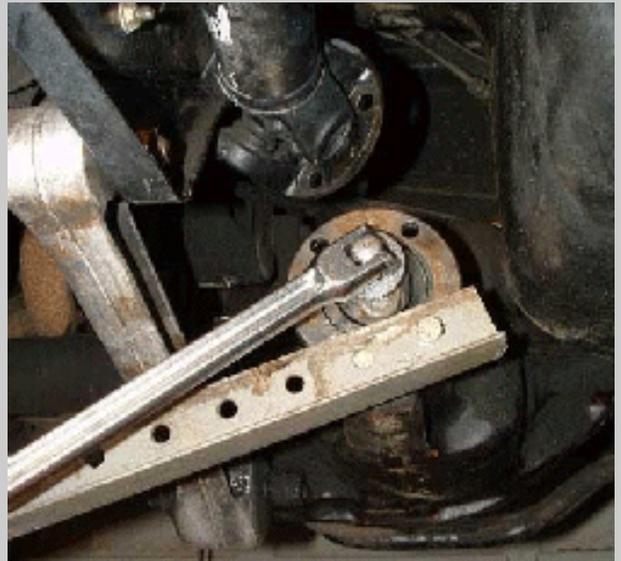
The tool looks something like this:

Bad representation, but hopefully it gets the point across. I bolt this tool to the flange attached to the rear end and bracketing it against the ground, I have something to work against to loosen that nut. I removed the pinion nut using a 1 3/16 socket. Since the teeth on the socket were recessed in about 1/16" in from the edge, I ground down the edge so that it would get a better bite on the shallow pinion nut. The opposite end of the "counter hold tool" rested on the floor. The breaking torque of this nut, if torqued to 150 ft-lbs, is about 180 ft-lbs. With the nut off, I can pull the pinion flange off using a harmonic balance puller (Harbor Freight has these) and get at the seal to replace it. Re-installing the flange is easy: it should slide on far enough that you can get the nut back on the end of the pinion and pull it in place by tightening the nut.

Flange Nut Removal Tool [Dave Farrington/Tom F] Replacing the pinion seal is really pretty easy, but the trick is to remove the u-joint flange to get at the seal. You need a good home-grown counter-hold tool to remove the pinion flange nut! I took a piece of angle iron around 28 inches long when I cut it down. Then I took the rear drive shaft that I had just taken out of the car and marked two holes of the u-joint flange near the edge of one leg of the angle iron. I then bolt this length of iron to the pinion u-joint flange, but I still have a problem. That is I can't get at the center nut holding the pinion flange in place. Easy to fix: just mark some clearance around the socket you plan on using - it presumably fits that nut. Then grind some of the angle iron off.

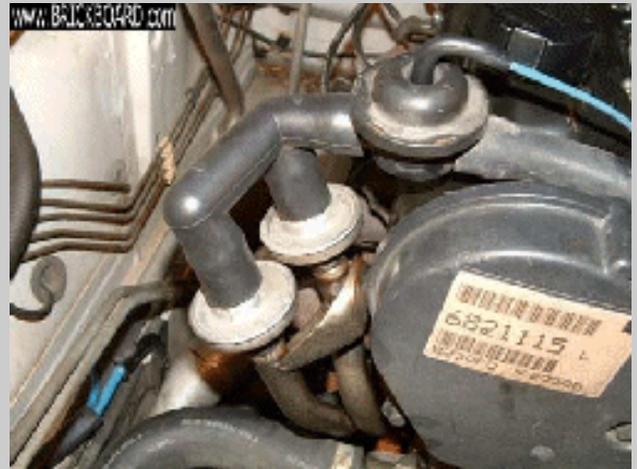
Air Injection Valve. [Inquiry] I noticed a noisy hose in front of the engine of my 1995 940 B230F. The noise goes away when downward pressure is exerted, and air can be felt at the corner junction. What is this thing? [Response] This is the air injection valve, with a one-way check valve (the wider discs) for air injection into the exhaust to heat the catalytic convertor and O2 sensor on cold start and provide sufficient O2 to the catalytic converter so it can do its job. It is used on selected non-turbo engines for pollution control and is controlled by a solenoid. While the connection is still loose, idle the engine and take the time to pull the rubber hose off, and be sure hot exhaust isn't blowing back through the discs...if it is then replacement is in order, else hot gasses will soon burn through other parts. A good cleaning and a bit of black RTV should repair your hose 'for the life of the product'. Use hose clamps on reinstallation.

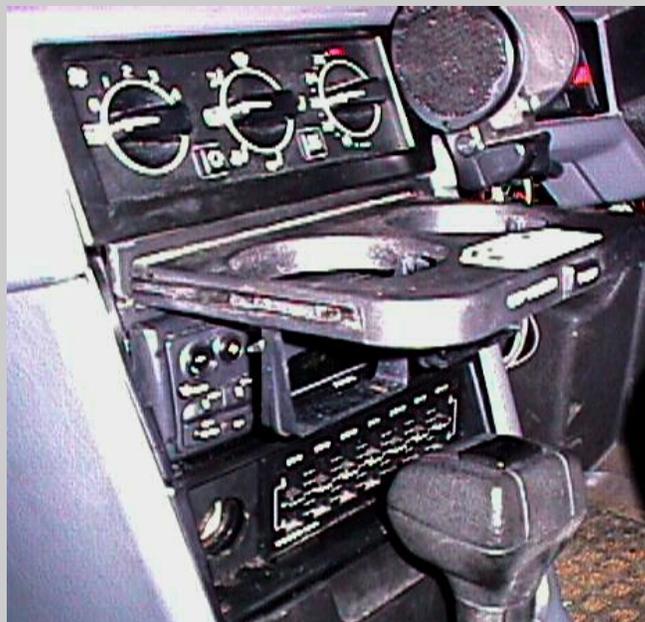
- cut to remove the coinholder
- remove the console 1 1/2 DIN opening / rack
- remove 1/2 mm each side of the console opening (the small lip) to allow the headunit fascia to be recessed into the opening
- trim side of cupholder to allow it to be recessed
- assemble mounting cupholder first. The headunit mounting frame should locate and fix this in place. Screw the frame to the base of the opening / rack

Installing a Ford Taurus Cupholder Above the Radio. [Tip from] I've successfully mounted a 1/2 DIN-sized cupholder in my 940 suitable for cups and some (but not all) small cans / bottles. This is similar to the cup/coinholder mounting in a 760 / 960 which has been previously posted. Source of the cupholder was a Ford Taurus. Caveat: if you can't use a chisel, hacksaw, dremel etc and convince yourself you know what to do - don't start. To do this:

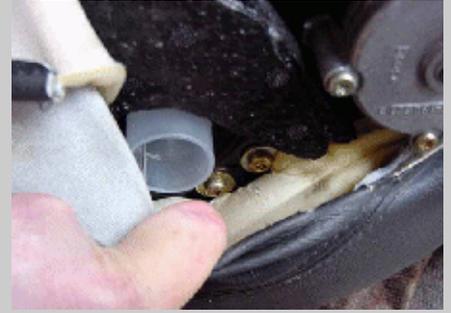
10. Remove the mechanism from its internal location. The problem will now be obvious and most likely be a break in the plastic bolt-like fixture. It has a hollow rectangular head. Mine was broken through this head. This head has a pin passing through it.

11. You now have two options- install the rebuild kit for \$65US -or repair by placing a 10mm bolt through the centre of the adjuster to tie it together and strengthen it.

1. To repair you will need - a 75mm x 10mm cup head bolt, an electric drill, drill bits from 11mm downward, hacksaw or grinder and file, and a small nail or pin.

2. Remove the pin that passes through the head of the plastic bolt by tapping with a rod of smaller diameter. This enables the broken bolt to be removed.

4. Fit the broken section back together and carefully align the drill so it passes through the plastic casing, then the bolt and then through the plastic casing on the other side. This is to enable the pin you removed to locate in its original place and at the same time pass through the bolt.

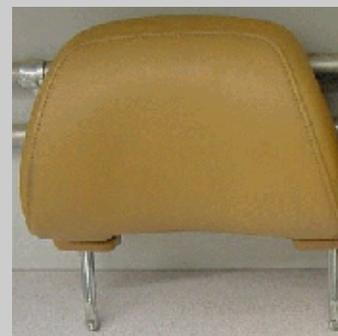
Front Headrest Removal. [Note 1:]It's a game of blind-man-buff... there is actually a hook/latch holding the two rods.. you have to press down firmly at the back of the seat about 6 inches below the top of the back to release them. [Andrew] Just below the headrest on the back - just where the fabric can be pressed in -toward one side (about three-four inches from the side edge) I found/felt a wire lever (seemed to have a small loop/circle at the end). It was horizontal mainly - from the side. Worked my fingers and pressed it - released the headrest.It does require some pressure. [Jay Simkin] As you face the back of the seat, you will see there is a rear seat pocket. About nine inches above the top edge of the seat pocket, there is a line of stitching, which runs from right to left, about 5" below the top of the seat (there are also lines of stitching, that run down towards the top edge of the seat pocket). About one inch above the top line of stitching, there is an angled area, where the fabric is stretched, so that the central part of the seatback forms a recessed panel. About 1.5" above the top line of stitching, you will feel - when you press gently forward (i.e., as if you were going to press your finger through the seat, to the front surface [that closest to the steering wheel]) the edge of a frame. Using your index finger, press gently but firmly forward, directly below where the "foot" of the headrest joins the seat, right below the frame and about 1 1/2" to the "inside" of the angled seam. When you have pressed your index finger 1 - 1 1/2" forward, you should feel something springy. It will move forward, as you press on it. This is the headrest catch release lever. The front edge of the steel headrest post has a notch in it. The headrest catch locks into that notch. When you press forward on the headrest catch release lever, you disengage the catch from the notch. It is sometimes helpful to push down on the headrest, push the headrest catch release lever forward, and then pull up on the headrest, to disengage the headrest catch from its notch on the headrest post. You should free each side of the headrest, by lifting each side 1/2", before trying to pull the headrest out of the seat. To re-install the headrest, simply align the posts with the holes, and push the headrest downwards. It will automatically lock into place.

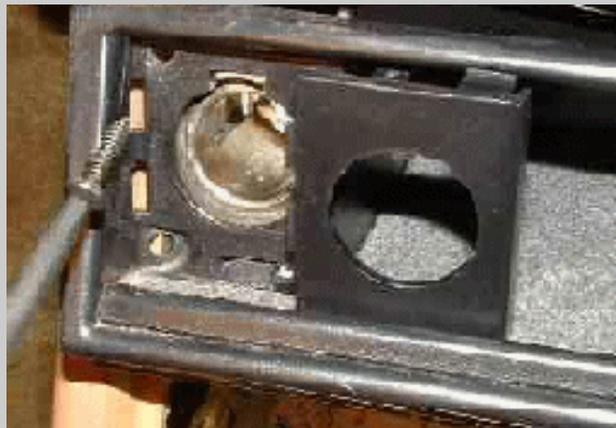
Storage Tray Under Radio. To remove the storage tray under the radio in order to access the relays, remove the snap-on cover over the cigarette lighter with your fingernail or a small screwdriver. Remove the two philips screws securing the storage box: one of these is angled in. Remove the storage box by gently tugging on the left side, pulling it and the cigar lighter wire out from the console.

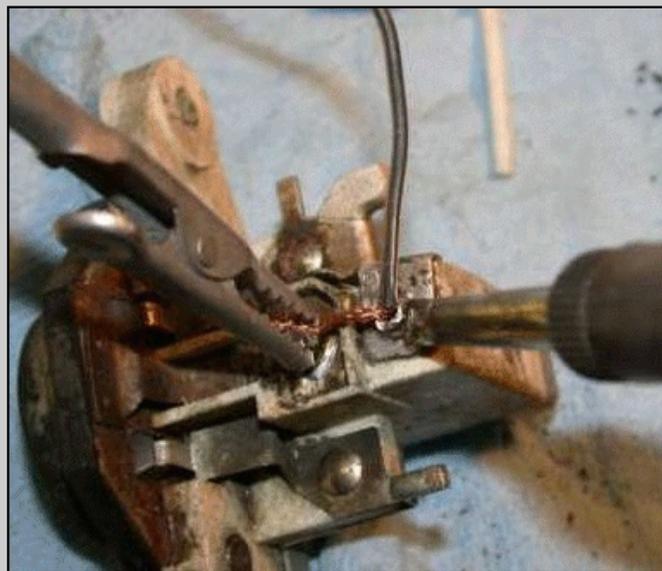
There was a question about how to drill out the solder connection to facilitate the installation of the new brushes. I have included an image here that shows the assembly. I use a flat file to file the

surface smooth. This gives a little more definition to the "target" area as well as providing a good surface to get the 1/16" drill started. Since the solder is soft the drill follows the path of least resistance removing the solder/leaving the holder intact (you will be drill towards the brush in each case). Once the solder connection is drilled out the old brush is released and basically "pops" out due to it's spring load. I apply paste flux to the lead of each brush. If you have trouble getting your solder to "stick" or flow out it is most likely because of the lack of flux. The new brushes from Volvo (part number 1362710- less than \$4) have a solid wire lead on them that makes it easy to "thread" them into the brush holder. Pull them down far enough that the sides of the brush holder support the brush in an upright position. At that point bend the woven wire at a right angle to the holder to keep each brush positioned properly. Use a clip as shown in the photo to hold the brush gently against the spring. Apply the heat of an iron to the junction of the brush holder and the woven wire. Take a relatively small diameter piece of solder that has been dipped in the flux and touch it to the brush holder where the woven wire exits. Use enough solder so that the drill hole fills in around the woven wire (don't get over zealous here you don't want solder dripping out the backside into the brush holders). Trim the excess wire off and reinstall the assembly. Be sure to tilt the assembly as you position it so that when you press the assembly into place the brushes are pushed back down into the brush holders.

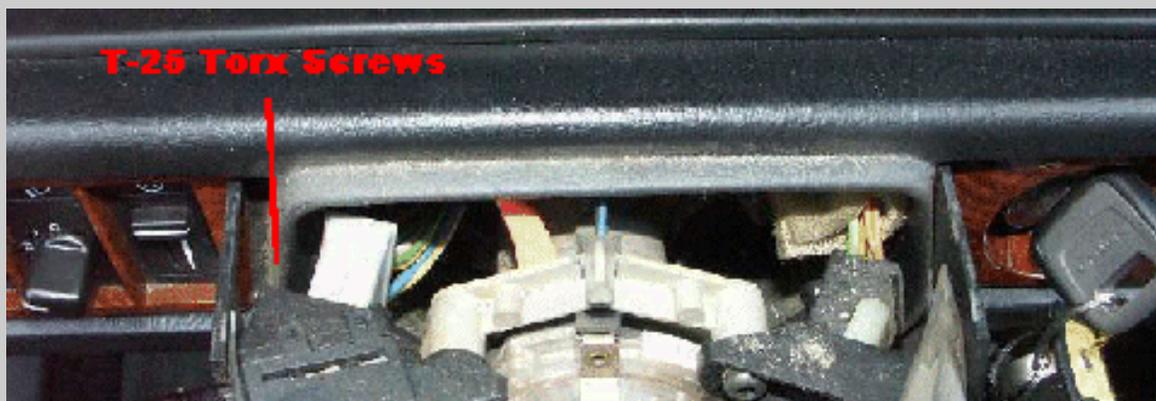
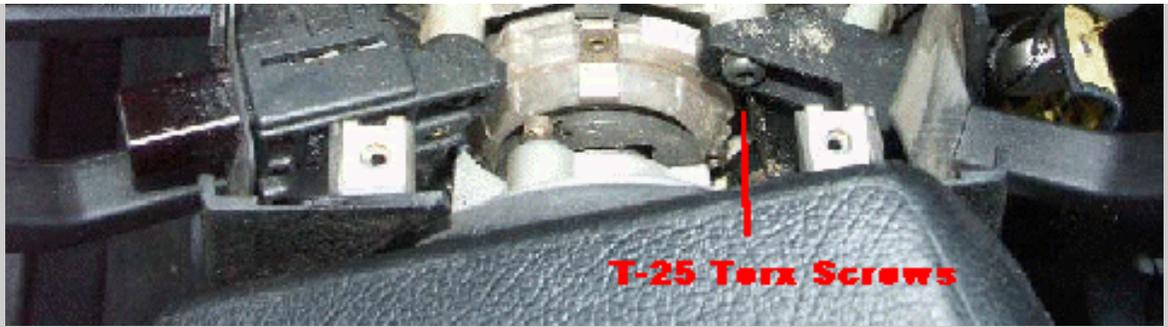
Replacing Turn Signal or Wiper Stalks. [Photos

Courtesy of
Jurgen
Winkelvoss]
[Tip from
Editor] My
kid's 940
cruise control
died and I

traced it to a broken wire in the turn signal stalk. The Volvo manual instructs you to remove the air bag and steering wheel to replace the stalks, a nightmare if there ever was one. After looking carefully at the assembly, here's an easier way to do it:

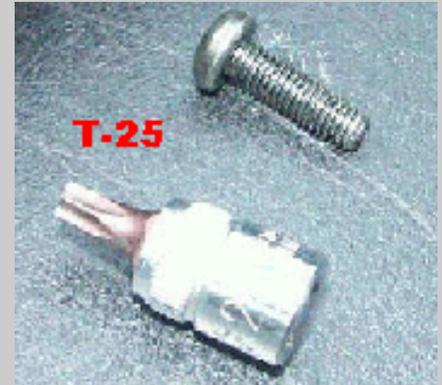
6. Pull the stalk out and replace the new one in inverse order.
7. Torque the knee bolster screws to 5.8 ft-lb and button it up.

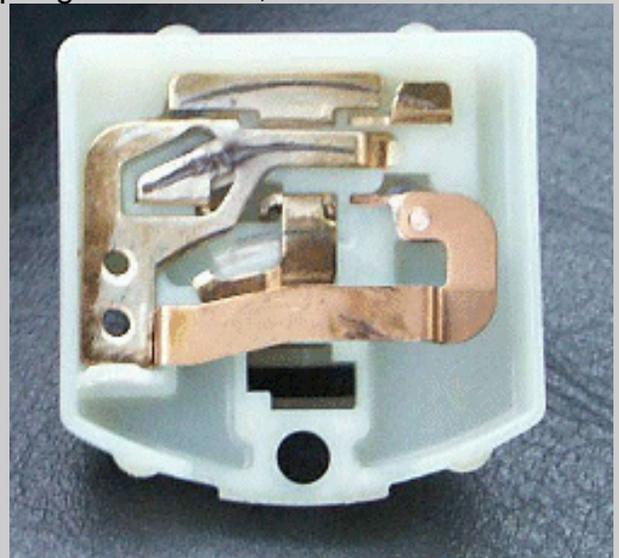
Turn Signal Contact Repair. [Procedure from Jurgen Winkelvoss] Once the stalk has been removed, lever the cover off at the points shown in the photo. CAUTION: There is a small spring and button contact at the inside center which must not be lost, so be careful in separating the pieces. Remove the contact and spring. Using polishing paste and a small foam swab, remove dirt and oxides from the brush surfaces. Note the contact wear path on the brush surfaces and clean this carefully, removing particles and dirt from the surrounding area. Make sure the brush tracks are not damaged. Reassemble, including the small center spring and contact, and reinstall.

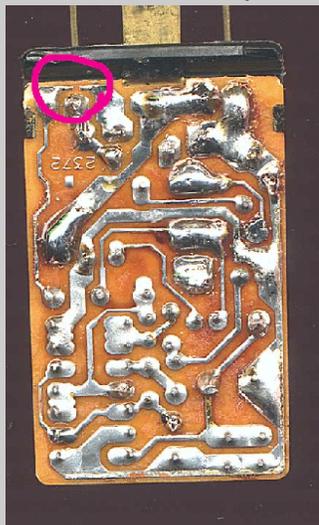
relay or a main lug connector. Under a bright light, and using a magnifying glass, inspect the soldered connections. Don't forget to look for broken conductive traces as well. Simply resoldering these circuit board very often restores them to perfect performance, and it's a whole lot better (and cheaper) than a \$50-\$100 replacement part. I have recovered literally dozens of Bosch relays (OD, fuel pump, wipers) to perfect performance this way at \$0. In fact, I resoldered ALL the relays in my family's 6 Volvos before a failure stranded us. The illustration shows an overdrive relay with solder cracks. Not shown is a broken trace (discovered with a magnifying glass) at the top of the board, repaired with a soldered jumper wire

[Don Foster:] Over time (like 10 years), the solder used in production manufacturing tends to become crystallized and cracks. The type of solder used in high-volume production is different than that used in an electronics repair shop. The problem with the relays is tiny, almost invisible microscopic cracks in the solder. These cracks usually encircle one (or several) heavy connections, such as from the

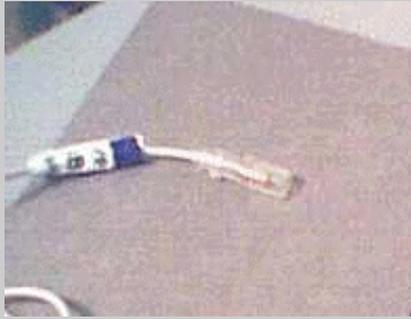
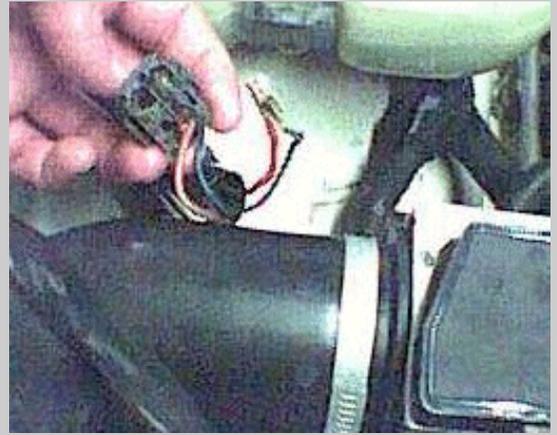
These are in stock at Volvo. They are terminals, the insulated kind that insert in various grey connectors, including relays, wiring harness hookups and fuel pumps. These are complete with a pigtail so they can be soldered or crimped together. Volvo number is 3523813-8. Suggested retail is 5.29, got mine for 2.95, so they are reasonable.

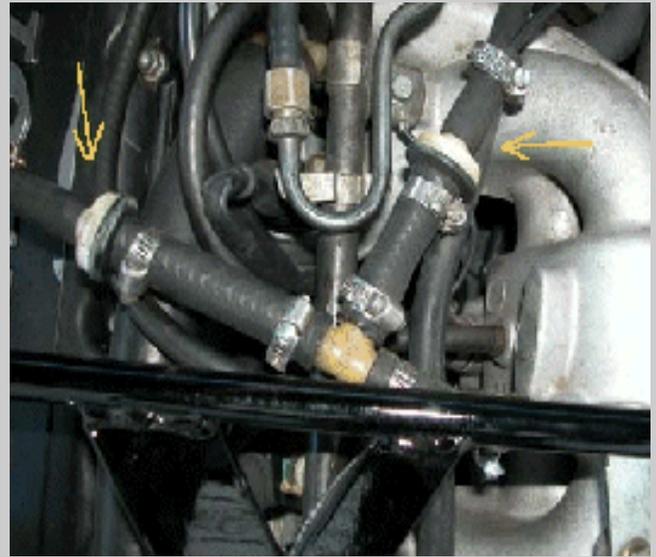
[Response: RL] There are numerous sources of potential vacuum leak (including some of the vacuum motors (bellows) on the actual heat AC system) but those two valves are a common

problem. They are check valves to prevent lose of vacuum and if you bench-test them individually, you may find that they perform well under a fair amount of vacuum but that as soon as you try minimal vacuum, the valves will give up. You may try cleaning them out in WD40 or some rubber-softening substance but failing that, your best bet is probably an OEM replacement. [Tip: Chris de Courcy-Bower] If the air conditioning misbehaves and hisses when accelerating, check the two "one-way" valves that connect the climate control system vacuum pipes to the inlet manifold. If they let ANY air through in the "from manifold" direction when you gently blow into them then replace them. (The good news is they are cheap.) [John Sargent] The two black and white check valves are shown in the picture to the right. The car is a 1988 760T but most are similar. One hose is for the ACC, and the other is for the temperature sniffer in the dome light (if so equipped). I found that the hoses leaked at the check valves and using the small worm drive hose clamps took care of the leaks. Prior to that the panel vents would snap shut as soon as you depressed the gas pedal

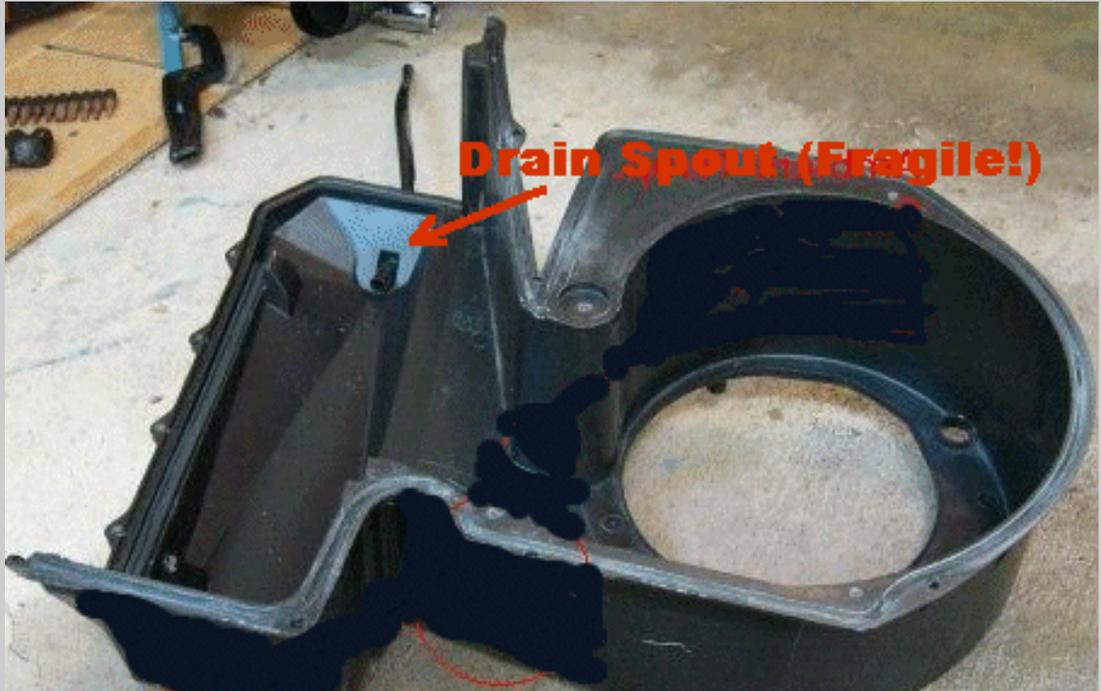
Tips For Removing and Installing the Evaporator and Plenum Cover. [Jan Kinner] Taking an evaporator out of a Volvo 940 is not an easy job!! There is ZERO clearance to get to some of the screws that need to be removed (see illustration of MCC plenum unit in right side footwell). And even when all the bolts were taken off I

still broke the evaporator drain spout pulling the thing out of the car. [**Editor's Note: Broken drain spouts are quite common, so be VERY careful.**] The mating surfaces are filled with sticky mastic which must be pried apart. The evaporator, once disconnected from the a/c tubes on the engine side of the firewall, came out easily enough, but the new one was as stubborn as a mule. Note that the evaporator has two tubes that extend through seals in the firewall. We finally got it through the firewall and hooked back up, but that was the easy part. The tough part was putting the evaporator cover back on -- this took almost 6 hours to do. Tip: take out all the insulating material around the drain spout that goes through the fire wall. That will at least give you enough clearance to put the cover over the evaporator. Another suggestion... everytime you get a screw back in take a break. You are laying upside down in the car working over your head in the dark...very frustrating!!!

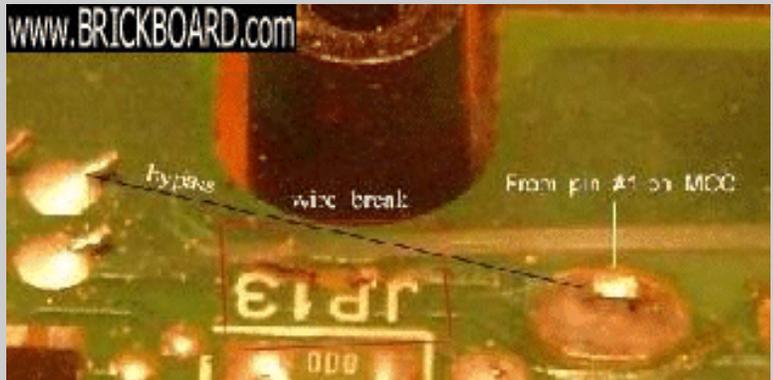
found the very small section of burnt out / broken wire, circled in red in the image to the right. Burnt / broken section of circuit board in red box goes from MCC pin #1 solder connection to another solder connection for a resistor (or something)

and then into the maze of connection within the circuit board. In the green wiring book, pin #1 appears to have no direct connection to the servo motor control the shutter for air temp, but it ultimately connects to ground. Solution: I took a single copper filament from a wire and soldered it at each end where the burnt wire was connected, marked bypass. Multimeter now showed good continuity between the 2 solder points. Imagine my surprise when I put it all back together: the MCC works perfectly!

Temperature Control Selector Not Operating . [Tip from Allan Hewick] Problem: temperature selector knob inoperative. Knob controls the distribution shutter servo motor behind the glove box. I looked all around the board with a magnifying glass and then

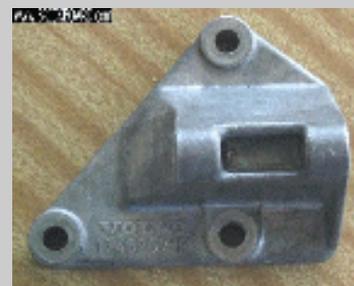
Power Steering Belt Wear/Noise: Pulley Misaligned. [Editor] If your power steering pump pulley is canted in toward the engine and not aligned with the crank pulley, then the pump bracket (Volvo p/n 1346267-6) is worn and in need of replacement. One usually discovers this when the belt makes noise. This bracket has holes that wear and enlarge over time, allowing the pump to shift position. Buy a new one from the dealer and [replace](#) the old one, which will restore correct alignment.

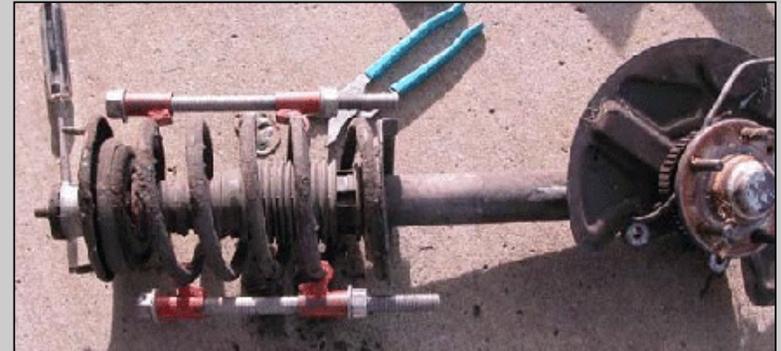
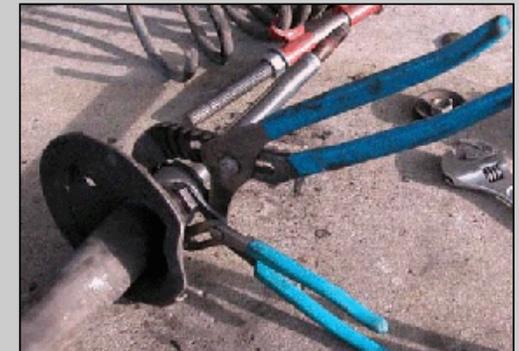
- Torques:
 - Top strut large center shock nut: 52 ft-lb for 1985 + vehicles; 111 ft-lb for 1984- with the center nut cover
 - Top strut small nuts (2): 36 ft-lb for 1985+ vehicles; 30 ft-lb for 1984-

- Sway bar end link top bushings: tighten so that the outer flats of the washers are 42mm apart

- Sway bar end link bottom bolt: 63 ft-lb
- Tie rod end nut: 44 ft-lb
- Wheel bolts: 63 ft-lb

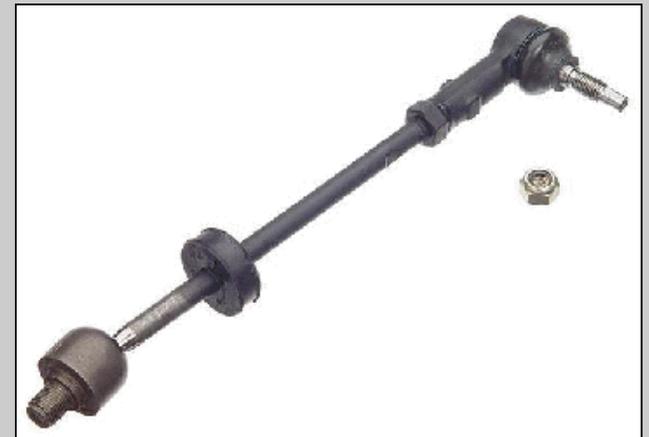
[Editor] If your tie rod ends are rusted in place and can't be removed, you will likely need a new inner tie rod (the shaft mounted on a ball joint inside the rack boot. Get one at an auto supply store, along with a heavy-duty cable tie for the rack boot. In my case, I jacked up the car, removed the tie rod end from the strut, crawled under the rack, cut the rack boot tie,

pulled the rack boot back to expose the ball joint, and used an adjustable wrench to hold the rack at the gear while I applied adjustable pliers to unscrew the inner tie rod and ball joint. DON'T allow the rack gear to rotate or you will ruin the rack. This freed the whole tie rod assembly, which I pulled off. I cut the inner rod with a hacksaw to remove the boot. Then I screwed the new inner rod into place on the rack end, using medium threadlocker, and staked it with a punch where the old one was staked. Clean off the boot and add grease to the rack gear, the ball joint and the inside clamping surface of the rack boot. I reinstalled the rack boot with a heavy-duty cable tie and the existing outer spring clamp and then installed the tie rod end. Ready for an alignment. BTW, the local NAPA parts store had my inner tie rod in stock for my '90 745 with CamGear. Make sure you get the right one with the correct length of both shaft and inner threaded portion. See the [Steering](#) section for help identifying your rack.

Tie Rod Ends Rusted in Place: New Inner Tie Rod Needed

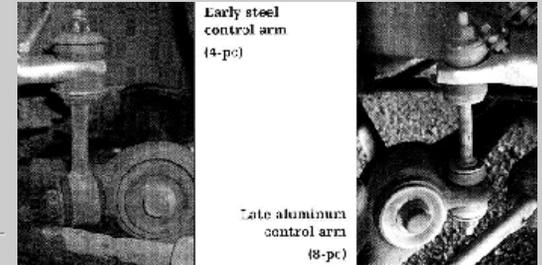
Sway Bar End Links. [Editor] Note that the rubber bushings in your sway bar end links will crack and wear. It makes more sense to replace the entire link, due to likely corrosion, than just the bushings. Note that there are two styles when ordering: the photo from [IPD](#) illustrates the differences between the early 4-piece link for steel control arms and the later 8-piece link for aluminum control arms..

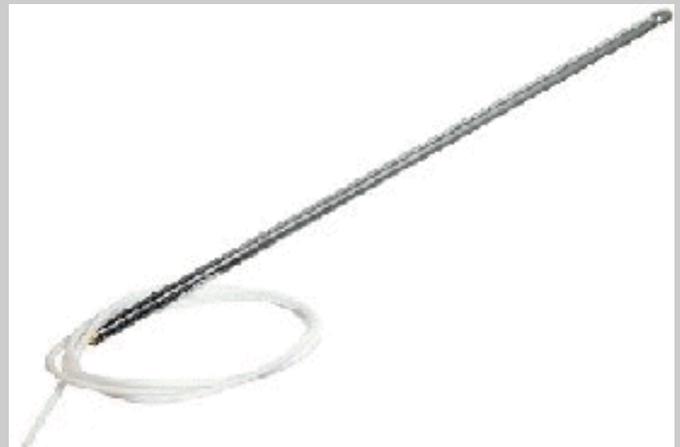
[Kenric Tam] To remove the old mast, turn off your radio to retract the antenna as far as possible. Undo the fixing nut at the antenna base on the fender or roof top and remove it by pulling it up and over the retracted antenna. Then have someone turn on the radio to raise the antenna and while you hear the motor going, pull up on the extending mast to remove both the mast and nylon cog line. You can do this by yourself too if you're quick enough to run back and forth. Once you get it out, remove the small metal retainer sleeve at the bottom of the old mast for use with the new one.

Compare the old mast with the new one. If the nylon cog line is shorter on the old one, you've got plastic cog left in the motor assembly and you may have to open the motor case and pull it out (see instructions below.) Don't cut the new line to match the old one unless you KNOW it is too long. First try removing the interior panels to get to the bottom of the antenna tube and removing what's left of the nylon/plastic cable. If this does not work, you have to remove the power unit.
