Volvo Maintenance FAQ for 7xx/9xx/90 Cars

Editor: S. Ringlee

This list was developed for the owners of Volvo 7xx/9xx series cars who are interested in maintenance tips that are not generally available in commercial manuals. It was compiled from Brickboard and specific websites with useful information. Items which appeared to be of lasting value to 7xx/9xx/90 series owners were excerpted and copied to this file. Sincere thanks to all those who took the time to answer others' questions and contribute to this public discussion. Because these remarks represent contributors' personal opinions, users need to exercise caution about any advice given; indeed, some of the comments are contradictory. This list is current as of the revision date below and was compiled by Steve Ringlee, who is NOT a consulting mechanic but only recording secretary. While this public domain list may be shared either whole or in part without attribution, it may not be sold or rented. This site is not affiliated with nor sponsored by AB Volvo, Volvo Car Corporation, Volvo Cars of North America, Inc. or Ford Motor Company. "Volvo" is a registered trademark of AB Volvo and Volvo Cars of North America, with worldwi

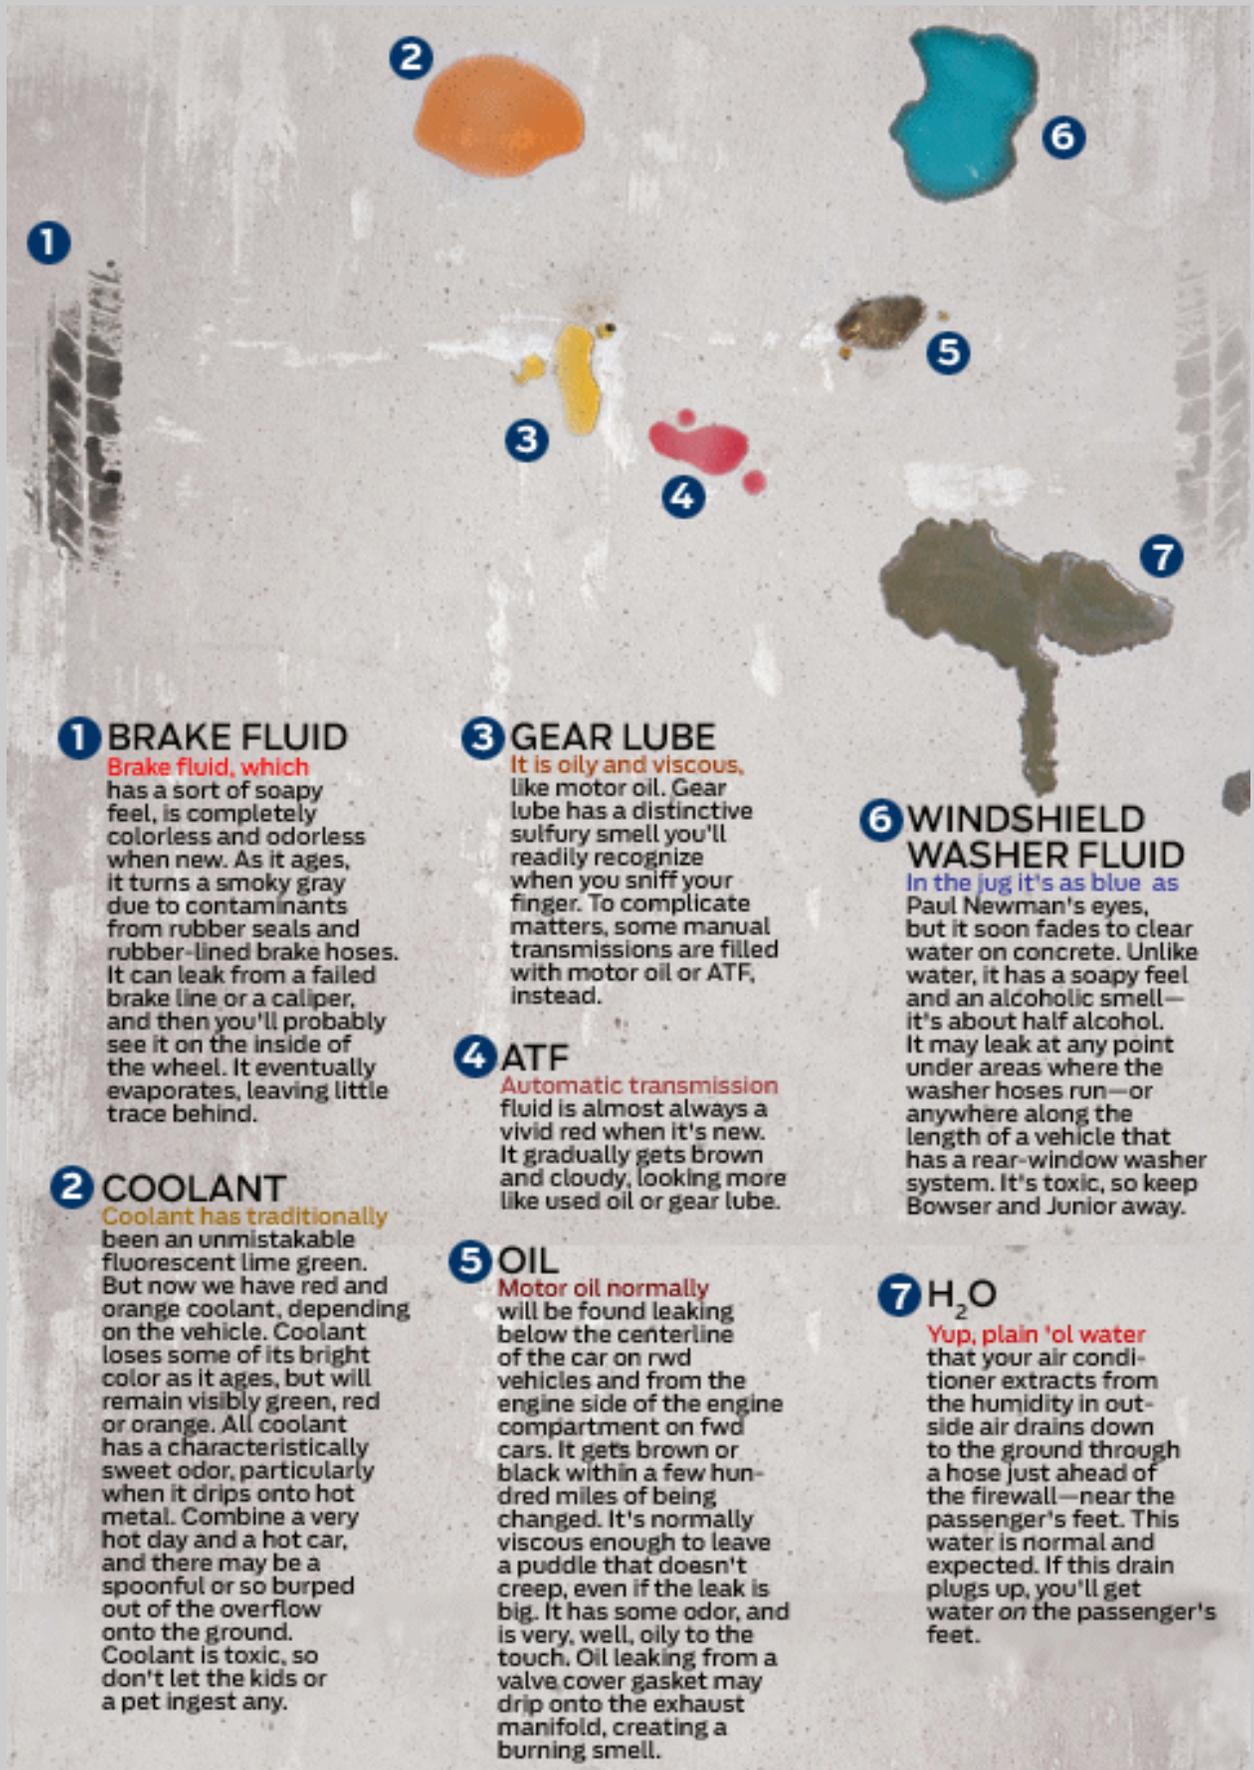
Garage Floor Mechanics: Fluid Leak Analysis. [Editor] See this useful chart, copyright by and courtesy of [Popular Mechanics Magazine](#), to help you diagnose fluid leaks on your garage floor.

1 BRAKE FLUID
Brake fluid, which has a sort of soapy feel, is completely colorless and odorless when new. As it ages, it turns a smoky gray due to contaminants from rubber seals and rubber-lined brake hoses. It can leak from a failed brake line or a caliper, and then you'll probably see it on the inside of the wheel. It eventually evaporates, leaving little trace behind.

2 COOLANT
Coolant has traditionally been an unmistakable fluorescent lime green. But now we have red and orange coolant, depending on the vehicle. Coolant loses some of its bright color as it ages, but will remain visibly green, red or orange. All coolant has a characteristically sweet odor, particularly when it drips onto hot metal. Combine a very hot day and a hot car, and there may be a spoonful or so burped out of the overflow onto the ground. Coolant is toxic, so don't let the kids or a pet ingest any.

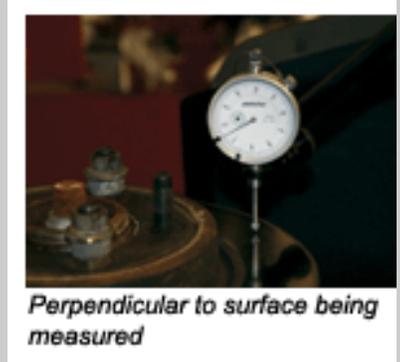
Mark the high and low spots of the runout on the face.

Observe the total indicator movement. If it exceeds the specs, replace the bearing assembly.

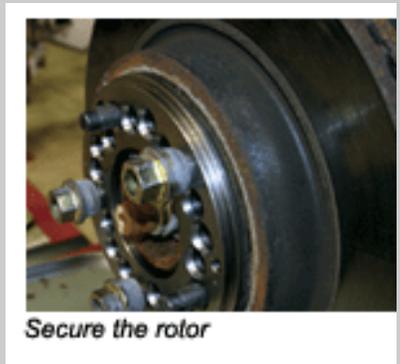
To check lateral runout, the dial indicator's tip of the indicator against the rotor's face in the center.

Mark the high and low spots of runout in the rotor.

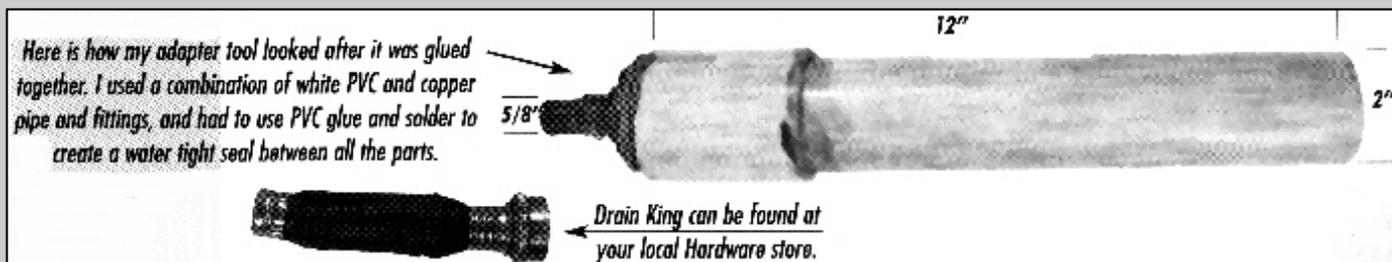
Homemade Exhaust Gas Leak Detector. If you suspect a head gasket leak resulting in combustion gases entering your coolant, you can test for this using special test fluid which turns from blue to yellow in the presence of exhaust gases. Mityvac has a fluid transfer bottle in their vacuum pump kits (pictured) or you can make one using a small jar and a lid with hoses through it. Fill the bottle part way with Lisle testing fluid 75630 for gasoline engines. Place one vacuum tube on your Mityvac or on a source of engine vacuum to pull gases through the bottle. Place a short tube on the other side of the bottle cap to extend down into the fluid to force the gases to draw through the fluid. Seal the coolant reservoir top with an old reservoir cap through which you have glued the sampling hose. Run the engine and draw vacuum: gases will rise from the coolant in the reservoir, exit via your hose through the reservoir cap, enter your test chamber by bubbling through the fluid, and if it turns yellow you have an exhaust leak into the coolant.

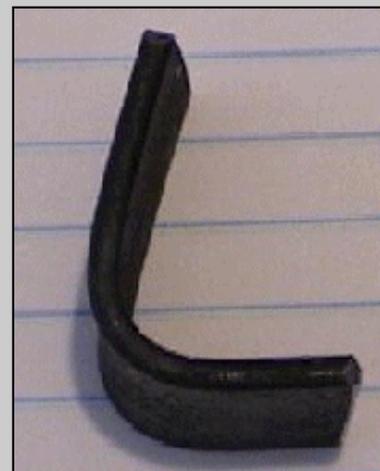
B230F Crank Holder Tool-Method 2. [Dana Manner] Here is another device used to immobilize the crankshaft by holding the flywheel gear in place.

Manufacture. Make a simple tool from 1/8" thick, 1" wide flat iron bar stock (available at any hardware store or Home Depot in about 4' lengths). Heat the bar stock with a propane torch (or MAPP gas, in the yellow tanks, which burns hotter) until glowing red at a point about one inch from the end of the length of bar stock. Place it in a bench vise and bend it over slightly beyond 90 degrees, so that it forms a shape that is "more" than an "L" and "less" than a "J" shape (see photo). Now, cut the bent portion you just formed in the end of the original long piece of stock with a hacksaw, so that it has a lower leg approximately that is 1" in length and an upper leg approximately 1.5" in length (see photo). Grind or file the edges and corners smooth with a slight bevel.

Use. To use this tool, remove the two bolts that attach the starter to the engine, and withdraw the starter, exposing the flywheel gear teeth. Insert the tool into the round opening of the starter hole, and engage the lower leg of the tool in between two teeth of the flywheel gear, with the bend in the tool resting on the inside of the starter hole against the engine block, and the upper leg of the tool pressing against the flywheel. Once engaged in the teeth of the gear, rotate the crank slightly to wedge the tool in its position. Now both hands are free to use

to loosen/tighten the crankshaft pulley and harmonic balancer bolt (a huge benefit)! When loosening the crankshaft pulley and harmonic balancer bolt you will install the tool against the top of the starter hole in the engine block, and the tool will jam the flywheel "rock-solid" from rotating counterclockwise. Install it against the bottom of the starter hole (opposite direction), to prevent the flywheel from rotating in a clockwise direction, for retightening the same bolt. This tool and method works better for me than the various other belt/pulley holding/jamming techniques, and the tool is easily fabricated from inexpensive, widely available materials, by anyone with a propane torch, bench vise, hacksaw and file.

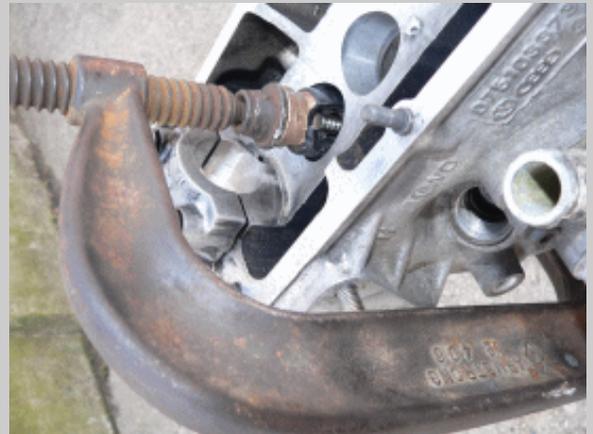
compressor out of a large C-clamp and a brass 1/2" to 3/8" reducing coupling. The C-clamp has a six inch opening and is four inches deep. Cut two good size slots 180 degrees apart, on the 1/2" side of the coupling. That's where your valve keepers can be removed. Grind off all burrs and wrap black electric tape around the two legs so it doesn't score the aluminum bores if it shifts to one side. Lay the cylinder head on its side with the coupling windows facing up and down. After compressing, the keepers will fall out with a little help from a small screwdriver. Or you can use a magnet. To reassemble, compress the spring then turn the head flat on wooden blocks. Drop the keepers through the windows. They'll fall right into place. I'm sure there are better ways, but this arrangement worked for both my B230FT and my D24T.

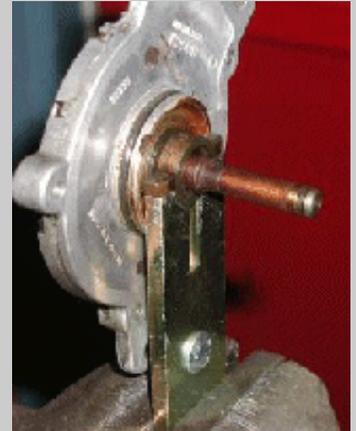
Distributor Drive Pin Remover Tool. [Tool design by John Vilas] This tool may be used with a vise or hammer to remove the shaft pin holding the distributor together. You will need it should you ever decide to change the inner o-ring seal on this shaft. You can purchase this from:

To use it, see John Sargent's excellent [procedure](#) in the FAQ.

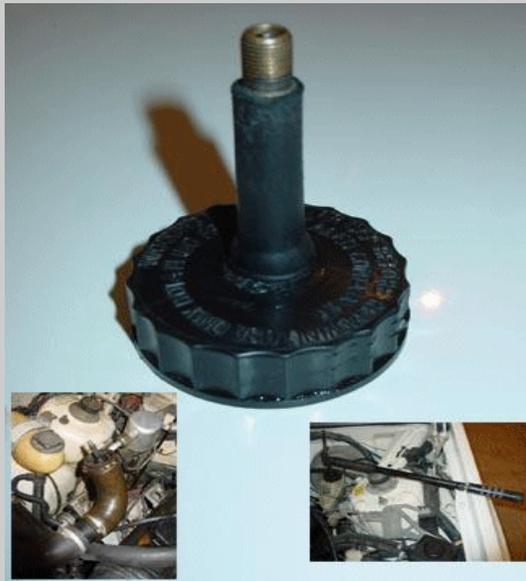
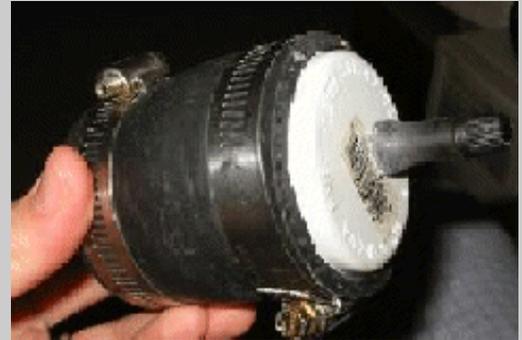
Turbo Intake System Leak Tester. [Tips from Josh Wingell/Brent Cook] To assemble a device to locate leaks in your turbo intercooler or intake hoses, try this. Parts Needed:

Pressurize the system, and listen all over for leaks. You might want to have a friend check out your boost gauge while you are pressurizing things to make sure you

don't put too much pressure on things. (20 psi should be safe, or whatever you run safely for boost) Make sure you or a friend listens under the bumper too, wherever there is intercooler piping. A leak will be obvious, they make a loud hissing sound.

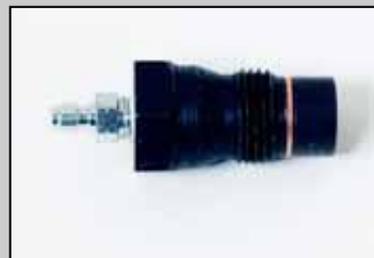
Compression Testing. You will need a serpentine belt tool (the cheapest is from Sears), a compression gauge reading up to 500 psi (very difficult to find) and an injector hole adapter into which you fit the gauge.

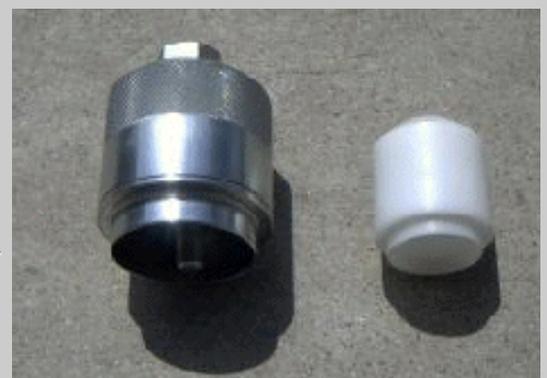
Cam and Front Crank Seal Installer.

Volvo Special Tool Images. Below are some images of Volvo special tools to help you construct your own versions.

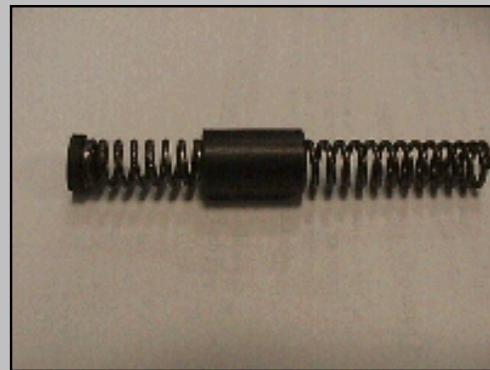
960 Oil Pressure Problems: Failing Oil Relief Piston. [Tip from JT] As you know I have had some problems with no oil psi after I got the 2.9l back together. I thought that the oil pick-up was plugged with sludge or something. I know I did not want to drop that oil pan so I figured that I had nothing to lose by trying to clean the sump. I put in 6 quarts of the gunk parts cleaner (comes in 3 qt cans) thru the dipstick hole and let it set for 2 days. When I drain it the oil sump was spic & span! I flushed it with oil, then tranny oil, and then with oil again. I then filled two caulking tubes with mobil-1 0w-30 oil and with a rubber stop (with a center hole) pressurized the oil system thru oil filter inlet. I put the filter on, filled the sump with oil, and cranked the engine. No oil psi! I had to know what the heck was going on with this no oil psi. Still not wanting to drop the pan I went after the new oil pump. When I got the pump off it did not look right to me. What I thought should be the oil psi relief valve looked strange. Never seeing one of these before in the new Volvo engines I was not sure how it was suppose to work. What I found was a cylinder in a cylinder with a spring going thru it. I went to Volvo and ordered everything I could (except the pump) that was associated with the pump. It was clear when I got the new parts. The inside cylinder used to be a piston. The wire snapping chipped away at the piston top everytime it

would hit the stop. Since the relief valve is made out of PLASTIC with the force of the spring behind the piston top, it was chipped away until the spring blew the top on the piston off! No oil psi. The new piston is made out of steel. So this will not happen again. This was a new oil pump that had this plastic piston in it. I am told that the 850's use the same pumps. My sisters 850's oil pump took the big vacation about 2 years ago and I wonder if this was the cause. The casting date stamp on the oil pump in the 960 with the plastic piston was 98. So formational purposes, the next time you do a timing belt, you may want to check to make sure you do not have a plastic piston relief valve.

Techniques: [From JT] The good news is that you do not have to take the oil pan off to check/replace the relief valve piston. I never took my pan off. I am really happy that I did not have to take that step. I do not know how many oil pumps came with plastic pistons or when there was a change to metal ones, but I say rather safe than sorry. If you are coming up on a timing belt change, pull the crank pulley and the crank timing belt gear. You will see four Torx head bolts that hold the oil pump in. Remove the bolts and the pump slides straight out. The piston was about \$12 and the oil pump kit was about \$23 (including front seal, oil pump seal, oil pump gasket). If you have a plastic piston in the relief valve you will have to separate the oil pump by removing the back gasket and removing 2 small hex head screws. Push the piston out and put the new one in. That's all. When you get ready to install the oil pump back into the engine you will need a special tool to get the front seal over the crankshaft. I used a thin walled piece of pipe but I think the book called for Volvo tool #5455. It makes the job real easy to get the oil pump back on.

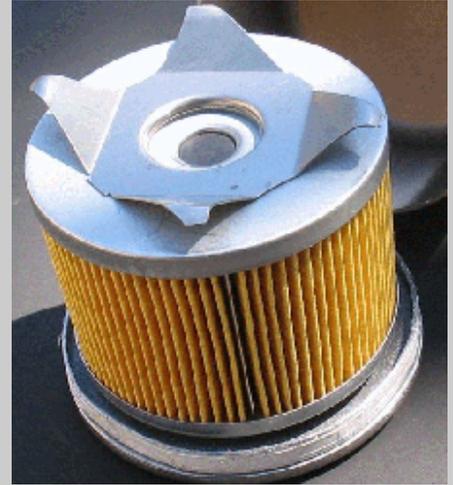
- A strong, spring loaded bypass valve with nitrile rubber seal.
- 90 pleats, pretty evenly spaced, each glued down very tightly. The paper is ribbed to keep the pleats separate.

- The filter pleat measured 2-1/4" tall, with 89 of the pleats measuring to 25/32" deep. The pleat at the crimp measured to 3/4".
- Each pleat offers 2 sides, for a total of 180 sides of filter surface. $(2.25 \times 0.78125 \times 178) + (2.25 \times .75 \times 2)$ yields just over 316 sq.inches. By comparison from the other oil filter study out there, the gigantic Ford/Motorcraft FL-1A offers 400 sq. inches of filtering area. In this same size, the Fram PH8 offers just 193 sq.inches. With the Volvo filters being shorter, you can imagine how little filtering area the Fram will offer.

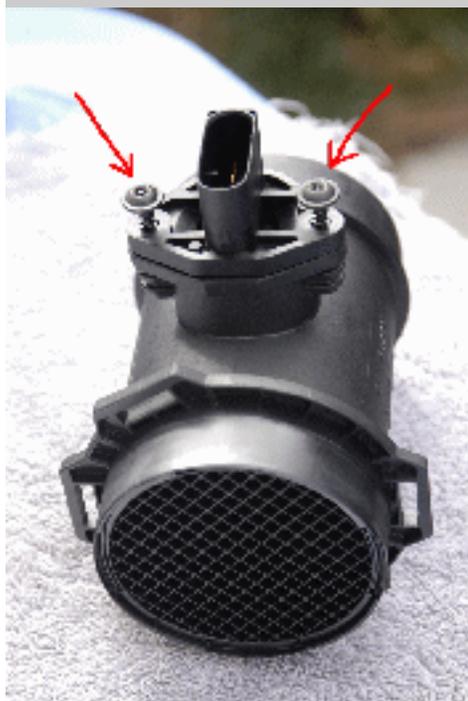
In later year 90 series cars (after 1996), the mass air flow meter uses a hot film sensor that can become dirty. To clean this sensor, remove it from the air box outlet and follow the instructions in the photos below.

1. Unscrew with T20 Security Torx

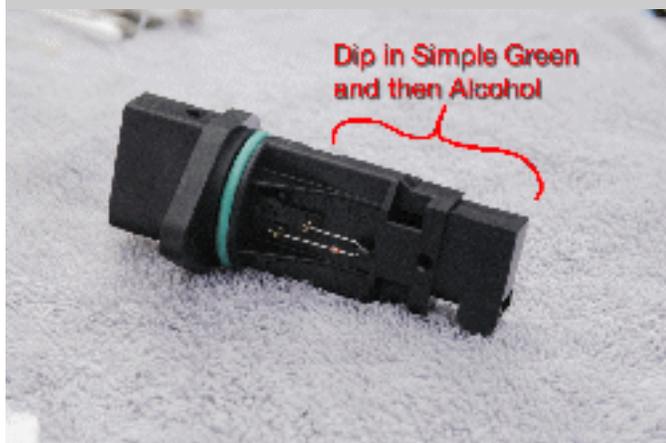
2. Dip this end in Simple Green 1:1 solution

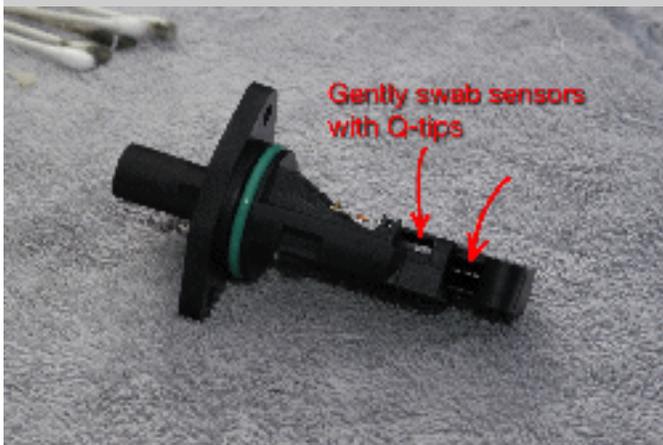
3. Clean gently with q-tips

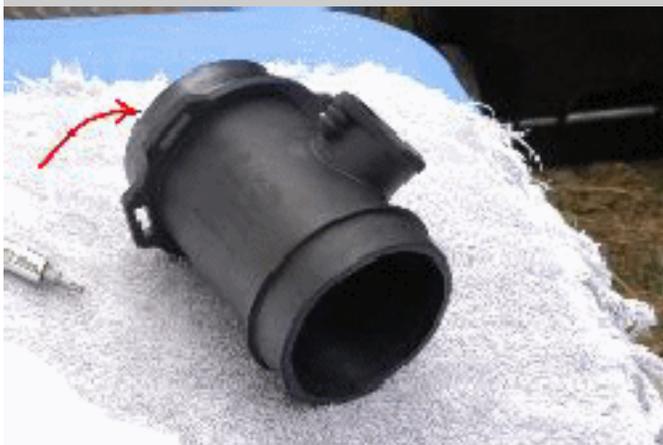
5. Dip mesh end in Simple Green and then

Alcohol

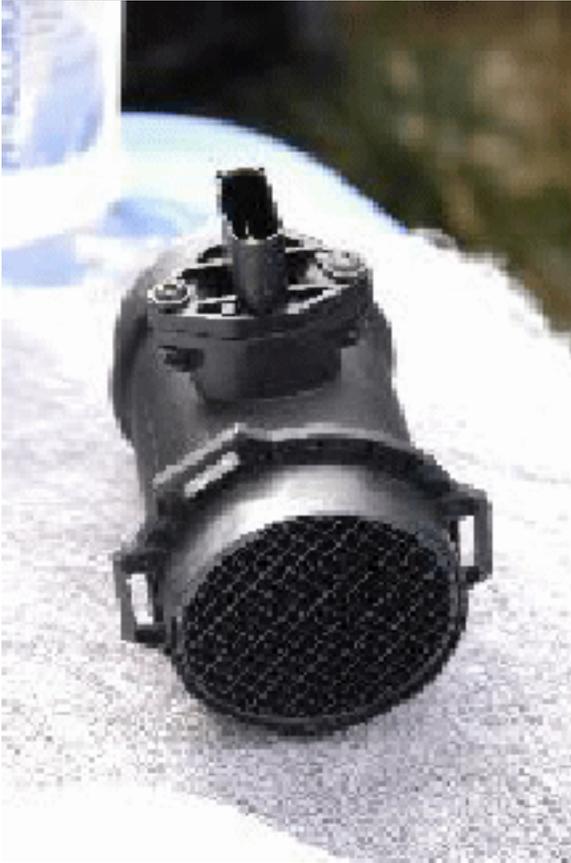
6. Screw clean sensor back into tube

Now reinstall it back into the car.

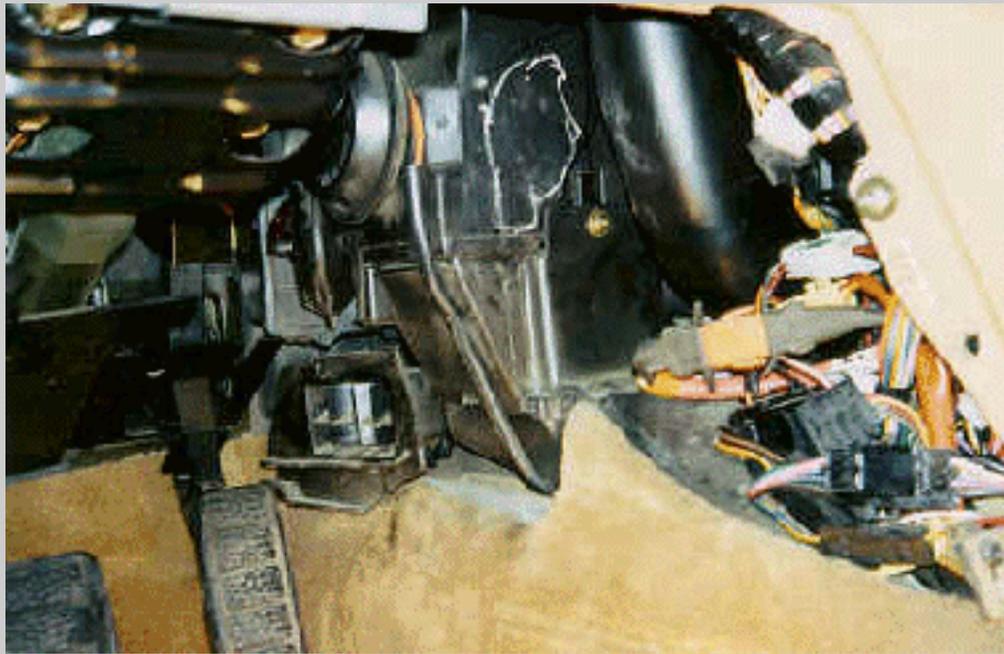
Picture #1 - Mark the area to be cut. Note the box in the picture and chalk marks. These are on the left side of the box. Drill 1/4-inch holes at the top left, top right, going

diagonally up at approximately 45 degrees. Drill another hole, bottom left and another hole on the right side of the box. Cut across side-to-side. Next, make a vertical cut, and swing the plastic flap to the right side. [Note: I would enlarge the hole in the photo downward another 4 cm to have more room to

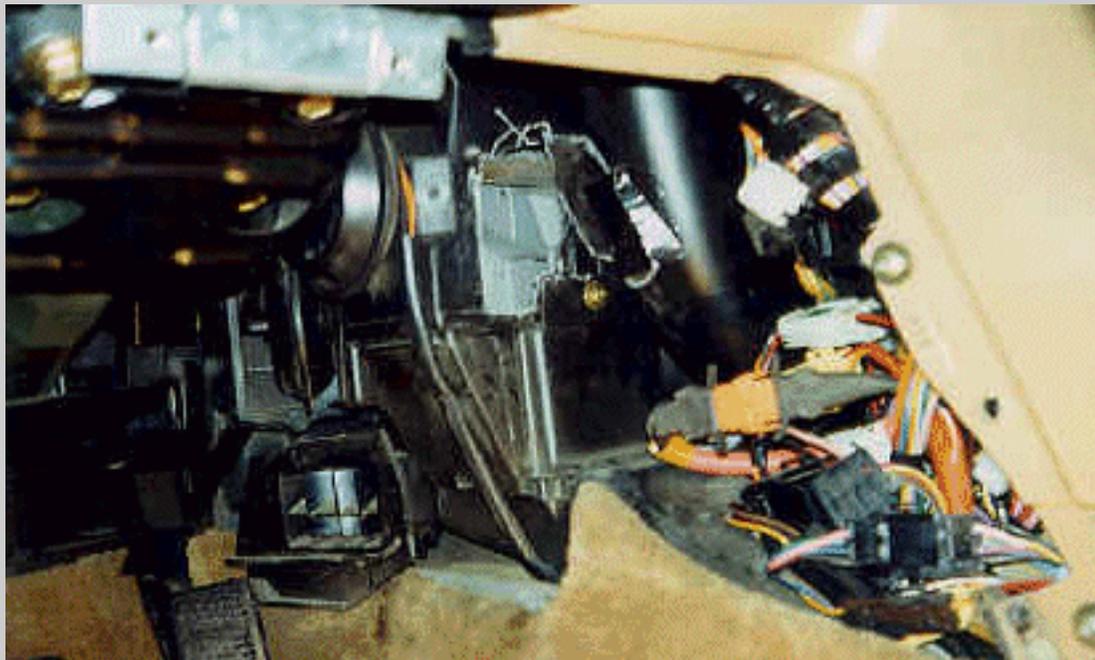
maneuver.] Picture 2.

.]The plastic is quite flexible and may crack, but should not break, thereby creating a hinge. Note: if it cracks off, use duct tape and epoxy to repair. Take the hacksaw and cut to the left, horizontally, on both top and bottom, and swing the plastic flap to the left. Place a rag in the bottom of the hole to prevent "bits" falling down.

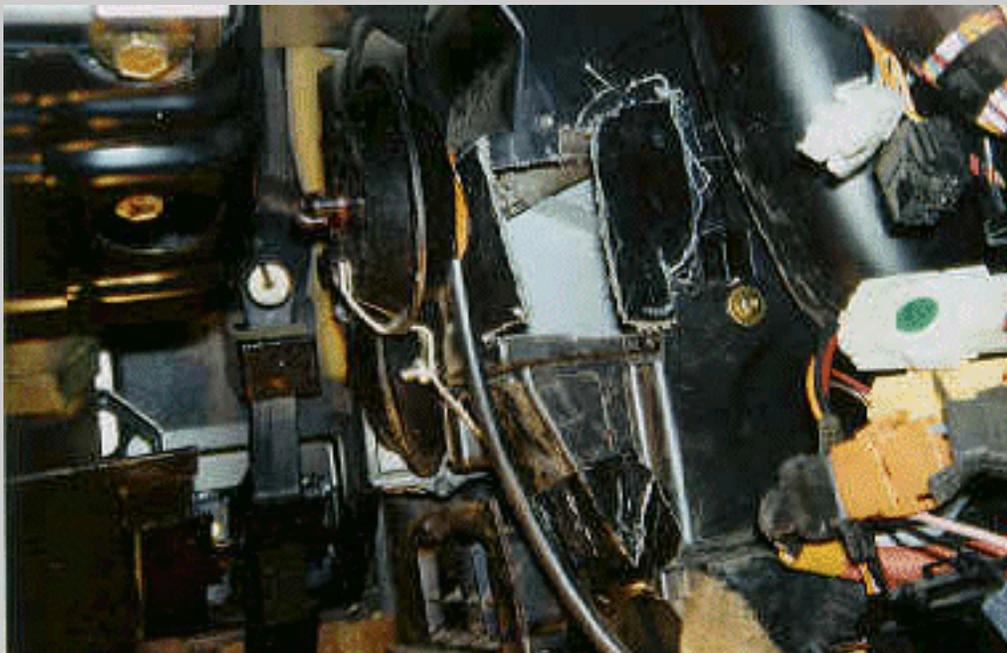
This is also a picture of the new valve installed. Before installing the new valve, install the nuts on the valve to cut threads into the plastic stud. Don't break off the studs, which are brittle. Now

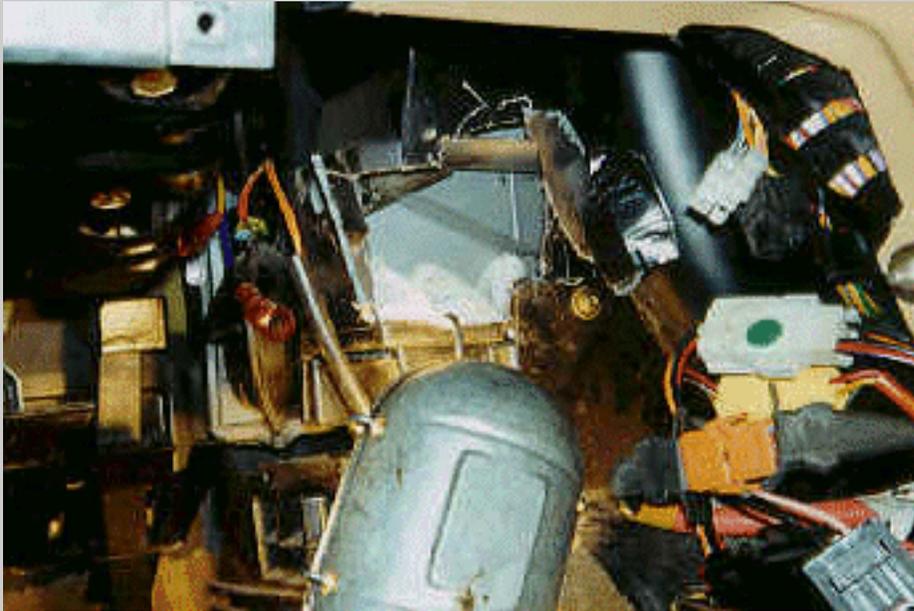
install the new valve, without the nuts. Attach the valve to the air-diverter post and replace the lock piece. Next, replace the nuts on the new vacuum valve. You may need to use some masking tape inside of the socket to hold the nuts in place to prevent them from falling out. Be careful putting these nuts back on as the plastic

I am now going to assume that you have broken one or both plastic studs on the vacuum valve. You will need to fabricate a bracket, as noted in picture #4. Bracket material is the same material as used to mount car radios. This has multiple perforations and is fairly easily bent. Tom Irwin experienced breaking both studs and fabricated a bracket which held the valve on by going over the vacuum valve. The bracket had a hole in the center, which was enlarged, to go over the center hole of the vacuum valve. The bracket was attached to the air-box by using small screws. The bracket I used had a small bolt going through the box. Make certain that wherever you mount the screws that they cause no interference with the movement of the diverter in the air-box.

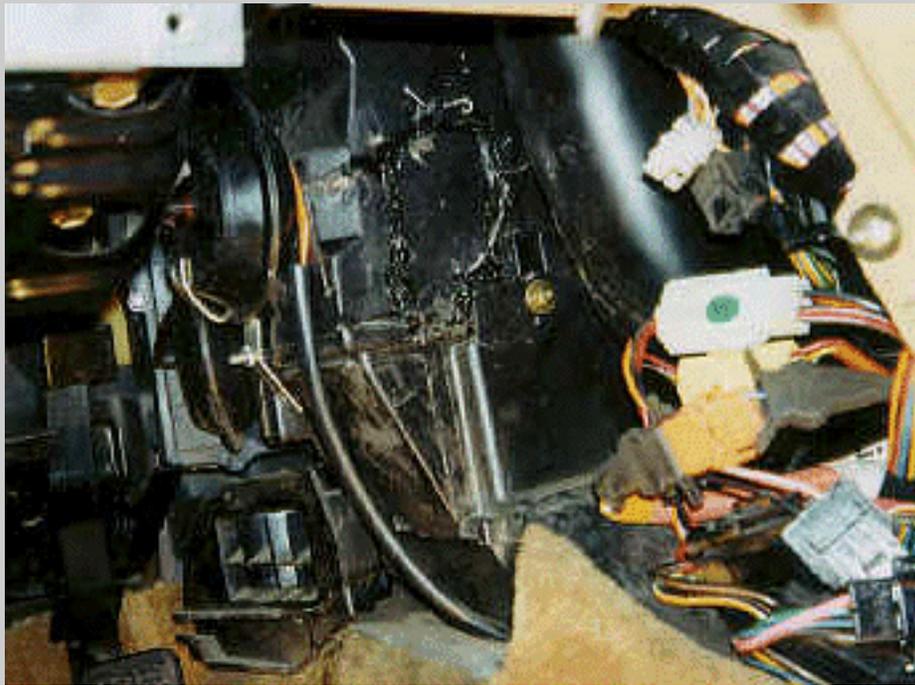
Attach vacuum hoses. Start the car, and check that the valve works properly by moving your heating-air-conditioning controls. If all is well, clean up the edges of the flaps which were cut, bend them back into position, and use J-B Weld or a similar product to hold in position. Next, use the black RTV-silicone sealant. Do not use too much as it could interfere with inside air-flap movement! After the sealant is dry, you may desire to put duct-tape over the entire incision. You will note in Picture #6 the reassembled unit minus the duct-tape. This has worked well for us during the past

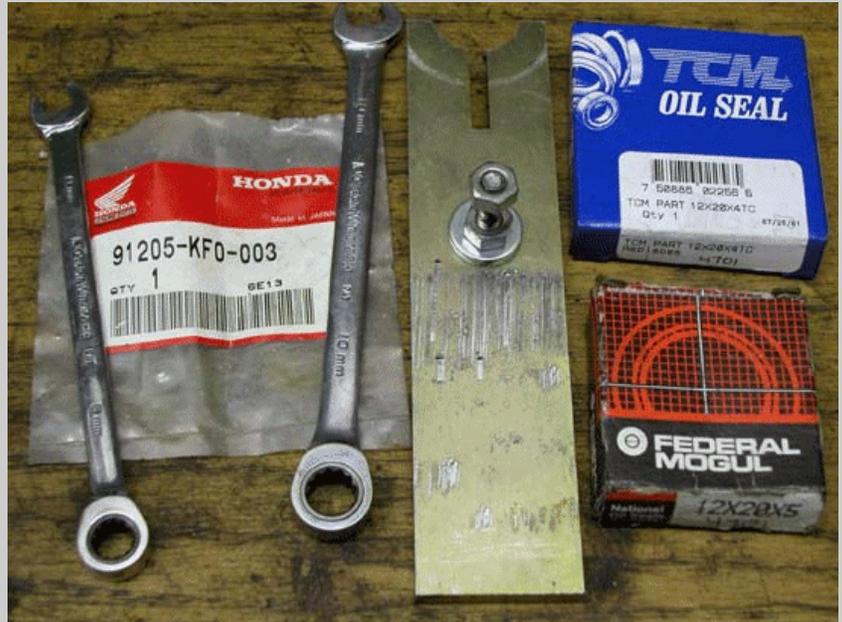
The next picture is rotated 90°, but it shows the distributor in the fixture (which in turn is held in a vise) and I am starting to drive out the pin which holds the drive dog to the shaft. Some of these pins are easy, and others are really tight and have frustrated some very fine mechanics. I always use a tapered pin punch to get the pin started. You will break a straight pin punch of the highest quality on some distributors, and you won't move the pin. I know this from experience.

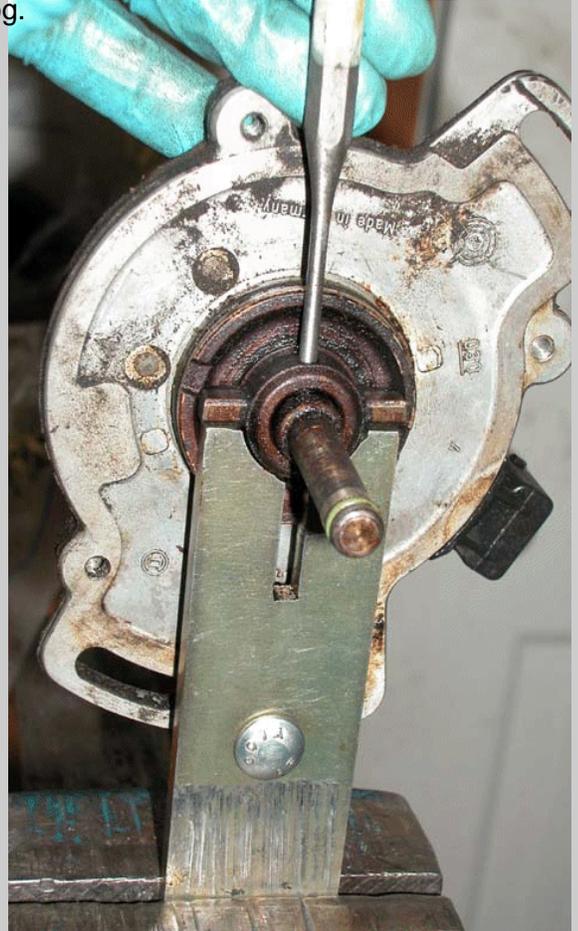
The picture to the right shows driving the pin out the last little bit. You have to quit with the tapered punch when it bottoms out in the drive dog.

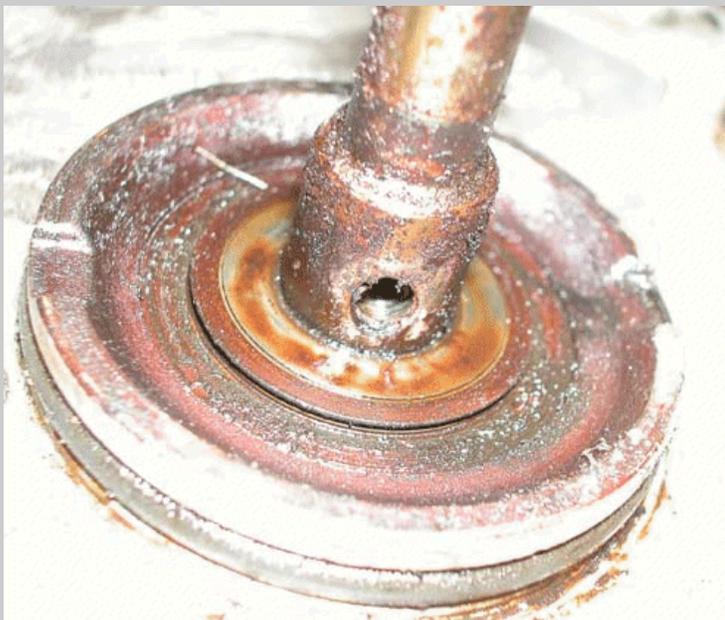
The picture below shows the shaft after removing the drive dog. The shaft is covered with old oil varnish.

You must remove the old varnish with razor blade scaper and ScotchBrite or you break the fiber

washers which cannot be purchased.

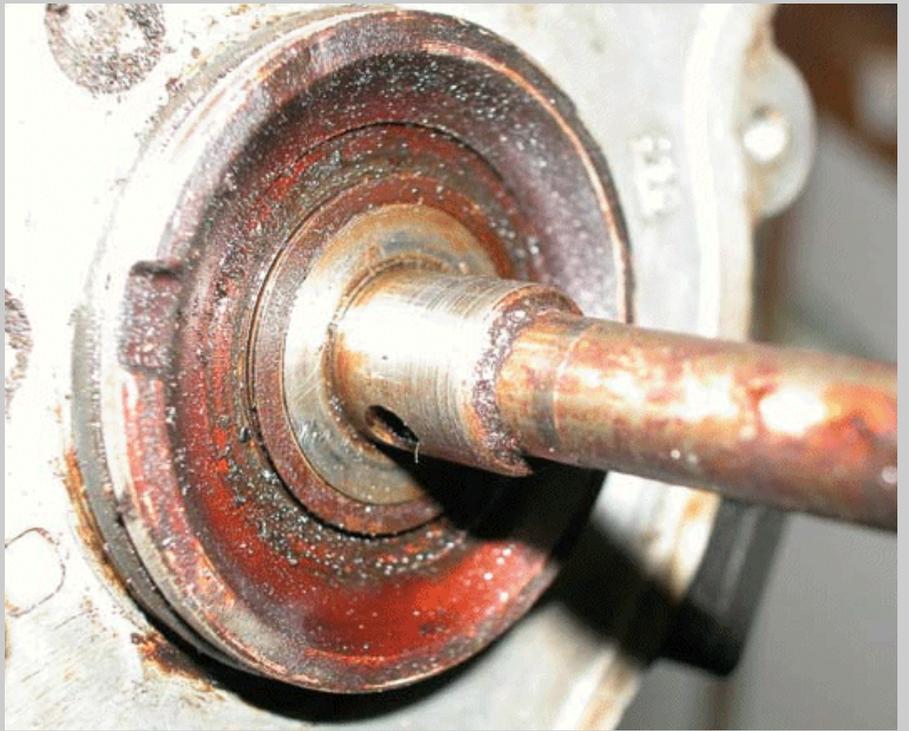
The picture below shows driving out the seal retaining washer with the tapered punch.

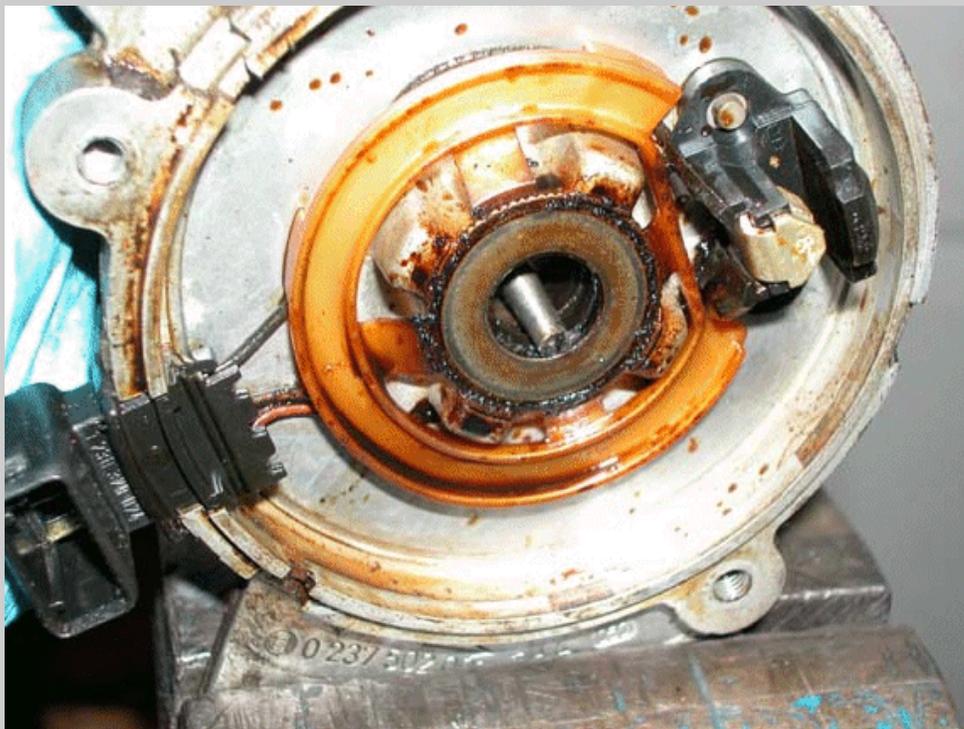
In this picture I have the distributor base cleaned up and ready for the

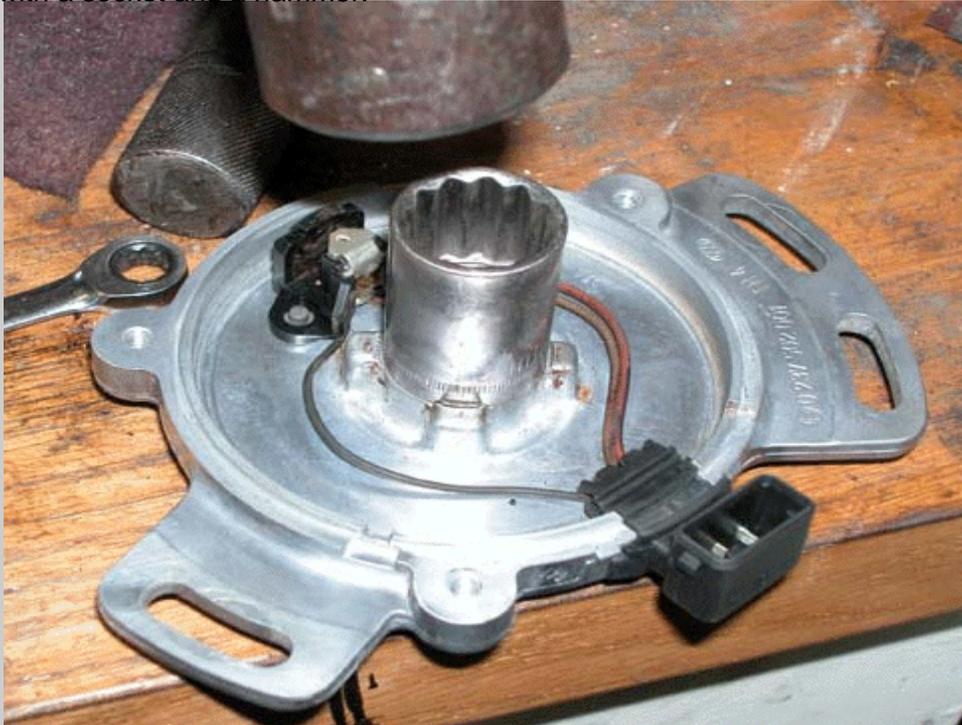
After pressing the seal in with my fingers I set the seal retaining washer

with a socket and a hammer.

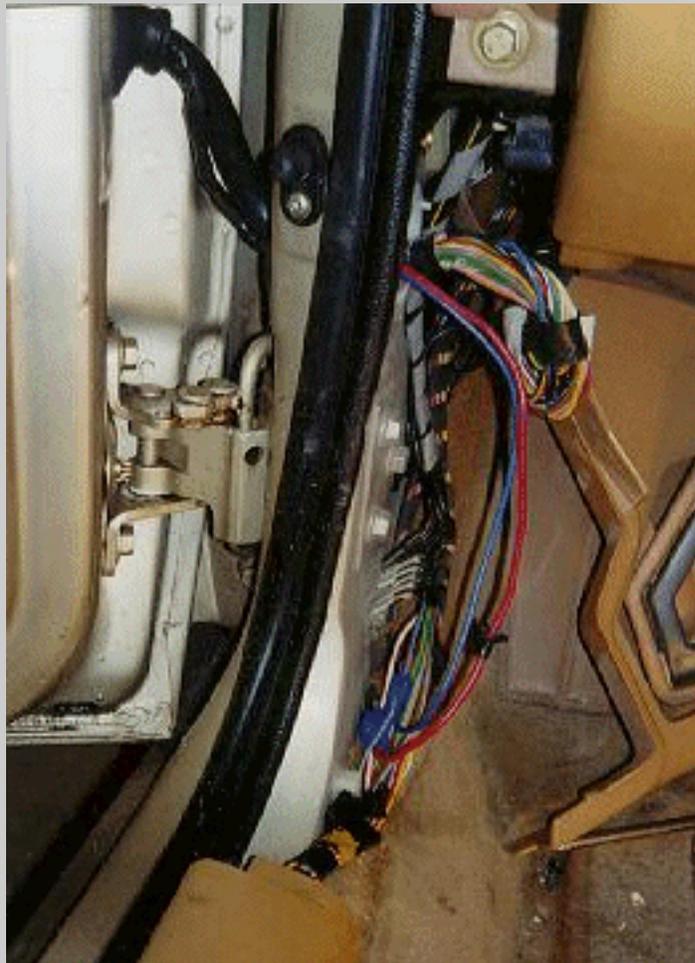
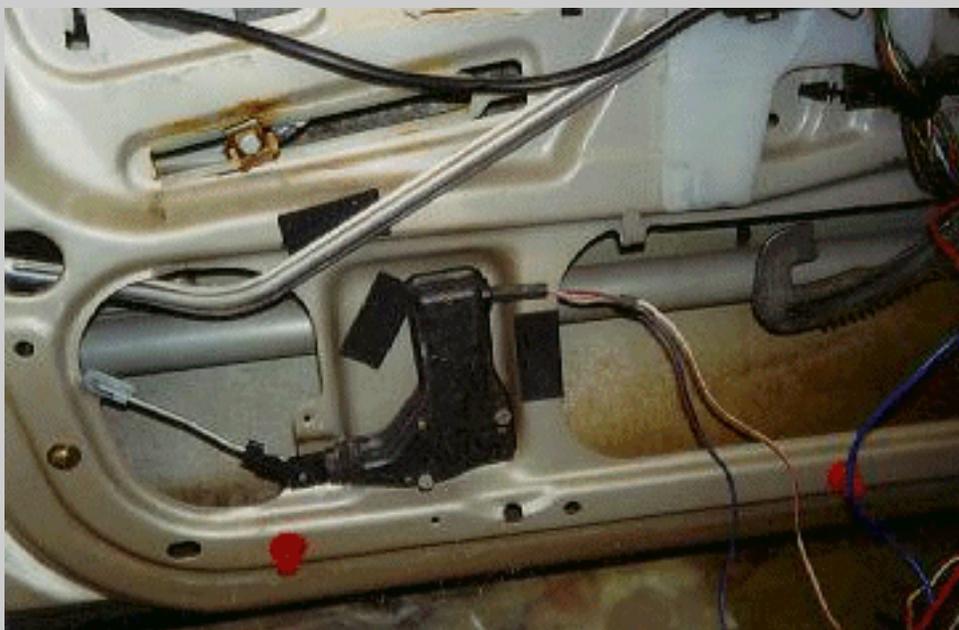
[Dick Riess] The 900 series uses a totally different lock motor system than the 700 series: the 900 motor is not "L" shaped and is directly connected to the lock and the knob. There is no linkage arm.. Finding 900 parts proved impossible, so a 700 series motor and passenger side linkage (shown in the photos) was substituted. You may also use a 200 series motor, but linkage does not work as well. The swivel and linkage were used, but the metal cage normally used to attach to the door was discarded. The holes in the motor, which normally hold screws fastening the cage were bored out, so that metal screws could fasten the motor to the door. Note picture

1. The plastic swivel was mounted on the inside corner of the door. See picture. One linkage rod was run to the motor...the other to the lock switch. Linkage was bent for best fit. The two motor wires were routed through the door with the other door wiring through a piece of shrink wrap. Note picture 2. The shrink wrap was used because there was not room in the factory conduit. Wires were attached in the area of the left kick panel. Wiring of the motor was reversed because of the reversed position of the lock motor. Note approximate position of wires and controller in picture 3. Leave the old door switch (which acts as a switch for the other doors) in place so that the process of unlocking will be as follows: The new motor gets a signal to lock/unlock the door. This is transferred to the locking unit via the linkage and raises/lowers the round knob. At the same time, the existing drivers door switch is triggered, signaling the other doors to lock/unlock. Comment: My wife likes it!

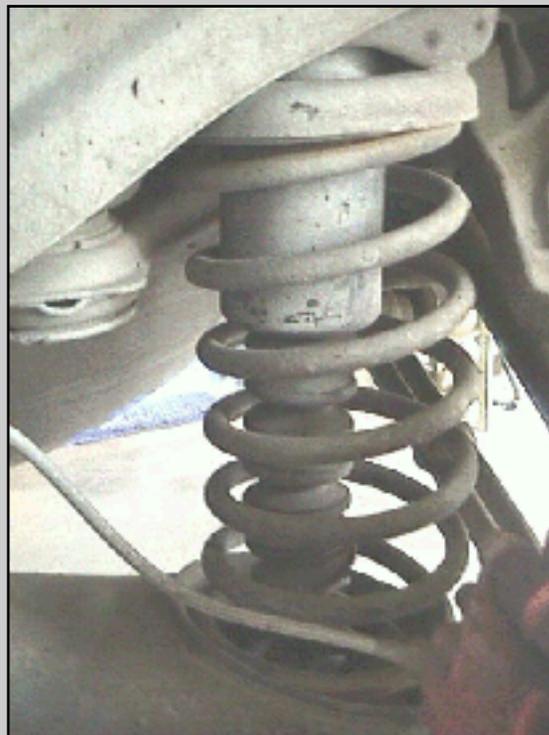
Tools. You will need a lift that will support the vehicle by the chassis, not by the tires. You will need at least one coil spring compressor, the type that goes inside the spring and has two sets of flexible jaws... two is highly recommended. Air tools will be a big help as well, as it can get mundane and difficult to compress the springs by hand. Also in the air tool department, a cut-off tool to cut the pigtail off the rear springs (get to that later). You'll also need a socket wrench set to remove a few bolts securing the brake caliper (to move it out of the way so you don't rupture a brake line... learned that the hard way) and the bolts that secure the shock. You'll also need a block of wood that will keep the trailing arm extended while you compress the spring. A large pry bar may also come in handy.

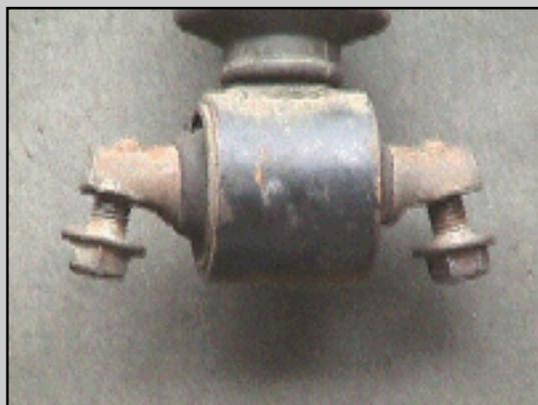
Lower Mount. The lower mount must be either fabricated or cannibalized from the old nivomat. I went with the fabricated route last time (see below for illustrations), and tried the cannibalization route the next time. Why? Because I spent about 4 hours trying to make my own mounts, only to discover when I went to install them that I had drilled the holes slightly off and a bit too far out, and they were too long in general and therefore wouldn't fit. Rather than leave the car in the shop, I took the old Nivos and proceeded to press out the metal center of the bushing. Naturally, the rubber was destroyed, so I just saved the center metal portion. Now here's the trick: the Bilstein already has a metal sleeve just the right size OUTER diameter in the middle of its rubber bushing. The metal sleeve is VERY firmly fixed to the rubber bushing. Fortunately, the rubber bushing is NOT very firmly fixed to the rest of the shock, and therefore can be pressed out without totally destroying it. At this point, I was running short of time, so I cut the bushing down one of the seams and used liquid wrench and a screwdriver to separate the rubber bushing from the metal sleeve. I then pressed the bushing back into the shock and the center metal portion from the nivomat back into the bushing. Seems to work fine. Next time, I'll look for a comparable bushing ahead of time, so I don't have to worry about saving the one I extricate from the bilstein.

If you fabricate your change to the lower shock mount... a machine shop should be able to do this for minimal cost, or if you have access to the right tools, it shouldn't prove too difficult to fabricate. It's simply a piece of steel tubing that's passed through the lower mount, crimped together, drilled, and then

slightly bent upwards. Once you get the parts and have a close look at the old lower mount on the Nivomat, this cryptic description will become much clearer.

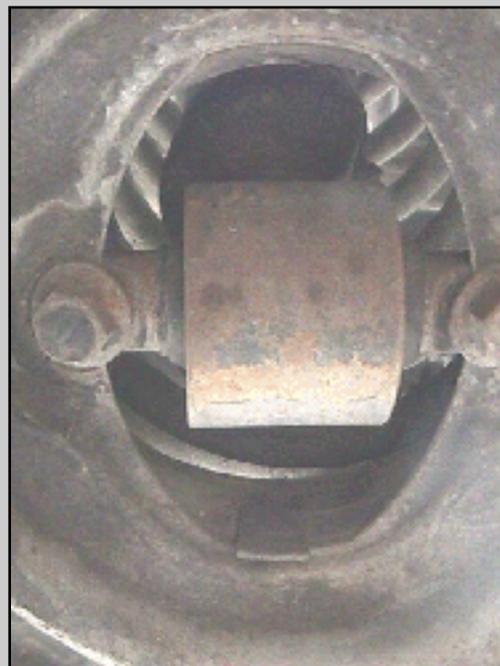
You've got to remove the Nivomat shock first, then put in the wood block to keep the trailing arm fully extended. I think I stuck the one I found between the top of the fender well and something else off to the side, I really don't remember. Just make sure that it is sturdy (I used a 4" by 4") because when you compress the spring and remove it, the trailing arm is going to want to retract, seriously limiting your room to work. If you do not have a jack to raise and lower the trailing arm, then remove the brake caliper so it's not in the way, and so you don't bust a brake line by mistake.

Three bolts secure the nivomat- one up top and two through the bottom of the trailing arm. Remove them. Three bolts and a nut secure the mounting point of the trailing arm (towards the front of the car) to the frame. [If you have a lift and are using a jack to support the trailing arm: I chose to remove them, because the way I had the car jacked up didn't allow easy access to the one bolt which went through the trailing arm bushings and secured to the mounting point. I had the car up on a lift when I did this, and used an adjustable hydraulic tranny stand to support the trailing arm as I undid the bolts & nut, then I lowered the tranny stand and the trailing arm to remove the old spring and drop in the new one.]

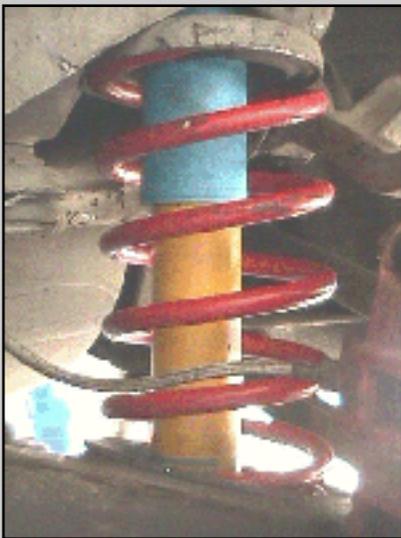
Procedure: Installation. Installation is the reverse of disassembly. Get the spring back in, then put in the shock. Next, put in whatever spring spacers you decided to use. [Note: not needed if you used the IPD wagon overload springs] .. that'll keep the car from riding on the bump stop. Don't install the spring spreaders before you put the shock back in, because you need to be able to see where the spring's maximum clearance is. Depending on what type of spreader you get, you may hear an occasional "thump" as the spreader whacks up against the shock tube going over a bump or around a corner.

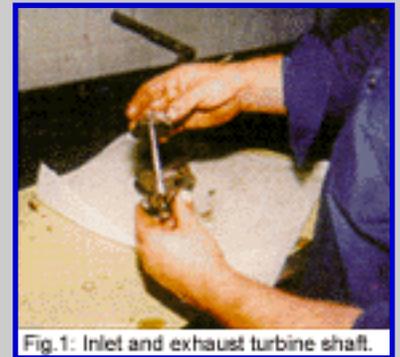
Fig. 1: Inlet and exhaust turbine shaft.

3. Remove the compressor housing, and then the exhaust housing. Try to mark the compressor wheel with the exhaust drive wheel so it will be assembled in the same manner as it was balanced from the factory (See Figure 1).

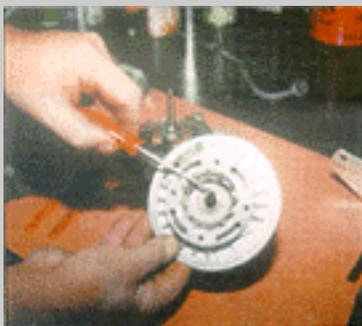
Fig. 2: Compressor plate.

4. Inspect worn areas, such as compressor plate on which the seal ring rides (See Figure 2).

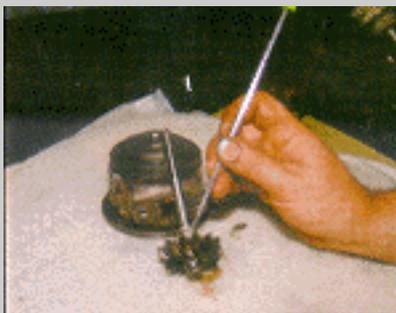
Fig. 4: Exhaust turbine seal area.

Turbochargers won't actually blow a seal; the seal on the exhaust side is usually a simple piston ring with a small ring gap. The seal on the compressor side is either the same style or a more positive carbon seal similar to an air conditioner compressor seal, or even a water pump seal. Before you condemn the turbo, consider the fact that even a good turbo will leak oil given certain circumstances. Here are four areas to look at:

9. Inspect exhaust turbine seal area for worn-out ring groove (See Figure 4).
