Volvo Maintenance FAQ for 7xx/9xx/90 Cars

Editor: S. Ringlee

This list was developed for the owners of Volvo 7xx/9xx series cars who are interested in maintenance tips that are not generally available in commercial manuals. It was compiled from Brickboard and specific websites with useful information. Items which appeared to be of lasting value to 7xx/9xx/90 series owners were excerpted and copied to this file. Sincere thanks to all those who took the time to answer others' questions and contribute to this public discussion. Because these remarks represent contributors' personal opinions, users need to exercise caution about any advice given; indeed, some of the comments are contradictory. This list is current as of the revision date below and was compiled by Steve Ringlee, who is NOT a consulting mechanic but only recording secretary. While this public domain list may be shared either whole or in part without attribution, it may not be sold or rented. This site is not affiliated with nor sponsored by AB Volvo, Volvo Car Corporation, Volvo Cars of North America, Inc. or Ford Motor Company. "Volvo" is a registered trademark of AB Volvo and Volvo Cars of North America, with worldwi

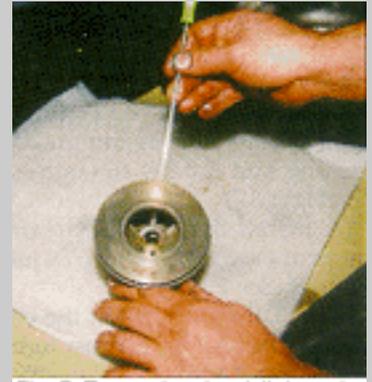
Fig. 5: Trapped carbon/oil deposits.

10. The carbon/oil deposits trapped in the main housing could fool you, as they look like the casting. Poke all around with a sharp object, and scrape away all the foreign particles! This is a very important step, as the oil has to drain through the housing without any restrictions (See Figure 5).

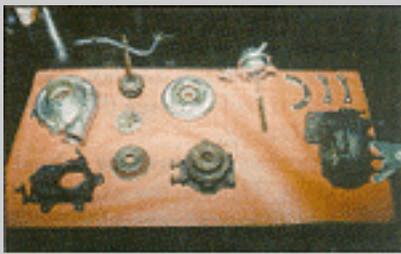
Fig. 6: Reassembly preparation.

11. Lay out the torn down turbo on a clean area with all the parts ready for assembly (See Figure 6).

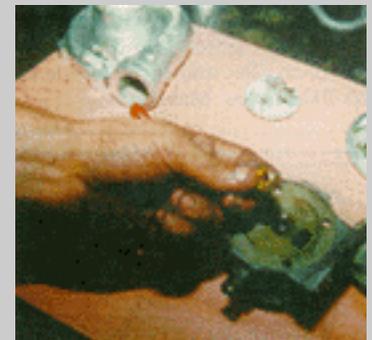
Fig. 7: Brass bushings in housing.

12. Replace brass bushings in housing and lube with engine oil (See Figure 7).

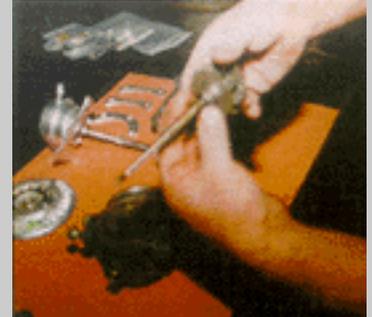
Fig. 9: Seal ring installation.

14. Install seal rings on the compressor side and the exhaust turbine (See Figures 9 & 10) and lube with oil.

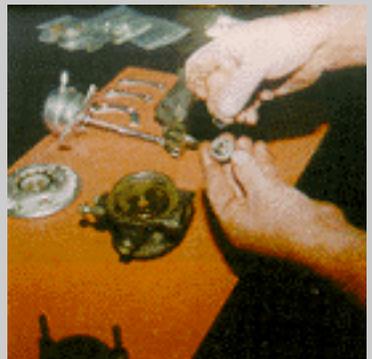
Fig. 10: Seal ring installation.

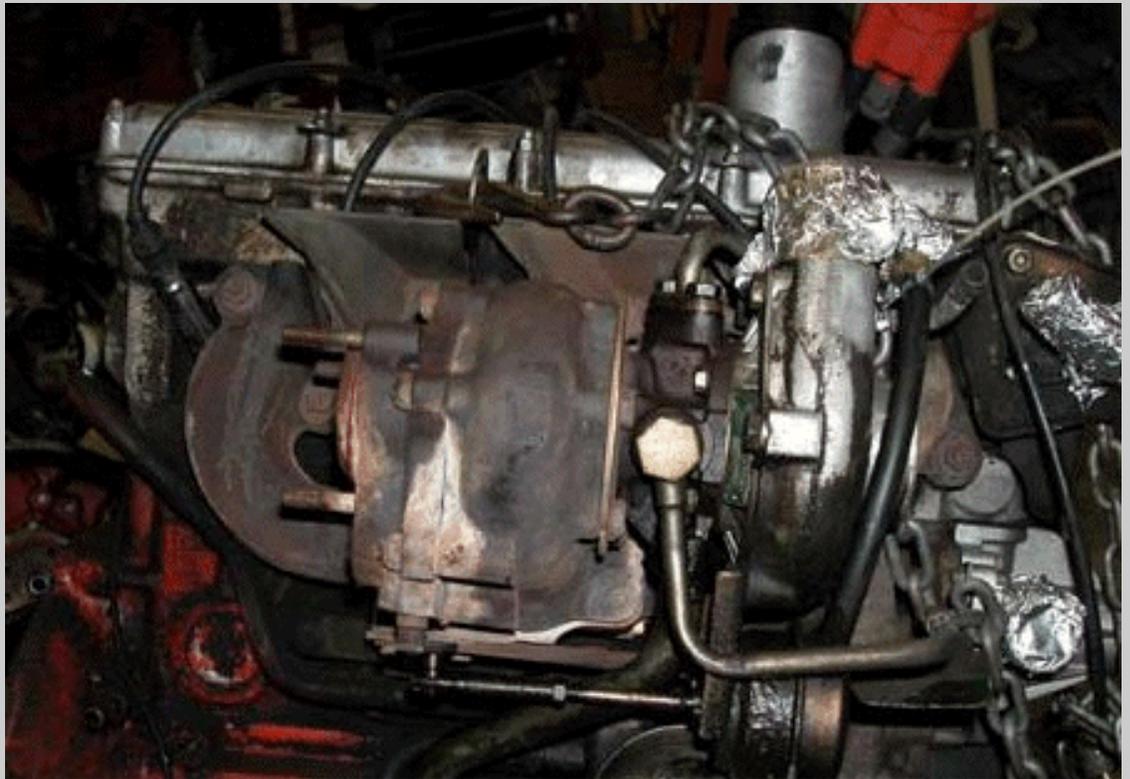
and most replacement T3s were water cooled. Note the flat flange oil supply directly on top of the turbo. The CBV (Compressor Bypass Valve) is mounted on the head and is on the far right of the picture.

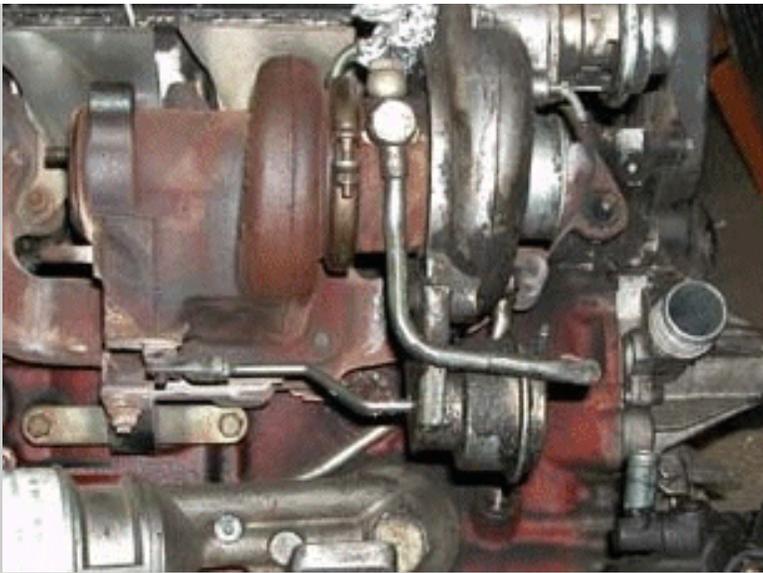
bolted to the exhaust manifold from the back side. This turbo is a factory rebuilt turbo. The original owners of the car didn't change oil very often, sometimes up to 12,xxx miles between changes. This turbo will put out more boost than the later Mitsubishi TD04, and the people who want lots of boost often use it. It has an integral CBV, as all the Mitsubishi turbos used on the 700/900 series do. 8

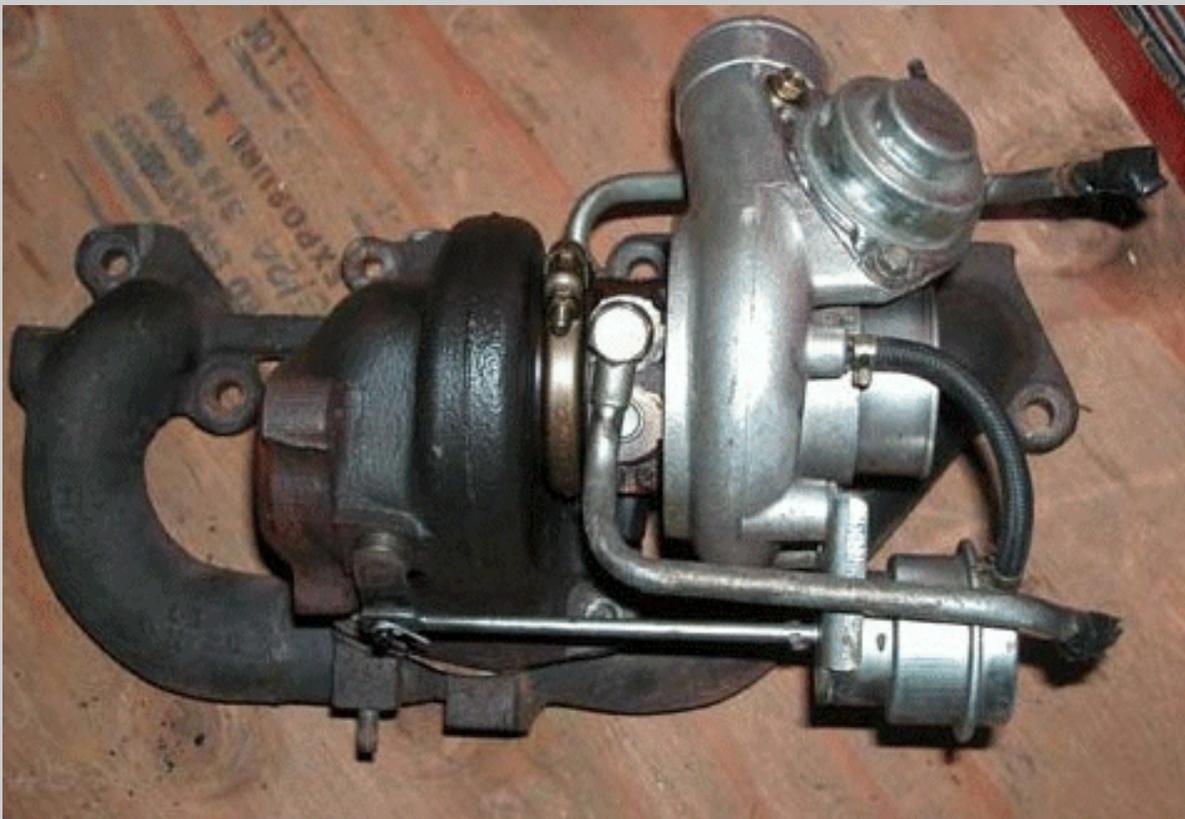
This is the later version of the Mitsubishi TD04 which is identified by the angular mounted CBV. There may be another version (with higher flow ratings) of this turbo used on a

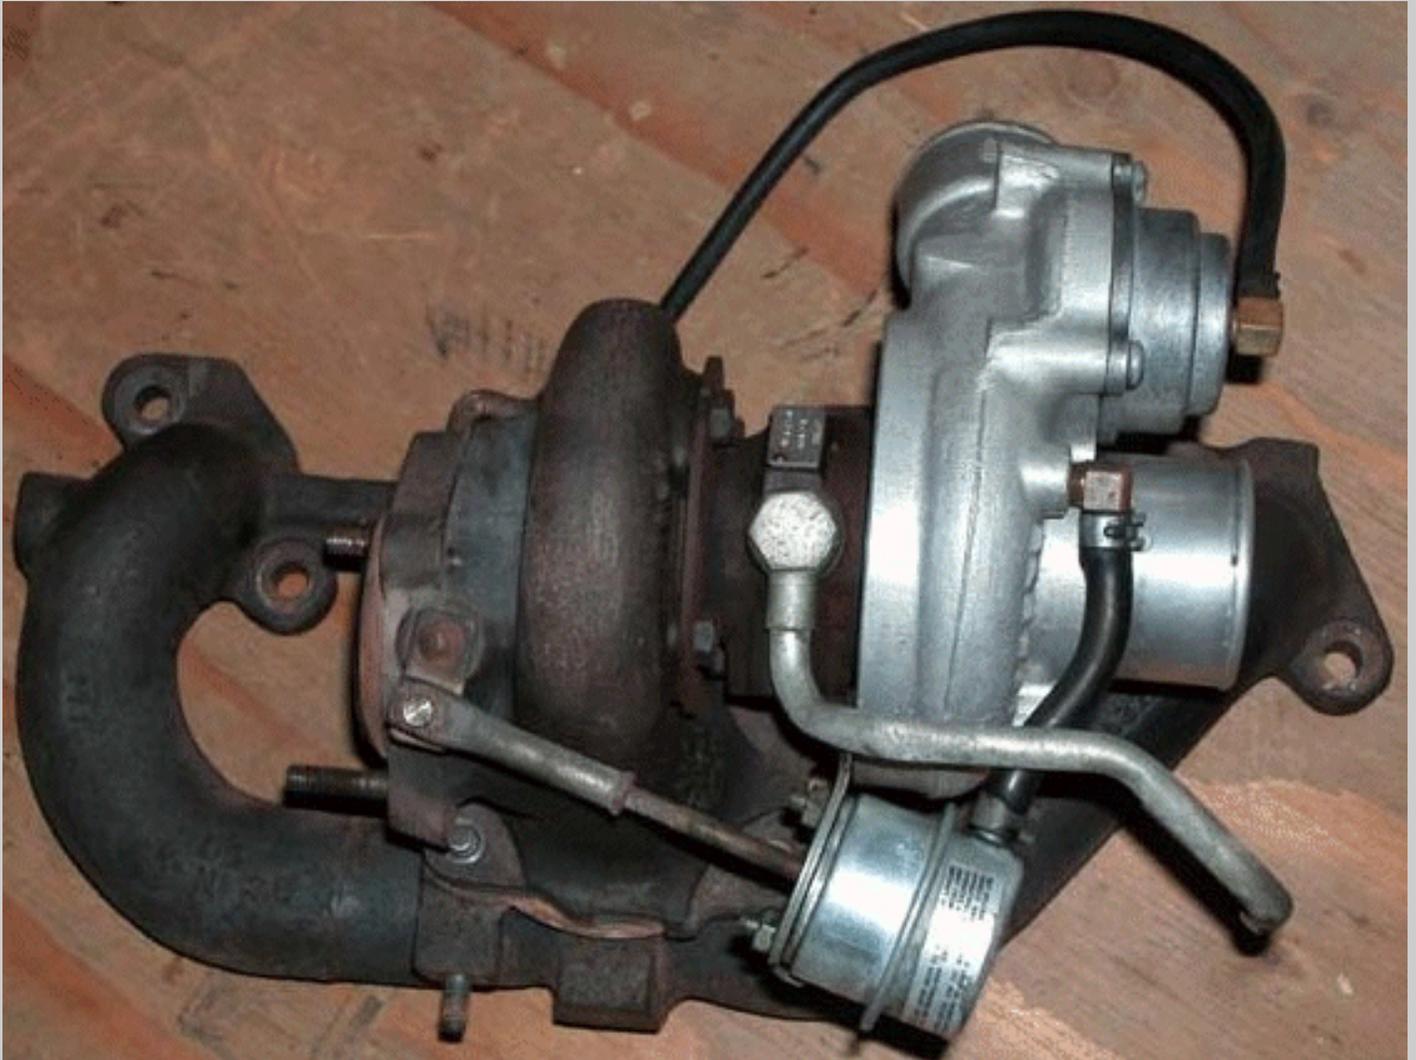
This is a Garrett T25. They are very rare. I bought this one from Brian Leppin and he said it is the only one he has ever seen. It has the integral CBV like the Mitsubishi turbos. It was used on the 940SE, and maybe a few other 700s and 900s. While the exhaust manifold for this turbo looks identical to the Mitsubishi exhaust manifold, the machined flanges which mate to the turbo and different and the exhaust manifolds won't interchange.

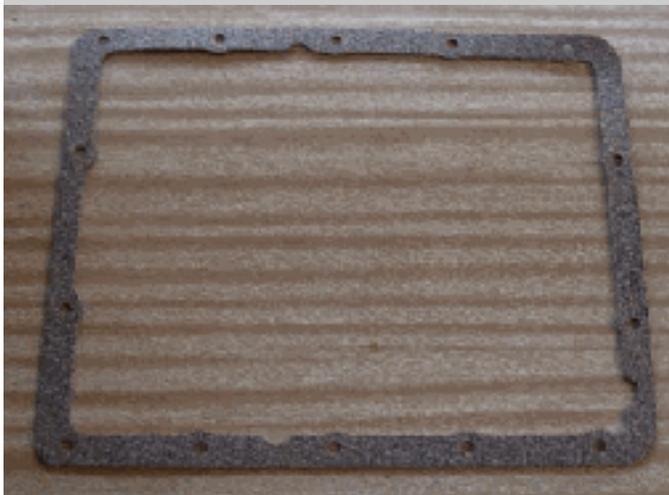
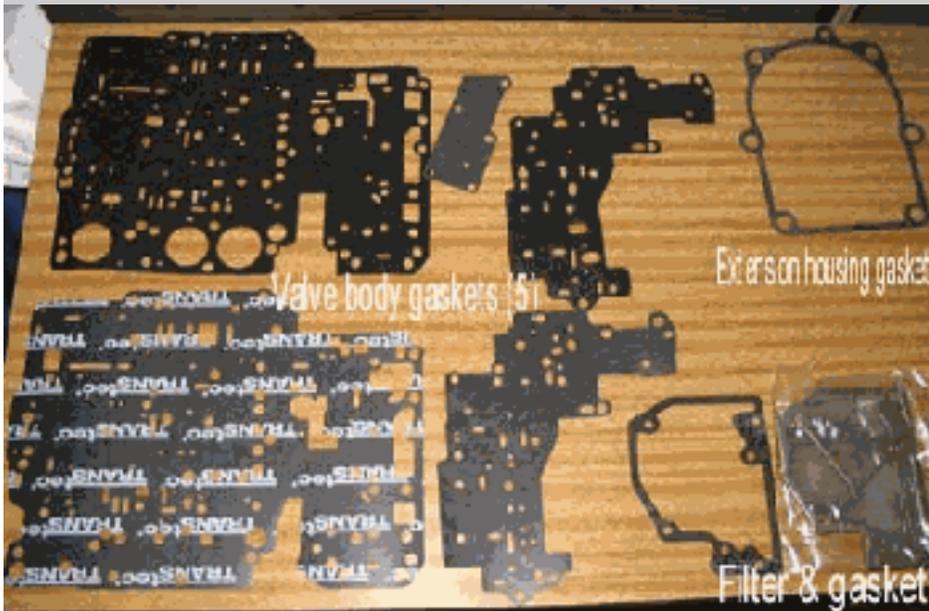
The valve body in the Aisin Warner 71L automatic transmission is a very complex piece of kit. Servicing this unit is not a job to be taken lightly. Go about it the wrong way and you could end up with costly repairs. Go about it the right way and the job is relatively simple albeit a bit challenging if it's your first time. Before even considering servicing the valve body there are some considerations: The Volvo Automatic Transmission service manual (TP 31642/1) is an absolute necessity. DON'T attempt this job without this manual. At a minimum, have the following parts on hand: Valve body gasket kit (5 gaskets), 5.5mm check balls (Volvo part number 1377746), transmission fluid, filter and filter gaskets (2), fluid pan gasket. See pics below.

Pan Gasket

Gasket Kit

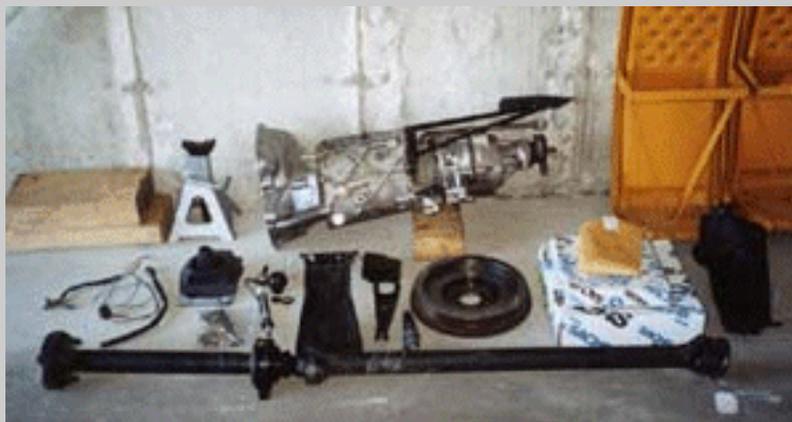
- M46 transmission
- M46 transmission mount
- 58-hole Flywheel (more about this later...)
- Clutch, pilot & throw-out bearings from [iPd](#)
- Driveshaft, from [Jeff Canter's Car World](#)
- U-joints, center bearing, & support
- Master Cylinder, from [B & D Used Auto Parts](#)
- Clutch Pedal, also from B & D
- Slave Cylinder, new from Volvo
- Clutch Hose, new from Volvo
- Clutch fork, new from Volvo
- Shift Lever and interior trim bits...
- M46 Overdrive Relay, from Car World

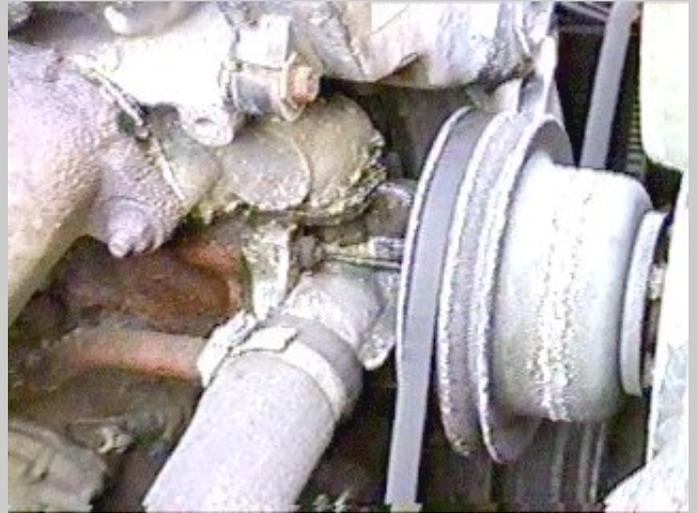
1. The water pump is attached to the front face of the engine block, by six (6) nuts and bolts, with an orifice on the top to the cylinder head, another on the right rear where a

metal pipe is joined to the pump with a bolt, and the bottom radiator hose connection, also on the right hand side.

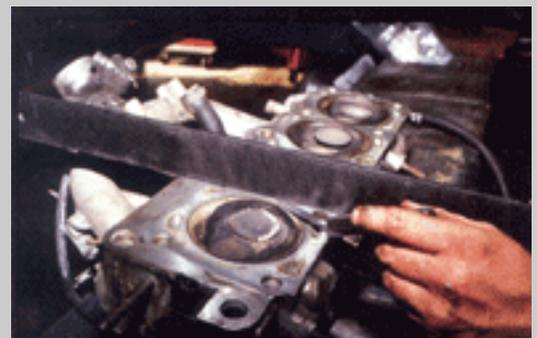
Fig 1. Check with a feeler gauge for warping between the surface and the straightedge.

For the head gasket to seal properly, the cylinder head and the engine block must be inspected for flatness. Place a straightedge lengthwise on the block and then the head. Check with a feeler gauge for warping between the surface and the straightedge. The total maximum amount of combined clearance between the head and block should not exceed .004 inch (see Fig. 1). Don't forget to check it crosswise (also should not exceed .004 inch).

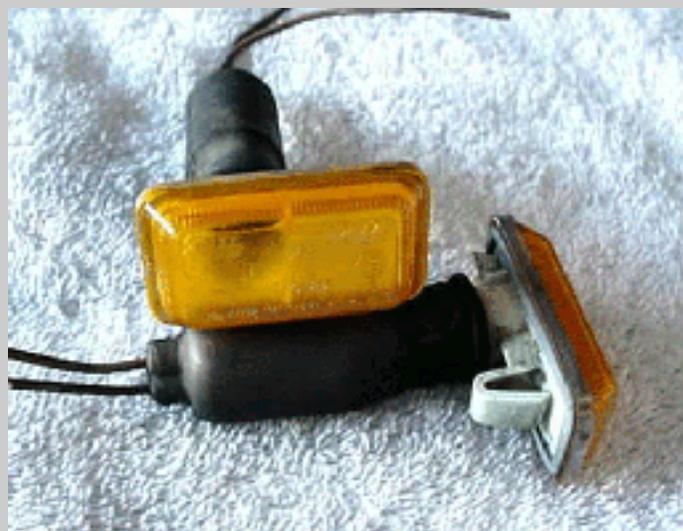
Where to Find Euro Side Marker Lamps. [Editor] New Hella side marker lamps and wiring kits are available from [IPD](#) (see the photo for their modern version of this lamp). Lamps without wiring kits similar to the amber version in the photo are available from aftermarket dealers serving Porsche and Audi owners, including [Pelican Parts](#) and [Vertex](#). Search their catalogs for European side marker lamps used on mid-1980s Porsche 911 cars. Used lamps and wiring connectors may be had from recycling yards with mid-80s Audi 4000 or Porsche 911/912 cars. To remove these from existing cars, just use your fingers to push the light forward (towards the front bumper) it will then come free on the back side and then it's loose.

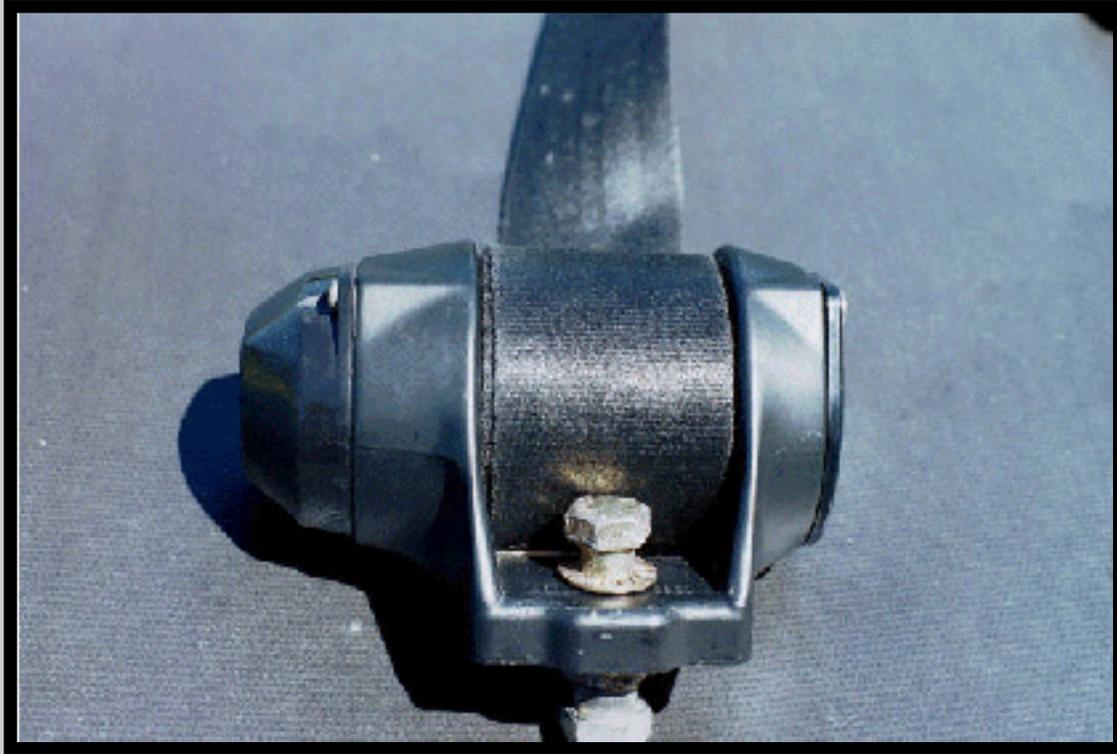
Retractor with mounting hardware

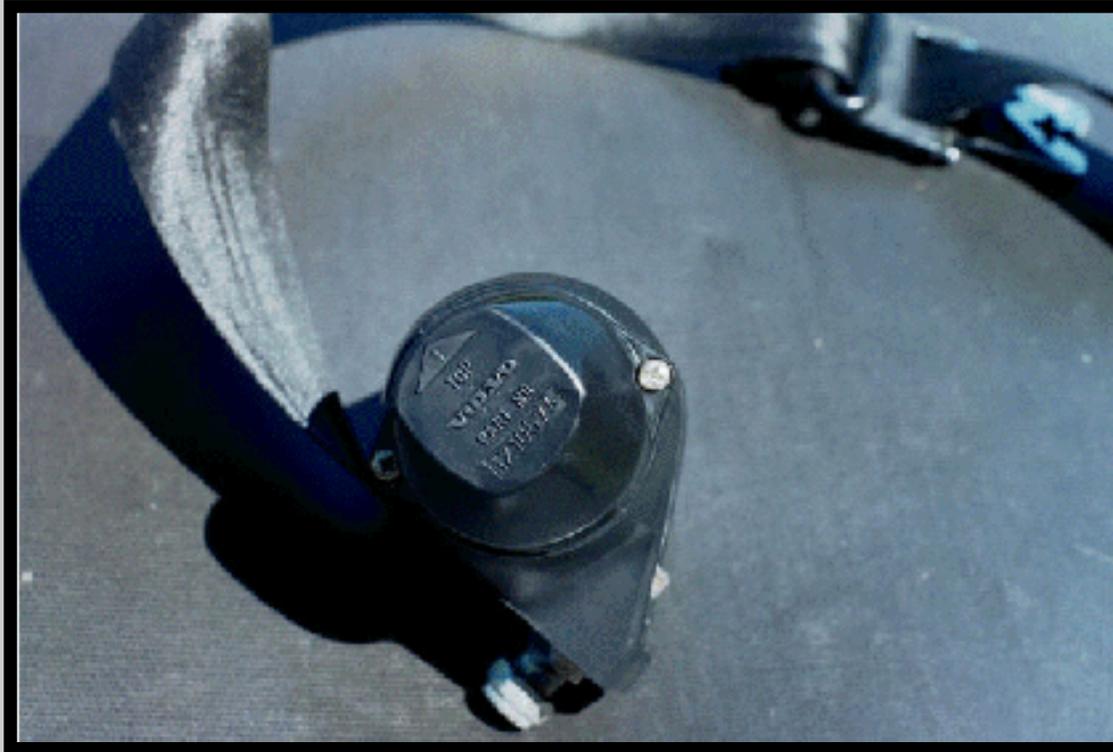
Showing part number on small end.

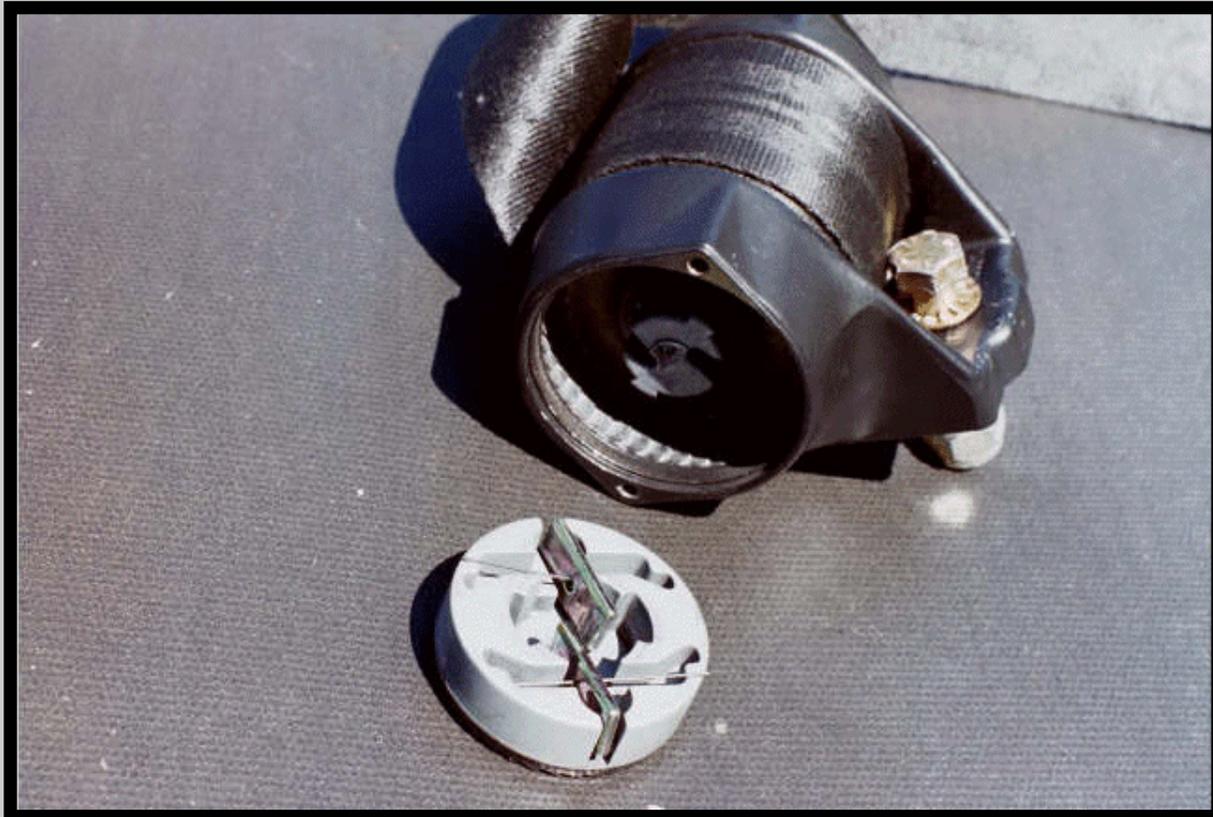
The two plates are held in place by spring wires. One of the wires was not in its slot, allowing the plate to easily lock the belt -- too easily.

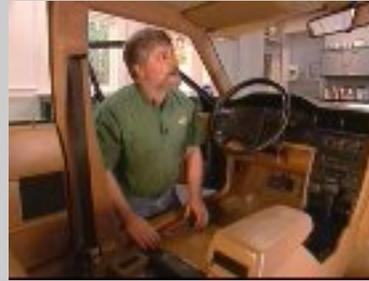
Figure B

- With the seats removed (**figure B**), there is more room to work. In order to get

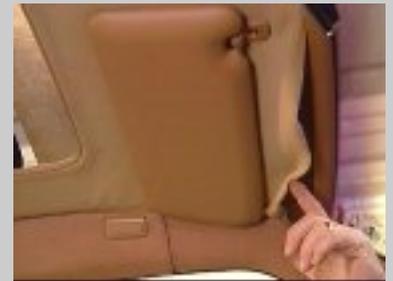
Figure C

In some cases, the headliner may not merely be sagging, but may actually come detached from underneath trim pieces (**figure C**). This can interfere with driver sight-line and cause a driving hazard.

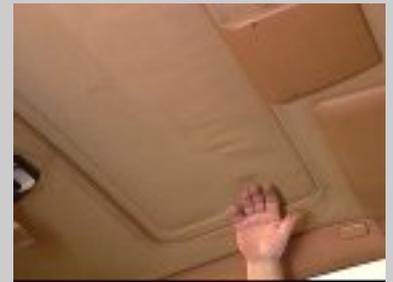
Figure D

Since our vehicle has a sunroof that is also covered in fabric (**figure D**), the sunroof panel will need to be removed and re-covered as well. (The sunroof has a vent panel inside the sunroof headliner.)

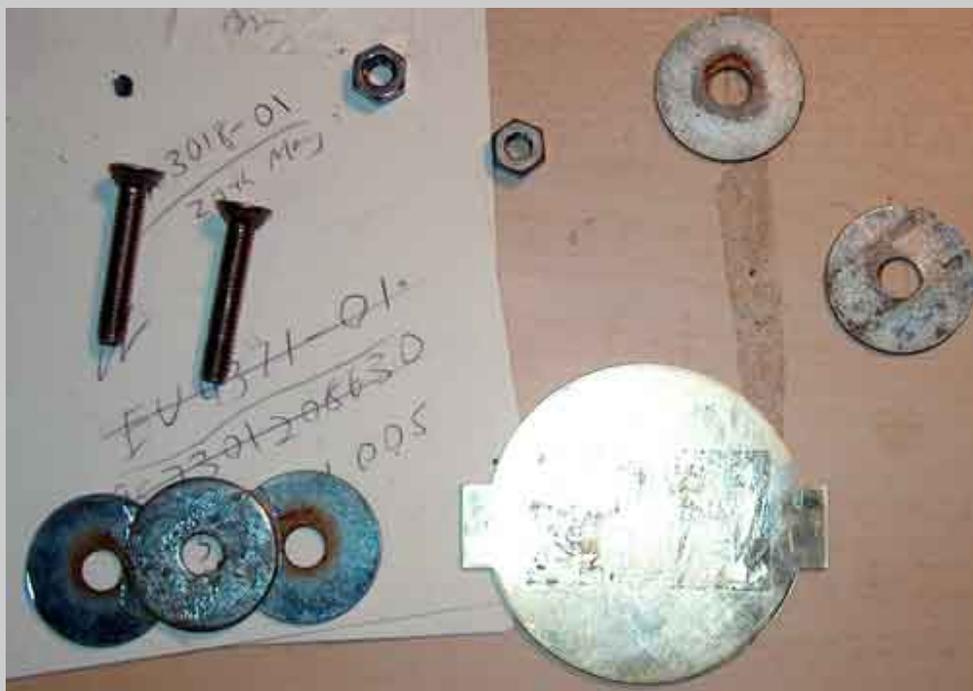
Parts you'll need. Mine uses 5 washers but I have been able to make them with 4. You will need 2 screws, 2 nuts, and a high mileage badge.

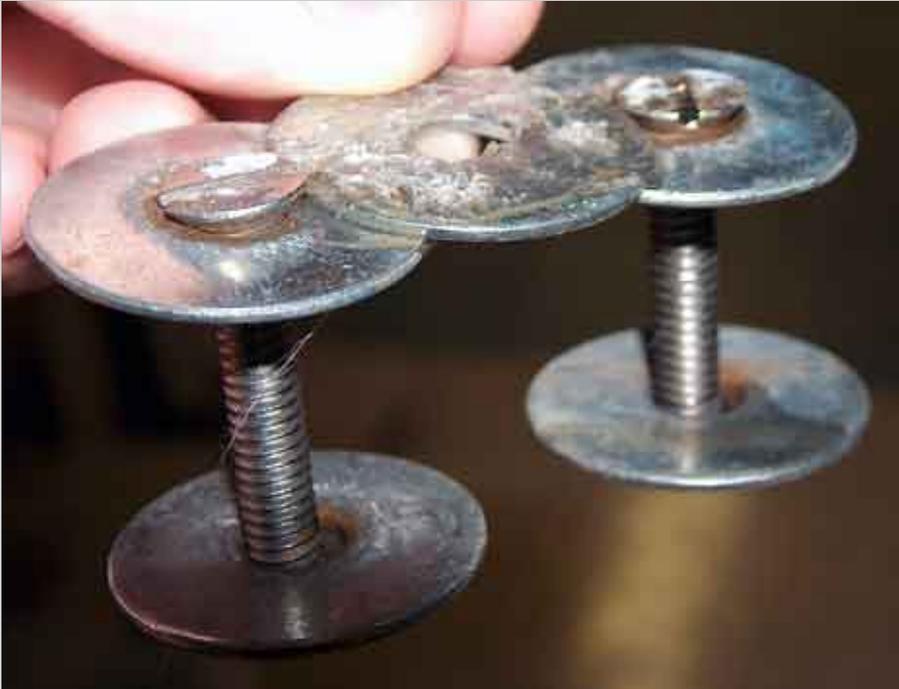
This is
what the
mounting
bracket
looks
like
without
the
badge.

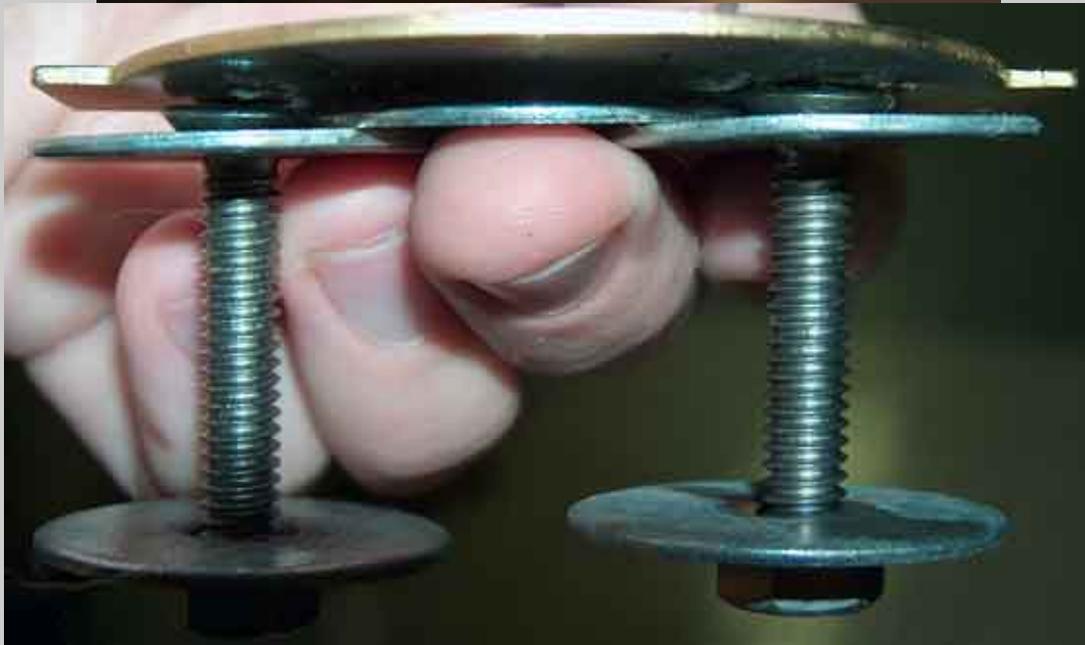
Picture
of the
mounting
bracket
with the
badge.
Not
glued
together
yet.

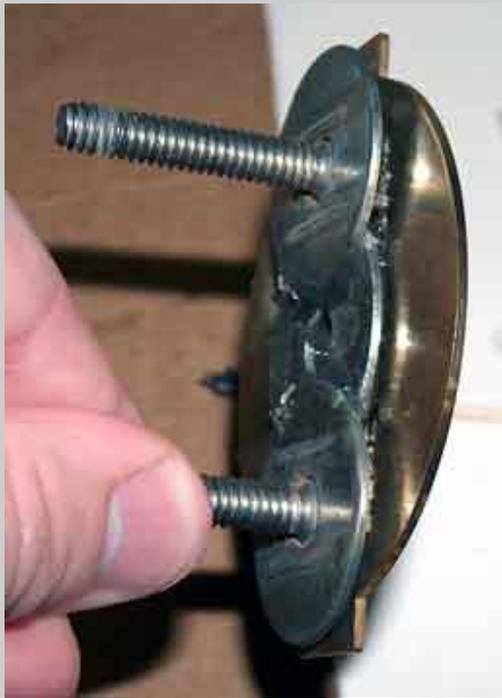
Picture
of the
mounting
bracket
glued to

the badge. I used J. B. kwik weld for this. I am sure any decent glue will work.

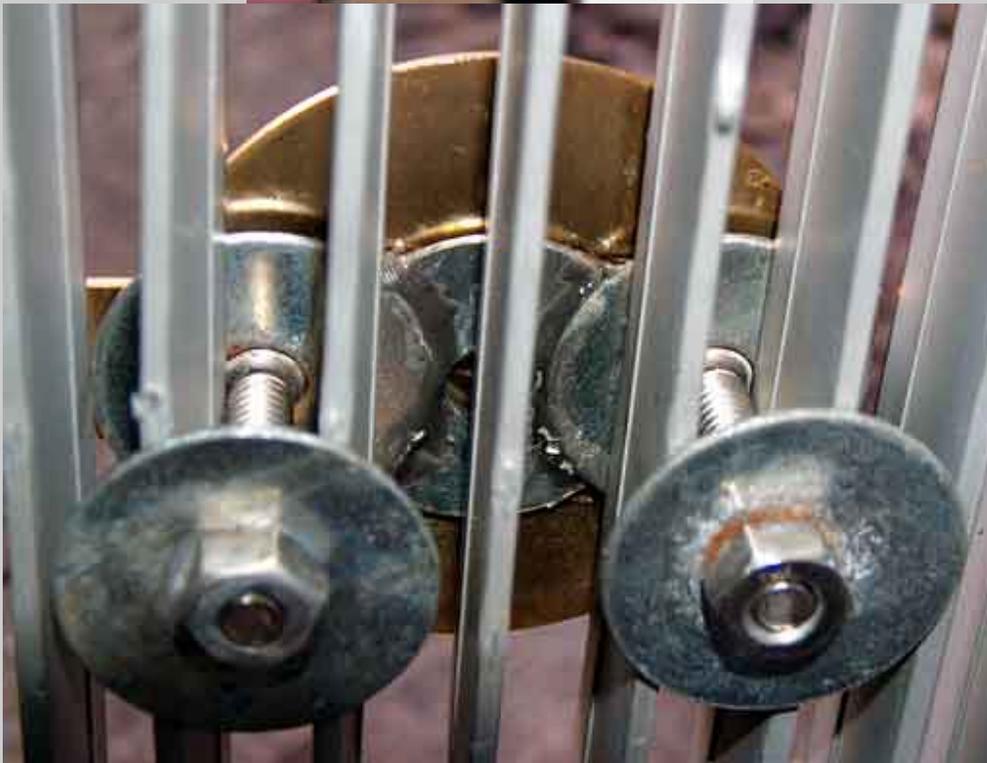
The mount bracket/ badge mounted to the grill. It is held in place by the nuts.

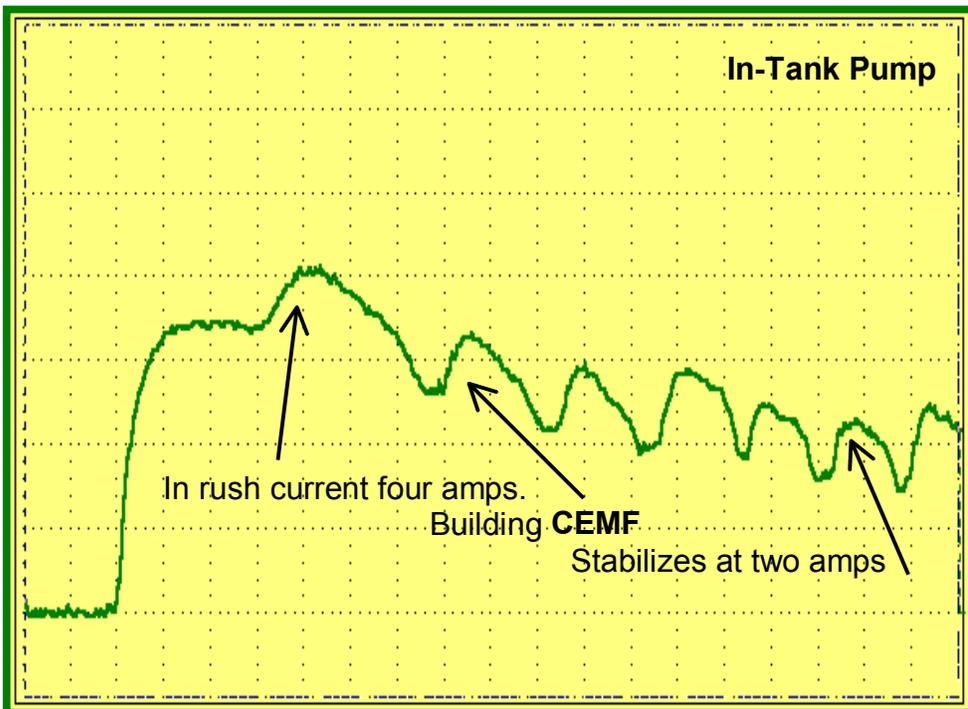
The in-tank pump stabilizes at two amps. This is a much smaller pump and is supplying the main pump. This pumps trace is showing a good pump and circuit.

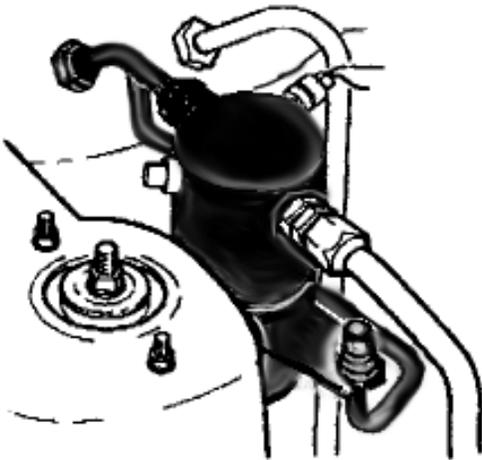
Basic Kit 9145660-8

The illustration shows a car with the pipe runs and the factory filling valve installed.

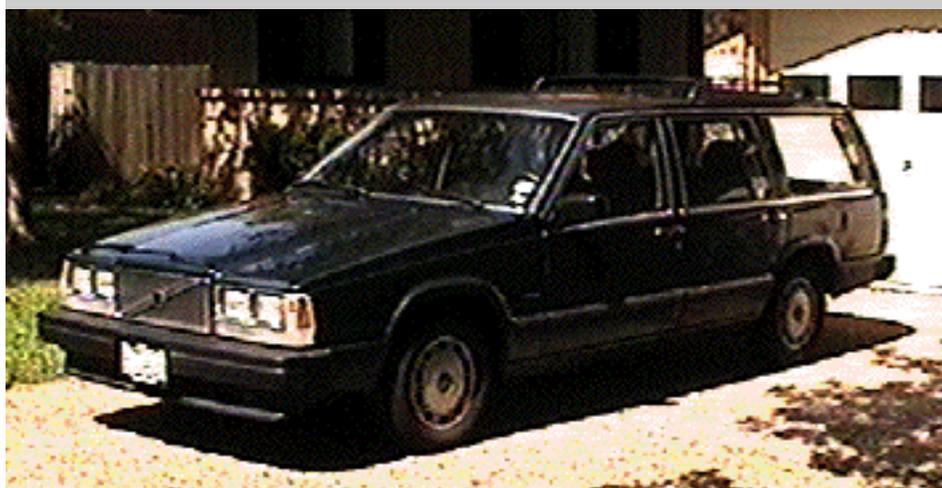
Here are some pictures of the retrofitted parts. Looks about the same.

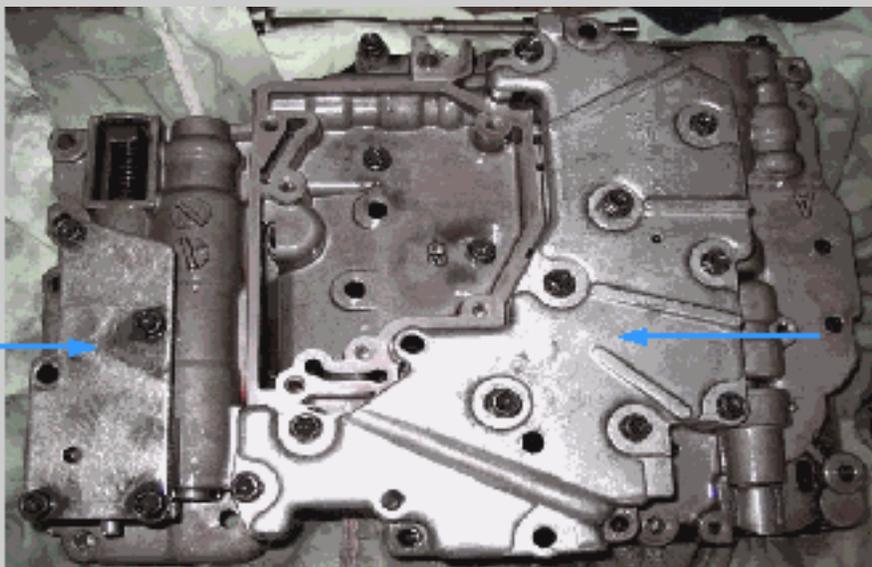
Underside of valve body on bench. Front is to the left. The arrows point to the 2 covers. Remove 5 bolts to finally separate the upper and lower sections of the valve body. See step 11.

11. Pull the gear selector valve gently out of its bore and also undo the bolt holding the selector pawl and remove it and place it aside. Refer to your manual and remove the last 5 10mm bolts to separate the upper and lower sections of the valve body. Grasp the lower valve body and the gaskets and separator plate and CAREFULLY lift off the lower valve body and place it, right way up, on the bench. See pics below.

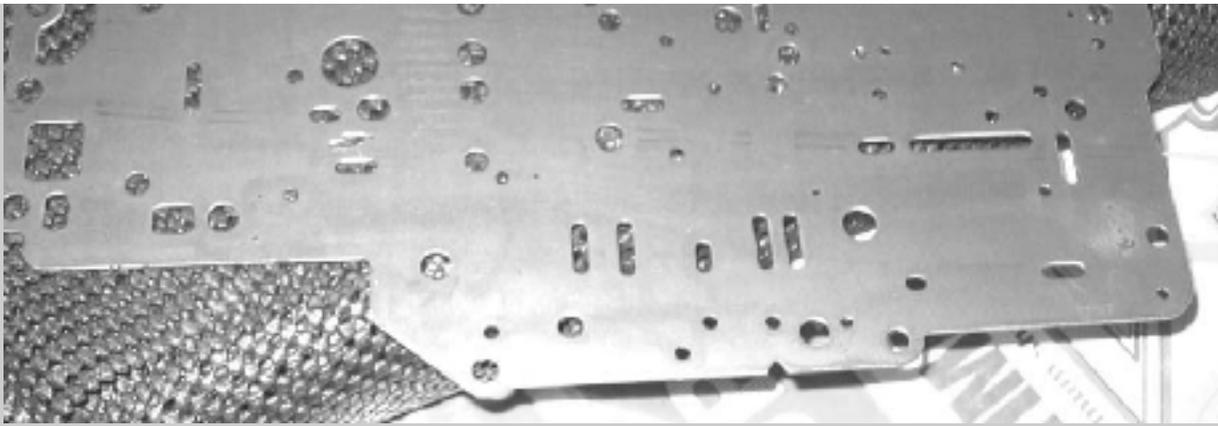
Valve body separator plate. This goes between the lower and upper gaskets as noted in the text.

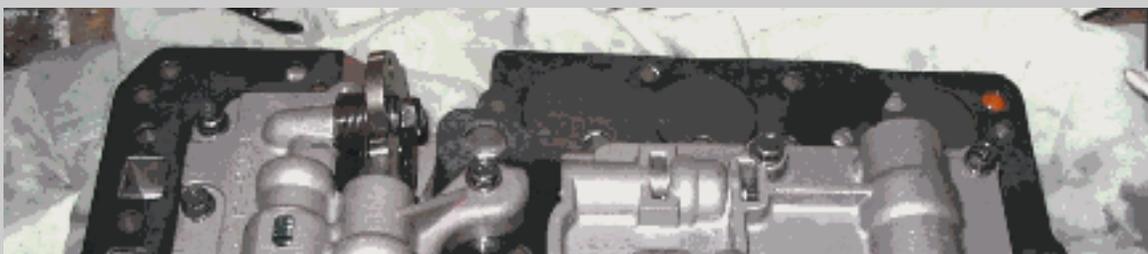
27. Remove the bolt from the lower valve body that was put there to hold everything in place. Position the upper front valve body and pick up the lower valve body and turn it over onto the upper front valve body. Put in the bolts finger tight. Turn over the whole unit and put in the upper bolts. Torque all bolts alternately to 3.5 - 4.5 ft lbs. (5 - 6 Nm). See pic below.

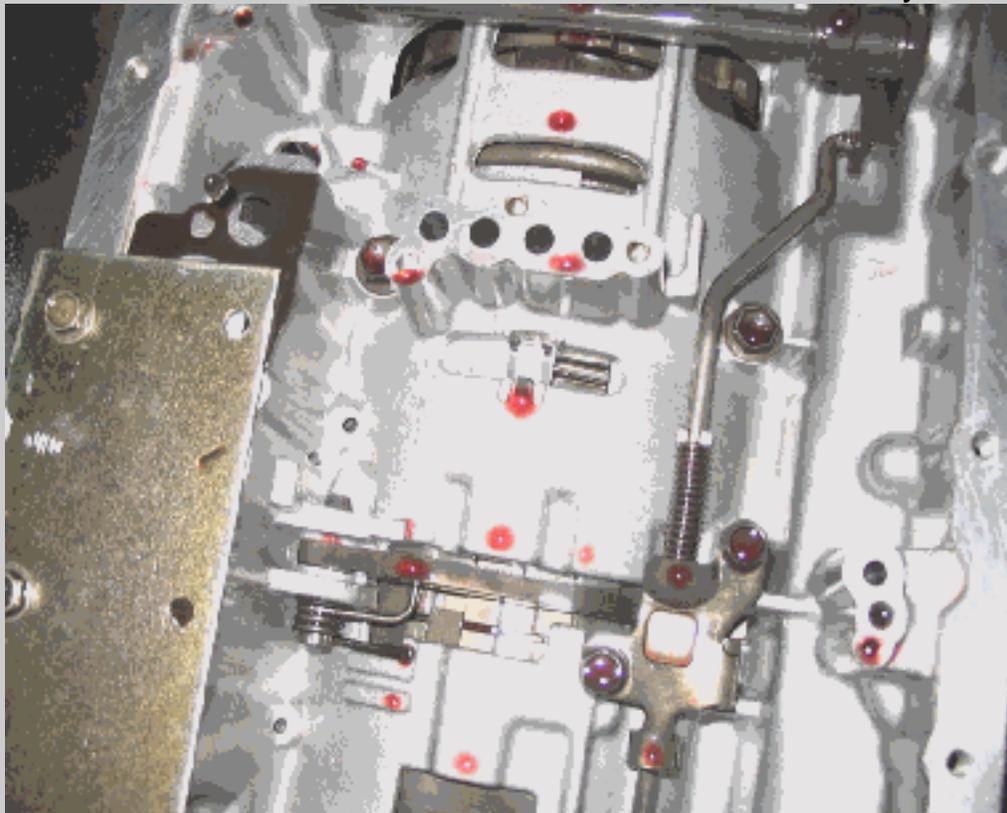
Front is to the top. Note the accumulator piston retainer plate in position on the left. This is held in place using 3 oil pan bolts.

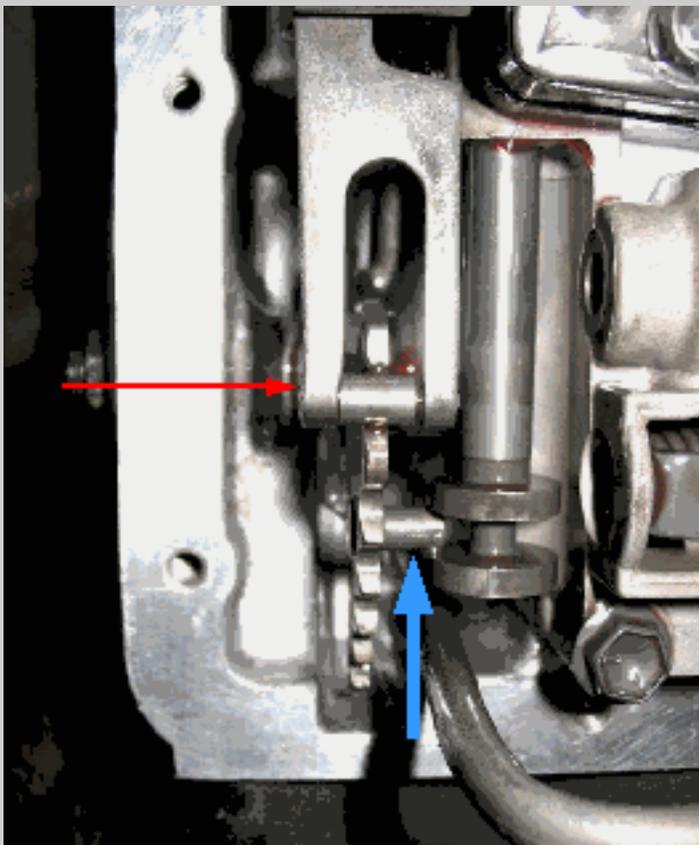
The pawl on the valve body (red arrow) should engage in the last detent of the gear selector cam when the gear selector lever is in park. Ensure that the pin is located in the gear selector valve (blue arrow).

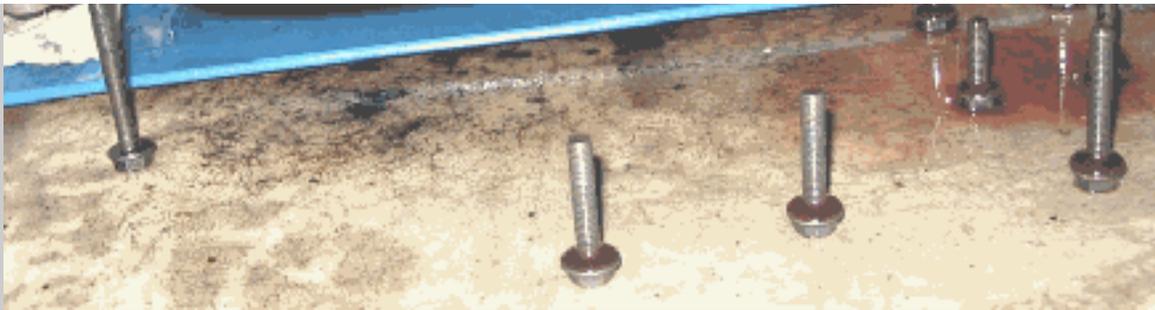
These are the valve body retaining bolts. It's a little hard to tell but they are different sizes. The bolts in the foreground are at the back of the valve body. They have been placed on the floor in positions relating to their positions in the valve body. You can see part of the valve body to the left facing the correct way ready to go in. The kick-down cam is visible at the top.

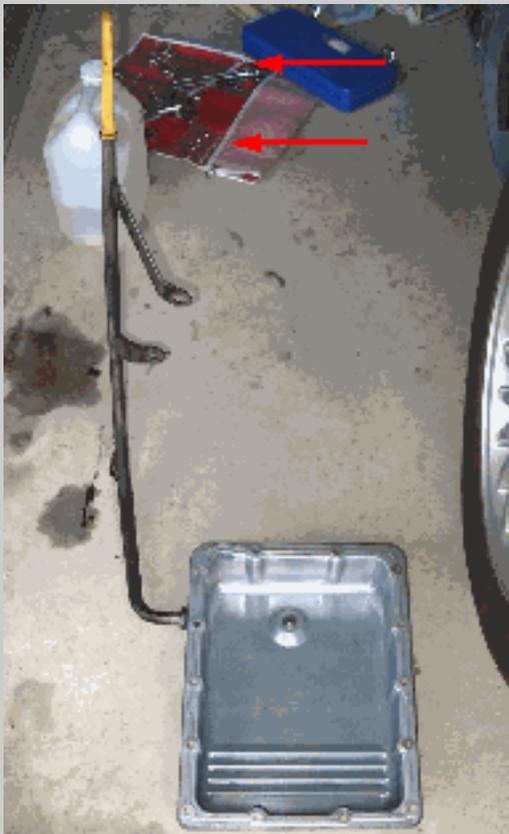
Pan & filler tube clean and ready to install. The filler tube stayed on because the nut had seized up. Starter motor bolts were removed to get the pan off. The arrows point to the brackets that are held in by the starter motor bolts.

34. Reattach the kick-down cable if you didn't do it earlier. Ensure that the cam pulley can return to its full rest position. Adjust the cable if necessary.
35. Clean out the oil pan and place its gasket in position. See pic below. Install the pan on the transmission and bolt in place. Torque for sump bolts is 3 - 3.5 ft lbs. (4 - 5 Nm).
36. Place the starter motor in position and install the bolts to secure it and the filler tube in position. Reattach the wires to the starter motor.

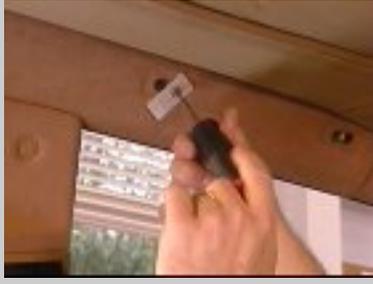
(figure A).

- Begin by removing the trim pieces in the front of the car using a torx driver

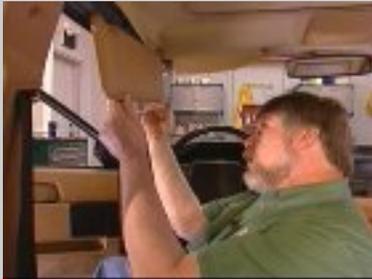
Figure B

- Remove the rear-view mirror.
- Remove the sun-roof motor cover.
- Since the sun visors are mounted into the headliner, they will need to be removed also (**figure B**), as well as the sun visor clips (**figure C**).

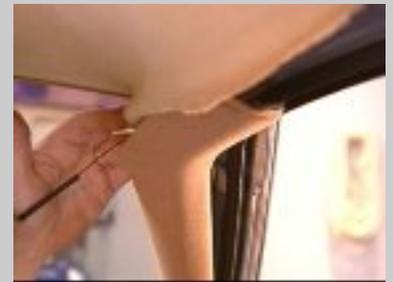
Figure D

Tip: You can use a pair of scissors to cut a slit in the headliner board and fabric to make it easier to move the wiring harness out of the way (**figure D**). The cut can later be concealed under the plastic trim piece.

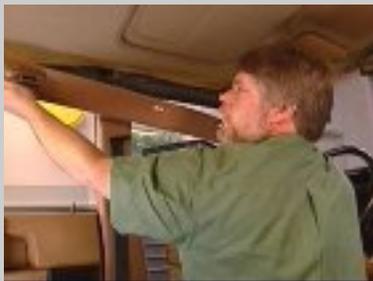
Figure E

- In the back seat, remove the covers from the grab-bars so that the mounting screws can be removed in order to take down the grab bars. Remove the rear courtesy light and detach it from its wiring harness.
- Remove the side trim-panel (**figure E**) first, followed by the rear trim panel.

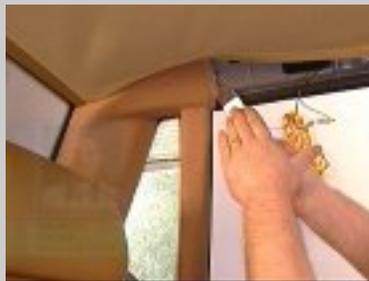
Figure F

- Use a headliner tool (or wooden spatula) to loosen and remove trim panel pieces (**figure F**). These pieces are removed by popping out the retaining clips behind each panel.

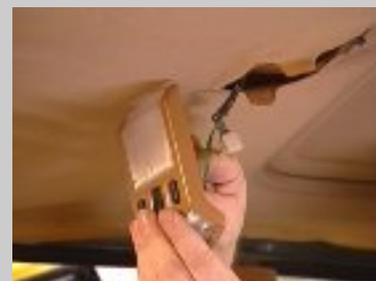
Figure G

- Remove the dome light (**figure G**), taking care not to avoid chipping the cut-out in the headliner board that accommodates the light assembly.

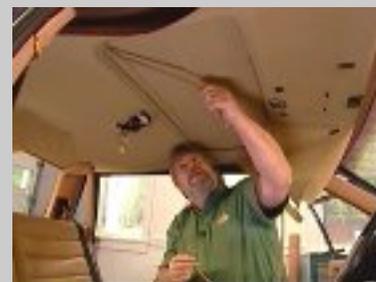
Figure H

- Remove the flexible edging around the sunroof that anchors the headliner cloth to the opening in the roof (**figure H**).

Note: Replace the sunroof edging if it is hard, cracked or broken.

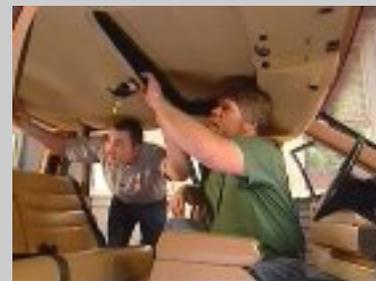
Figure I

- With the sunroof liner and all of the other trim pieces removed, the process of dropping and removing the headliner can begin by pulling downward in the center of the headliner board (**figure I**). Flex the board gently from the center, allowing the board to bow and begin to come loose.

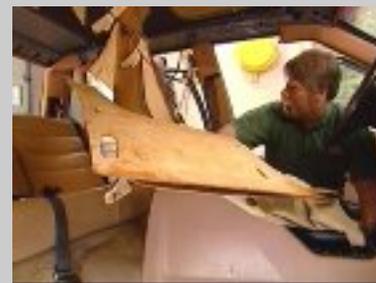
Figure J

- Take your time as you remove the headliner board. The corners of the board are the areas most likely to break.
- **Important:** The headliner board can be taken out in one piece by curving or bending it, but *only* if this is done slowly and carefully. Bending the board too abruptly will cause the board to crack (**figure J**),

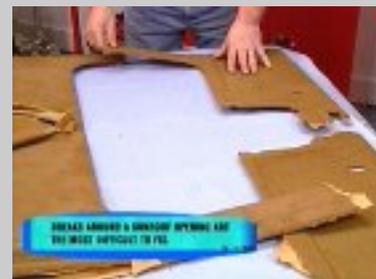
Figure K

- Since our board did, in fact, break apart upon removal (**figure K**), repair would be required. This situation is not uncommon since sun and heat damage typically causes headliner boards to become brittle and increasingly fragile over time. Many are simply made from a pressed-cardboard material. However, the damage to this board was repairable.

Since our headliner board broke apart upon removal to fix a sagging headliner, repair to the board would be required. This situation is not uncommon since sun and heat damage typically causes headliner boards to become brittle and increasingly fragile

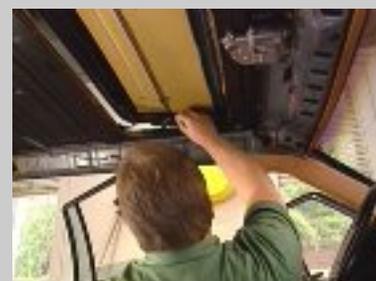
Figure L

- With the sunroof in the vent position, use needle-nose pliers to release the springs so that the sunroof headliner will lay flat.
- Slide the panel back so that the top can be removed.
- Mark the locations of the sunroof mounting screws carefully (**figure L**), then remove the screws.
- With the screw removed, carefully lift off the top of the sunroof (**figure M**).
- Remove the sunroof air-dam.
- With the top portion of the sunroof removed, the sunroof headliner simply pops out (**figure N**).
- Inspection of our sunroof headliner reveals that it is

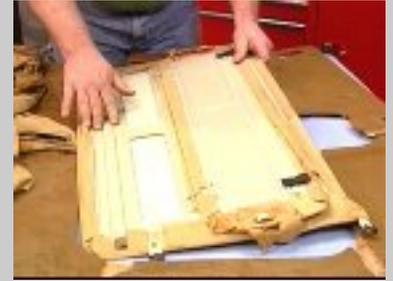
Figure O

in fairly good shape. The fabric on the sunroof headliner is actually attached to a metal framework (**figure O**). Repair for the sunroof headliner should be fairly simple when compared to the overall headliner repair.

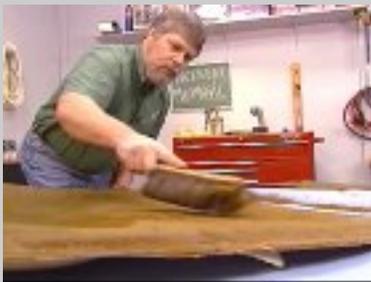
Figure A

- Begin by scrubbing all of the old foam and glue from the headliner board using a soft-bristle brush or coarse sandpaper. (**figures A and B**). This step is critical to repair of the old board since the new covering will need a clean surface to adhere to. Without a good attachment, a new covering will sag just as the old one did.

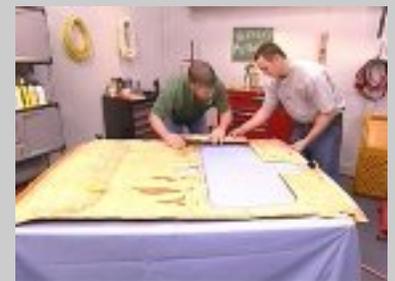
Figure C

- The repair begins of the back (underneath) side of the headliner board. Lay the broken pieces out onto a flat surface to align them (**figure C**).
- Use caution when aligning the pieces to avoid overlapping the edges. Creases left from overlapping will show through the new fabric.
- You can use ordinary duct-tape to join the cracks where the pieces join together (**figure D**). Double-tape all of the cracks to ensure a secure repair.
