Volvo Maintenance FAQ for 7xx/9xx/90 Cars

Editor: S. Ringlee

This list was developed for the owners of Volvo 7xx/9xx series cars who are interested in maintenance tips that are not generally available in commercial manuals. It was compiled from Brickboard and specific websites with useful information. Items which appeared to be of lasting value to 7xx/9xx/90 series owners were excerpted and copied to this file. Sincere thanks to all those who took the time to answer others' questions and contribute to this public discussion. Because these remarks represent contributors' personal opinions, users need to exercise caution about any advice given; indeed, some of the comments are contradictory. This list is current as of the revision date below and was compiled by Steve Ringlee, who is NOT a consulting mechanic but only recording secretary. While this public domain list may be shared either whole or in part without attribution, it may not be sold or rented. This site is not affiliated with nor sponsored by AB Volvo, Volvo Car Corporation, Volvo Cars of North America, Inc. or Ford Motor Company. "Volvo" is a registered trademark of AB Volvo and Volvo Cars of North America, with worldwi

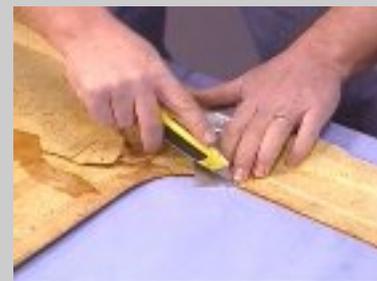
Figure E

using a razor knife (**figure E**).

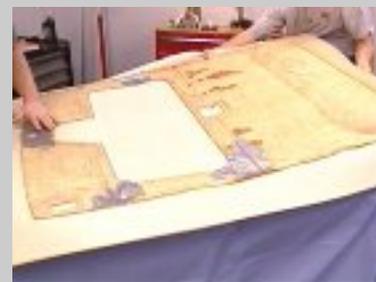
Figure J

- With the headliner fabric in place and properly contoured, you can flip the headliner board over (**figure J**) to trim the excess fabric from the edges.
- Start by cutting around the outside, leaving an inch or so of overlap. For the sunroof opening - cutout leaving 6" fabric to secure to the roof opening in the sunroof frame. (**figure K**).

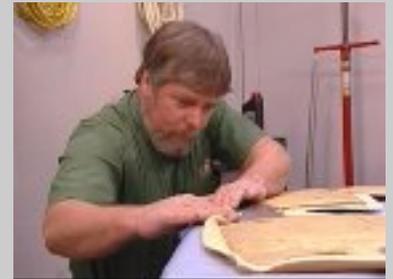
Figure L

- Use your scissors to punch holes in the fabric in the appropriate locations for the visors and mirror.
- Fold the overlap along the edges and glue it down along the front and back (**figure L**).

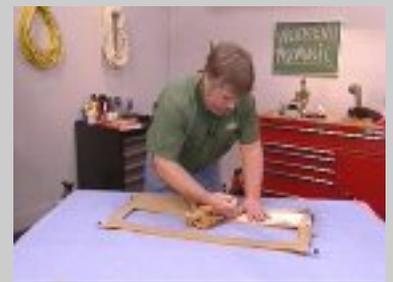
Figure M

- This **sunroof panel**, is consists of two pieces that will be covered separately. Begin by peeling off the old fabric covering the panels (**figure M**). This may be more difficult to remove than the fabric that was covering the headliner but the glue is easier to remove and cleanup is quicker.

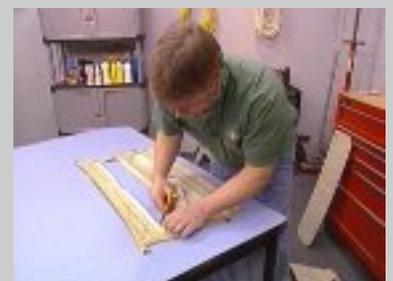
Figure O

- Once the glue has set, cut an opening for the vent and trim away the excess (**figure O**). Fold over any remaining overlap and glue it down tight.
- Repeat the steps for the other portion of the sunroof panel. Remember that glue only needs to be applied so that the edges are secured on the underneath side of the panel -- unlike the gluing process used earlier for the headliner board.

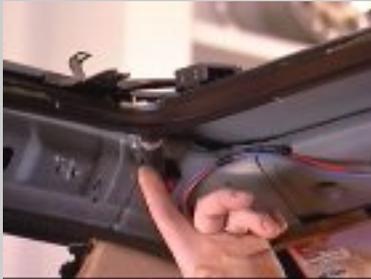
Figure P

- With the sunroof removed, it's a good time to check some of the operating components such as the drains and motor. On this vehicle, the drains connect to four separate water hoses (**figure P**) that drain the water away and out of the car. Check the drains to ensure that they are not clogged, and check the hoses and clamps to make sure they are in good order. Also check the drain troughs to ensure that they are not blocked with debris.
- Check to see if your sunroof mechanism needs lubrication. Since our vehicle has a power sunroof, we took this opportunity to check the electric motor and wiring (**figure Q**). If your power sunroof motor is dragging or causing problems, this would be a good time to replace it.
